US Army Corps
of Engineers

Kansas Citys Levees
Kansas and Missouri Rivers
Feasibility Report

Appendix D
Hazardous and Toxic Waste

HTRW Investigation
Kansas and Missouri Rivers
Reaches in the Vicinity of Kansas City

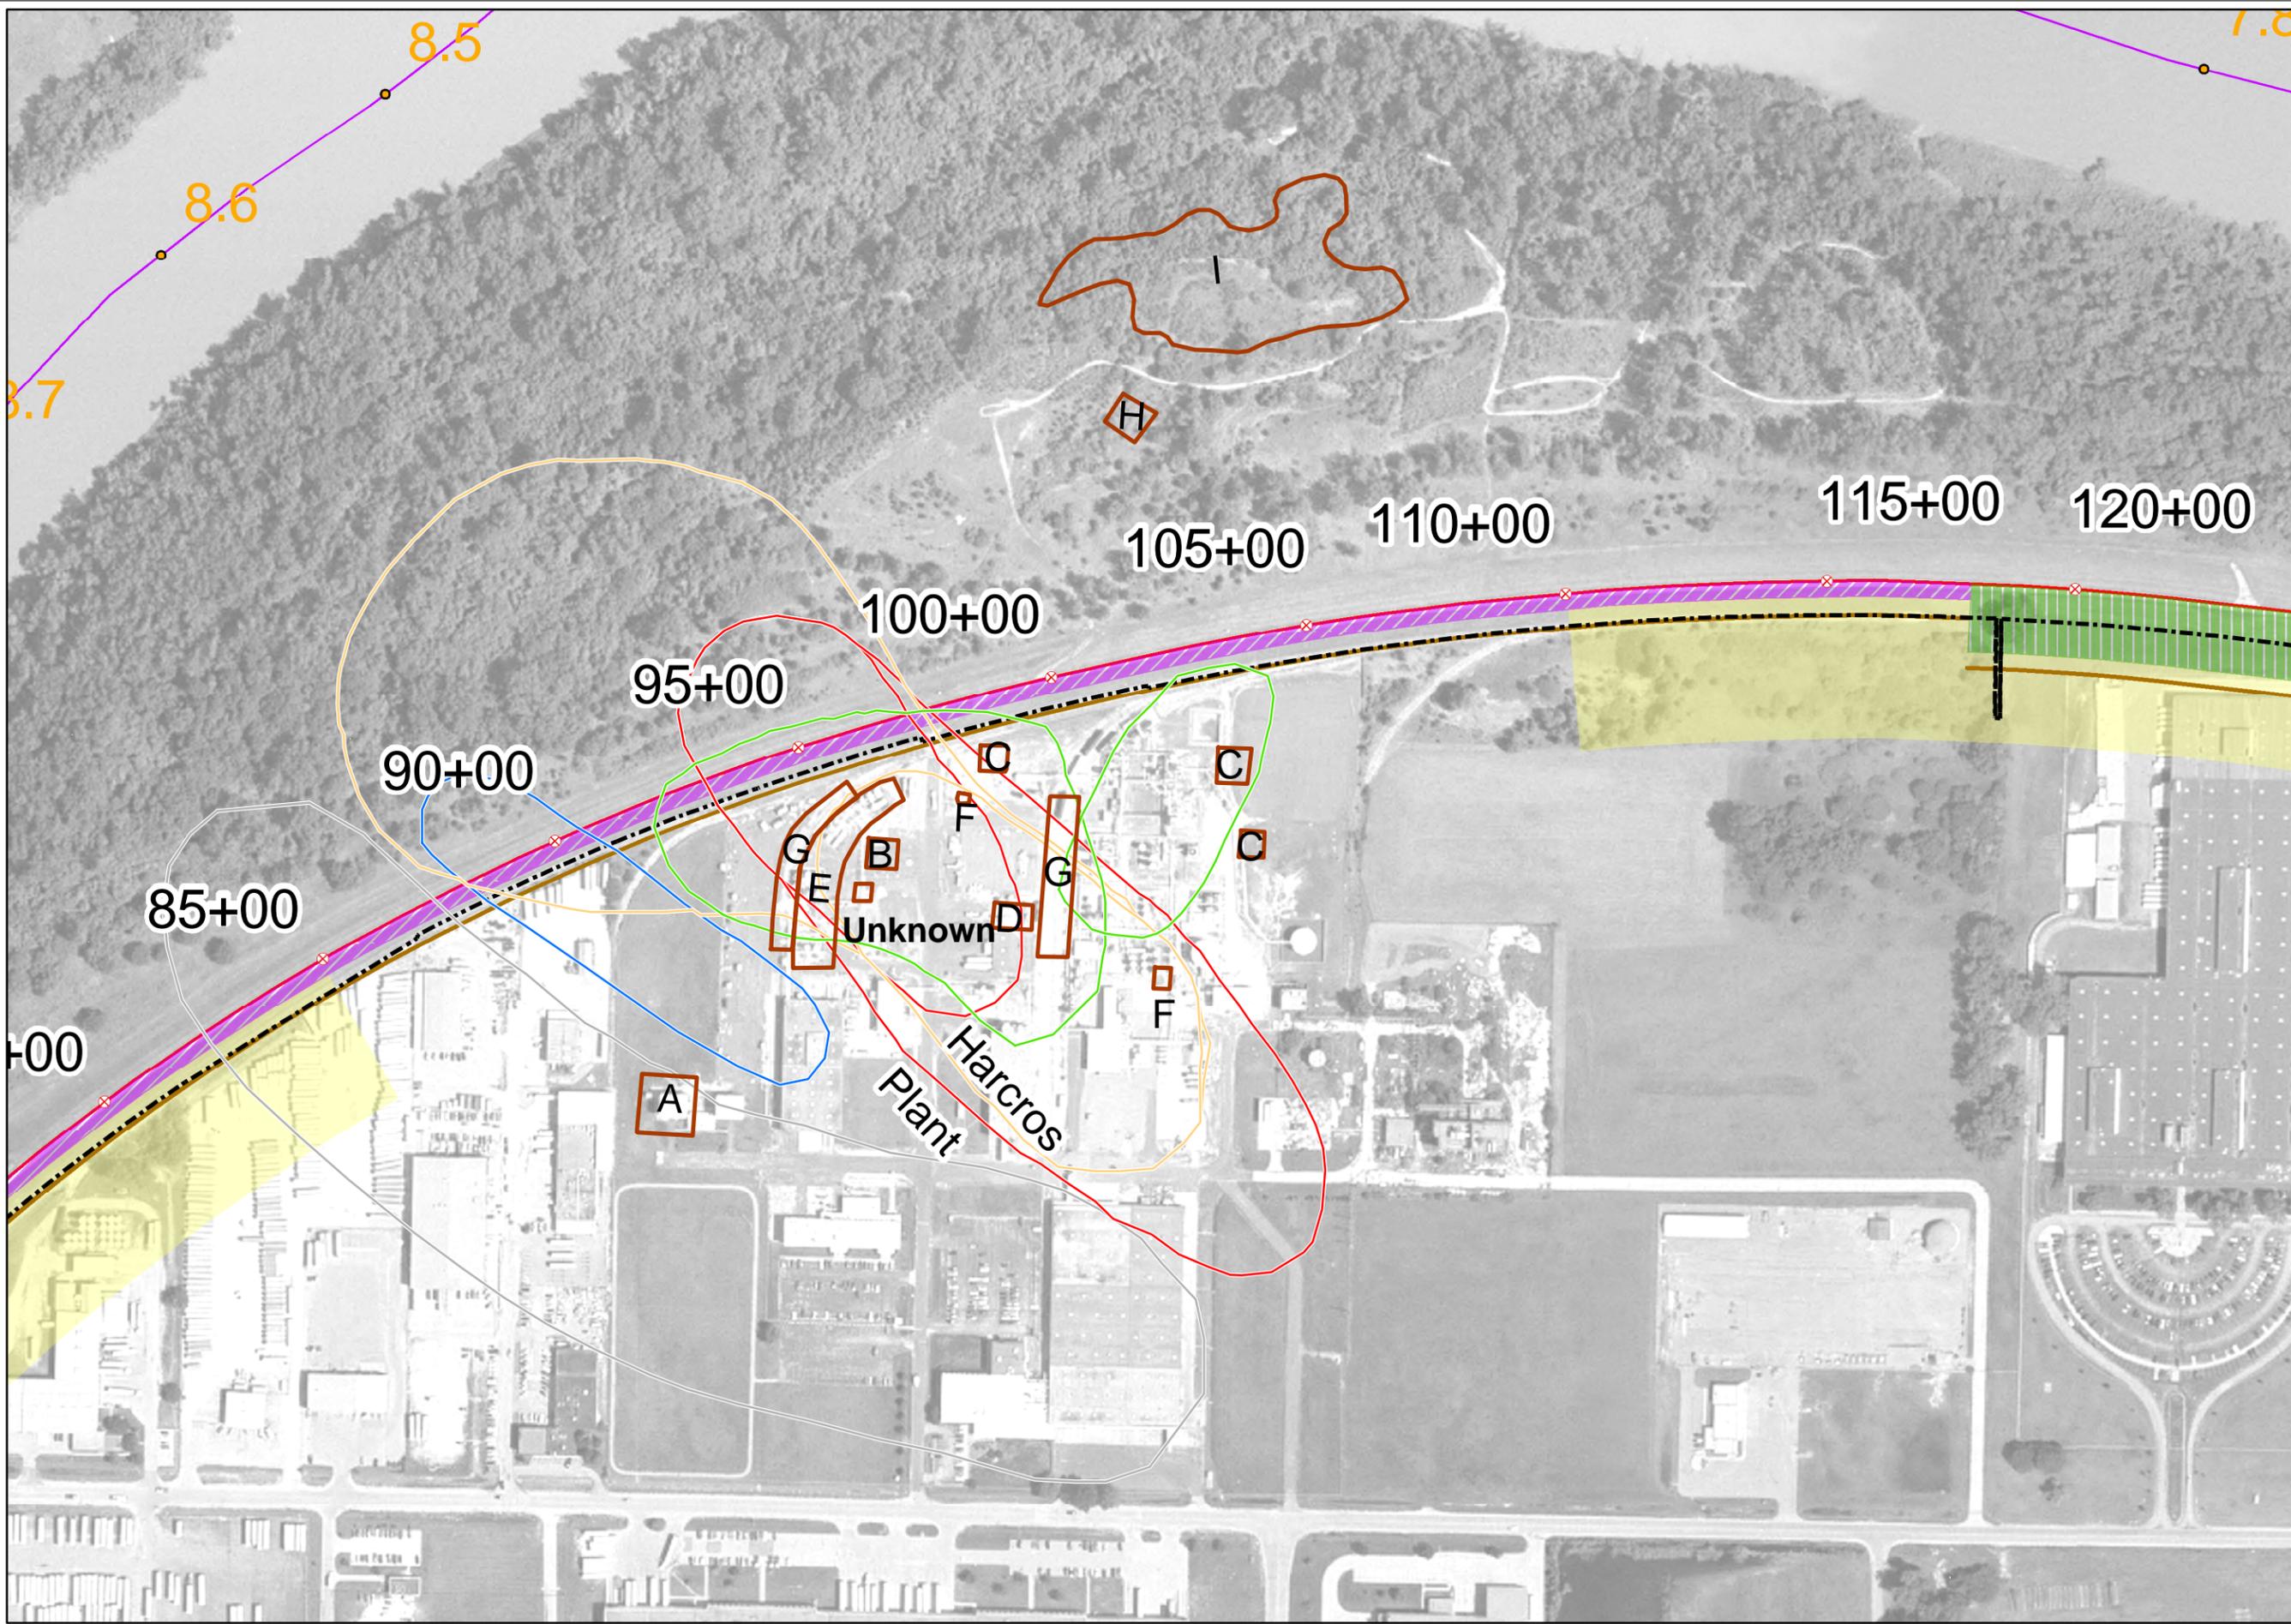
Figure 9.0

For this reach of levee, the alternative with the most impact case was used. It consists of the 500-year + 5 levee raise and stability berm that runs the entire length of the property and a filter blanket located between stations 202+00 and 207+00. The footprint of the alternative only extends outside the existing ROW at the extreme western and eastern section of the property, extending 40 feet. The original alternative for this reach included a buried collector system, which was replaced by a filter blanket (Figure 5.0). However, during the site evaluation process, existing groundwater contamination plumes from Sinclair Oil and Fairbanks Morse Pump Corporation were identified.

The locations of the existing plumes are shown on Figure 5.0 and 9.0. In order to avoid the possibility of adversely impacting the existing groundwater contamination plumes and the current groundwater cleanup actions, a filter blanket was recommended as a more feasible option for this area.

The most recent sampling has detected VOCs, halogenated VOCs, SVOCs, pesticides, and herbicides in the groundwater. LNAPL was found in wells near the Sinclair property southernmost boundary. Benzene concentrations were found in monitoring wells ERM-10, ERM-11, and ERM-14. MW-3S also showed benzene contamination of 1.7 mg/L. This well, while still on Sinclair property, is close to the street across from the levee. Sampling events for the first quarter of 2002 and the 2nd through 4th quarters of 2003 showed the concentrations were fluctuating. VOCs were also detected above the MCLs for drinking water standards in the groundwater wells near the Kansas River. Arsenic was found slightly above the MCL for drinking water standards in one well during the 4th quarter of 2003.

From boring logs for the temporary piezometers installed in August of 2003, petroleum was noted at various depths. They were drilled near the edge of the plumes to get a better idea of the extent of the contamination. These piezometers can be seen on Figure 9.0. The following table presents a summary of the boring logs.
