**Kansas Citys, Missouri and Kansas  
Flood Damage Reduction Feasibility Study  
(Section 216 – Review of Completed Civil Works Projects)  
Engineering Appendix to the Interim Feasibility Report**

## **Chapter A-12**

# **STRUCTURAL ANALYSIS EXISTING CONDITIONS**

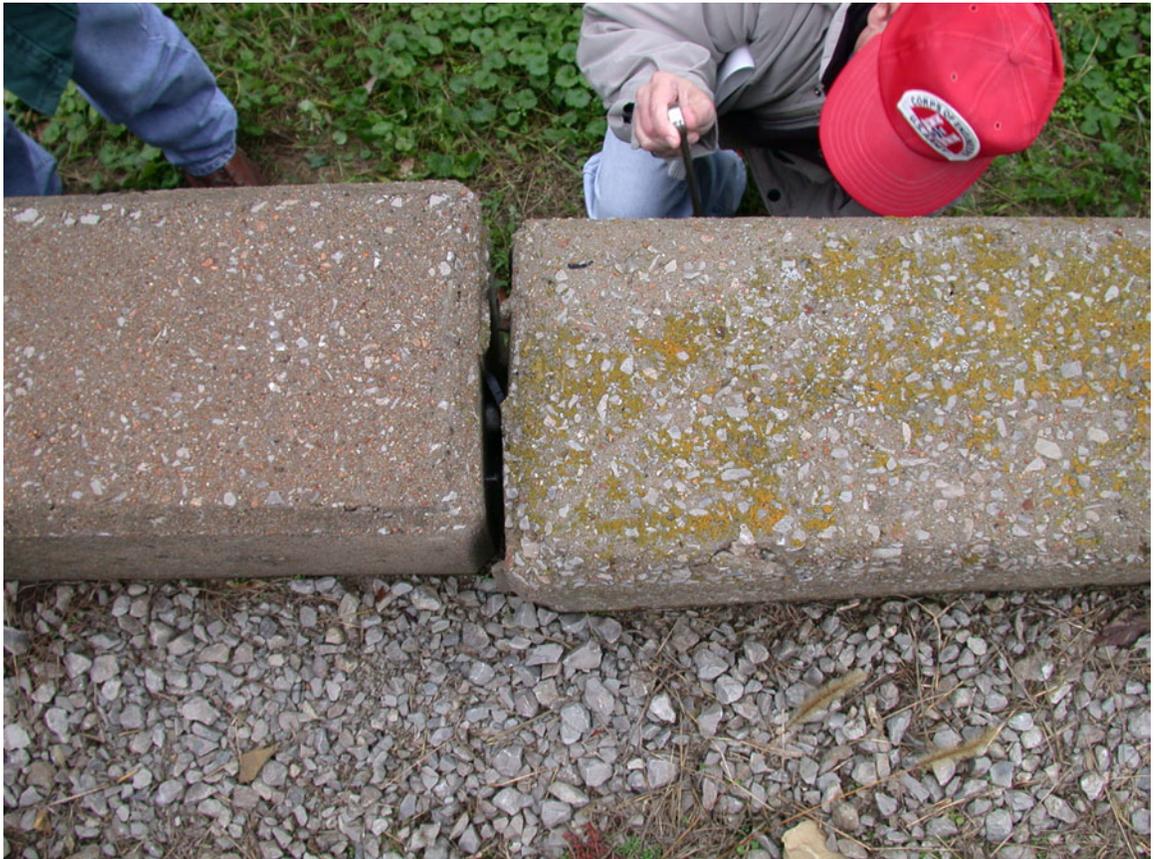
**EXHIBIT A-12.2**  
**Movement at a Floodwall Monolith Joint in the**  
**North Kansas City-Lower Unit**

Site visits uncovered no visual observation of distress or major structural problems with any of the floodwalls or retaining walls. However, minor lateral displacement has occurred with the two short floodwalls along the Hillside Ditch in the North Kansas City-Lower Unit and the floodwalls in the Birmingham Unit. Exhibit A-12.2 shows the displacement at one of the North Kansas City floodwalls. Because this wall functions as a retaining wall, this minor displacement has little or not effect on the reliability of the wall to function as a floodwall.
