RECURRING REVIEW REPORT
Former Jefferson Barracks Post Dumping Grounds
St. Louis County, Missouri

Defense Environmental Restoration Program
Formerly Used Defense Site
Site ID: B07MO0143

September 2014

U.S. Army Corps of Engineers
Kansas City District
Kansas City, Missouri

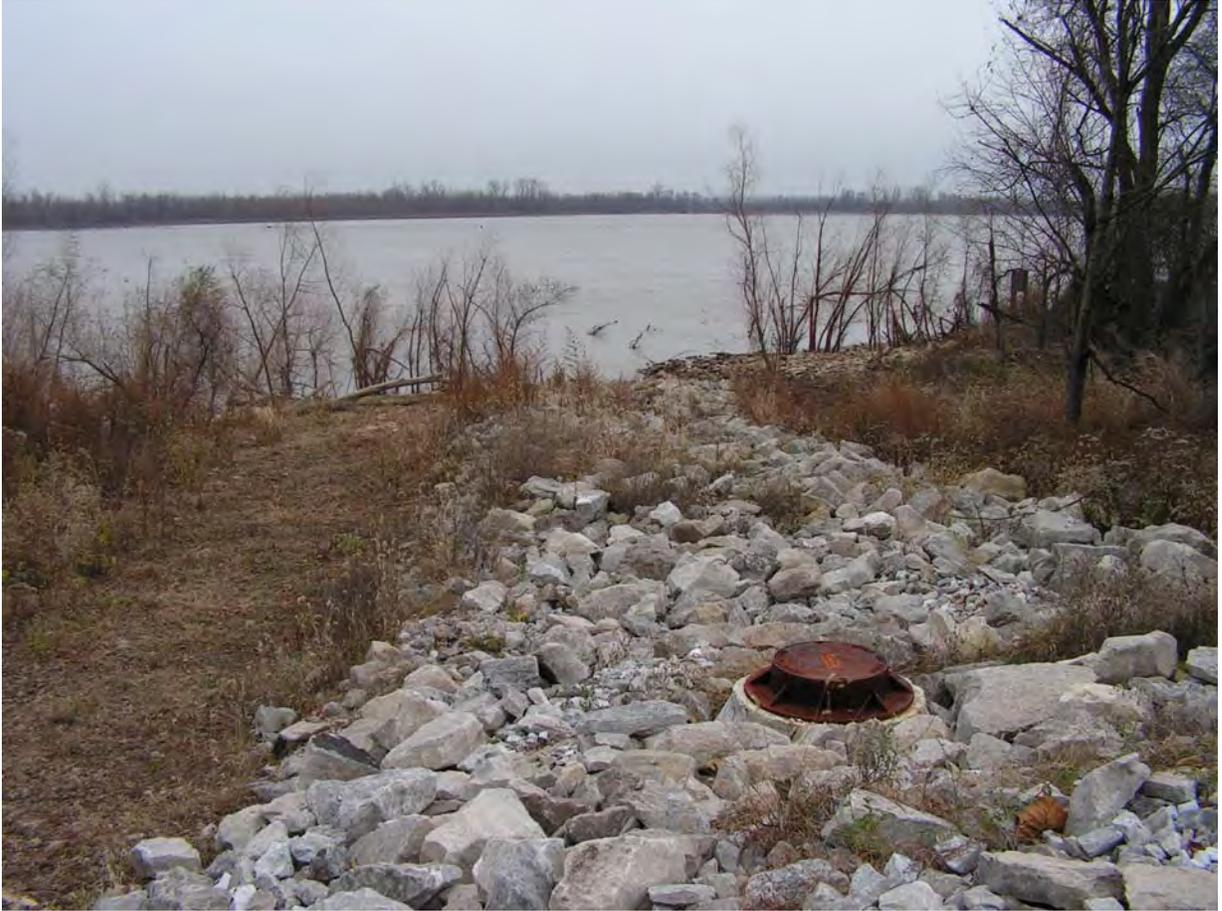
Extensive tree growth on riprap

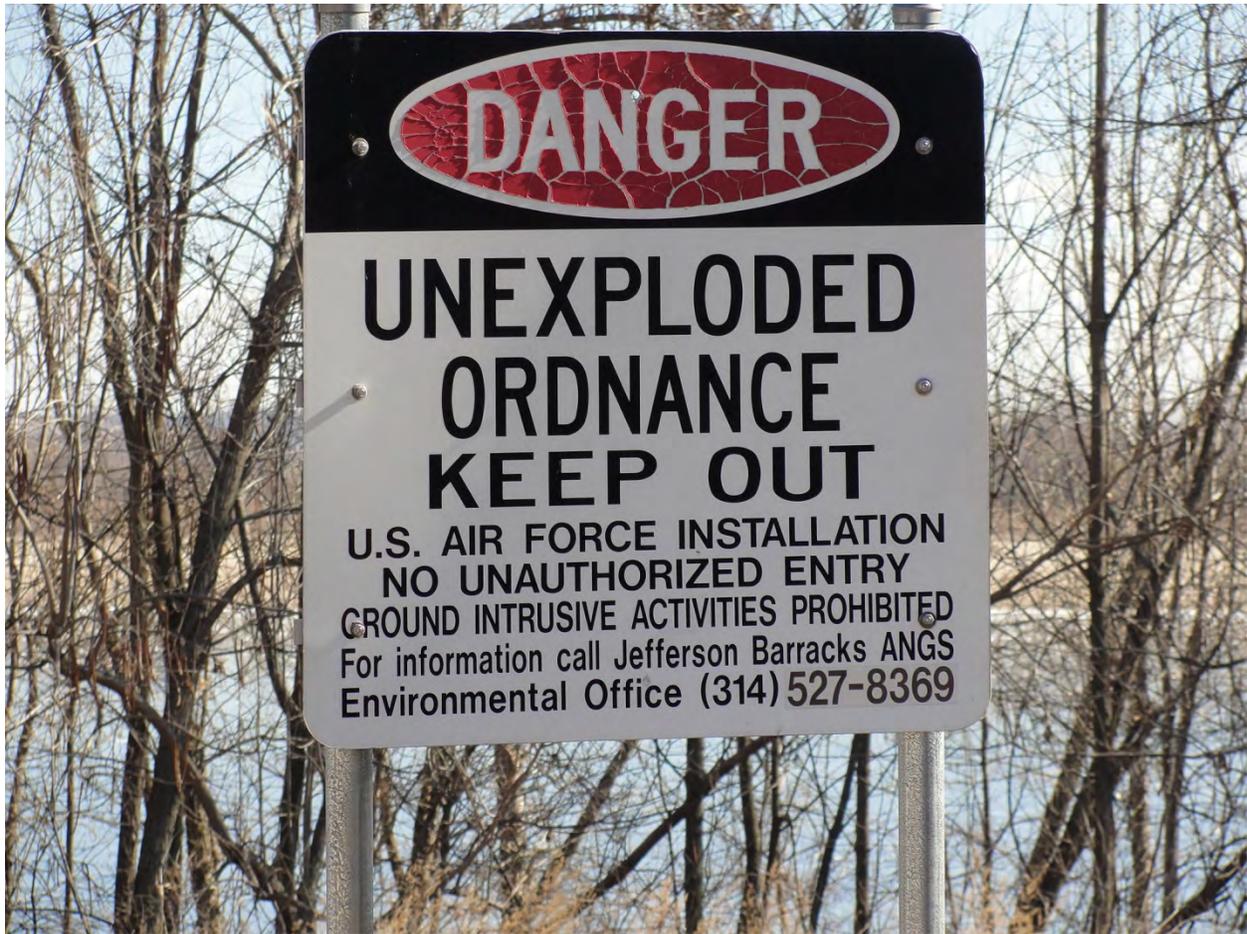
Description: Warning Sign No. 3, located at the end of the entry road depicted in Photo 1; note railroad tracks running parallel to river located directly behind sign; the top portion of Sign #9 is visible just above the RR tracks and to the left of Sign #3.

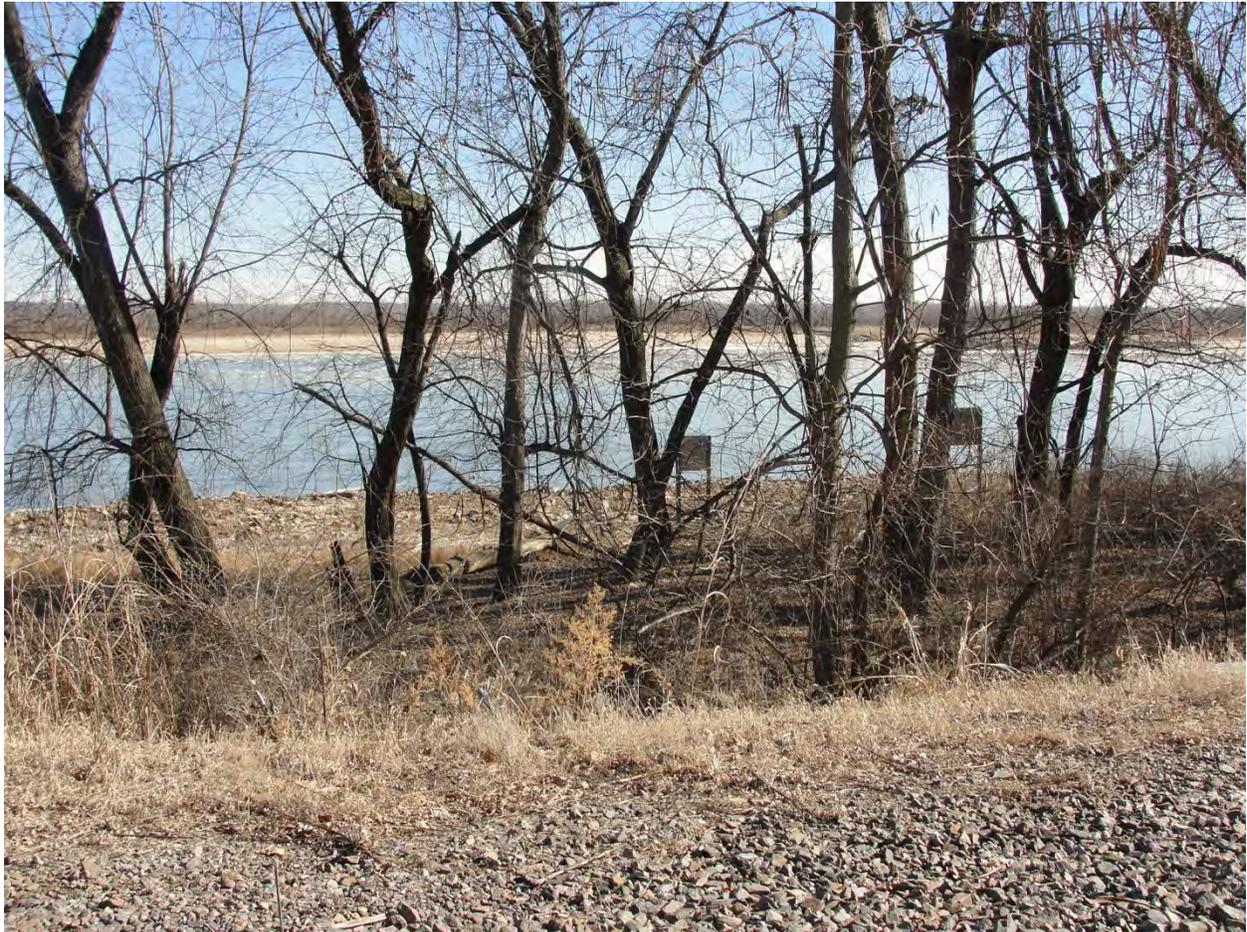
Description: View is to the east, from east-side of railroad tracks; Warning Sign No. 8 is visible; the original Warning Sign No. 8 is severely undercut and its replacement has already been erected; riprap is visible between the river and the tree line.

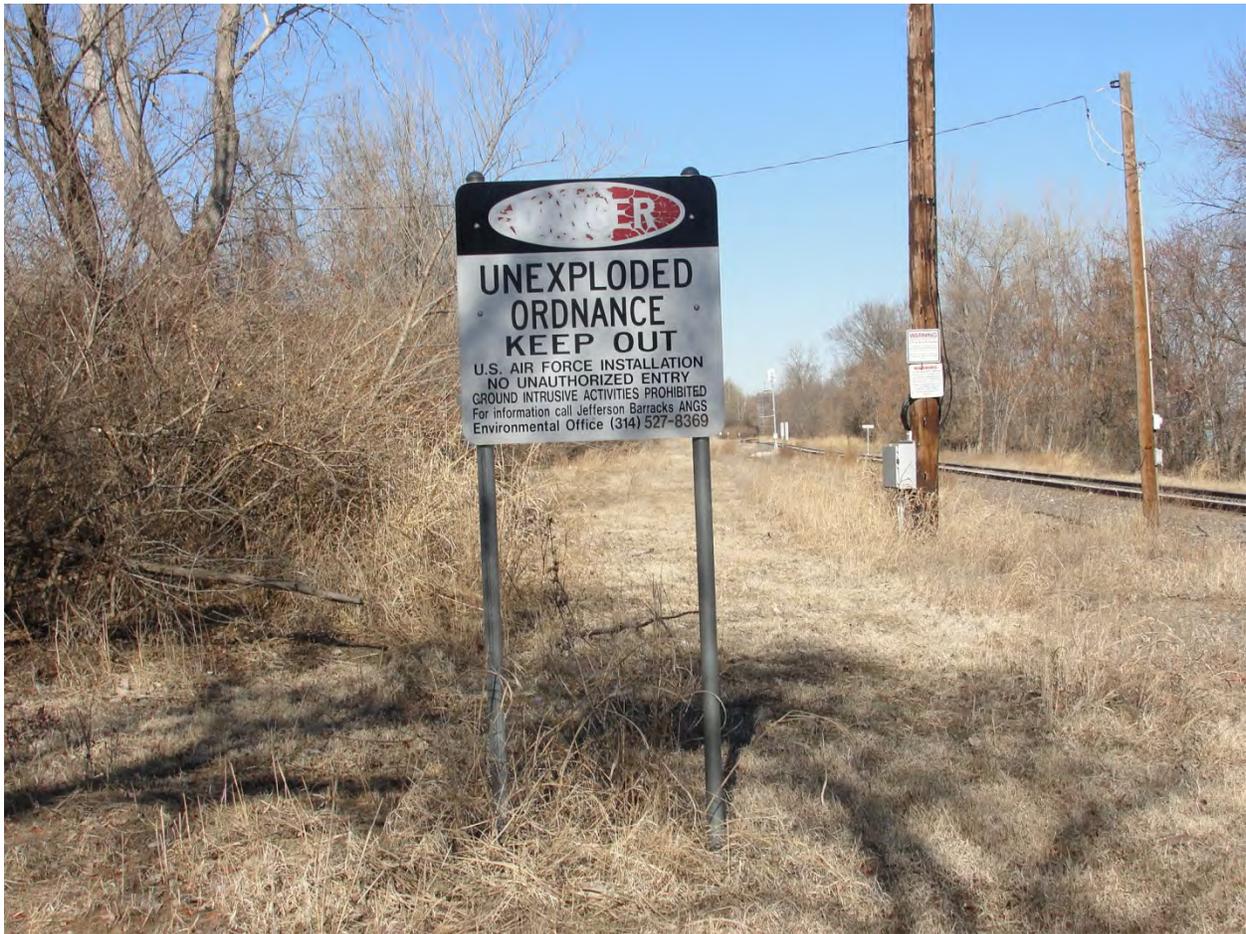
Description: Warning Sign No. 1, located at south end of Site, west of the railroad tracks; weathering of the “DANGER” portion of the warning sign is evident.

Issues and Recommendations Identified in the Recurring Review:				
OU(s): Site	Issue Category: O&M			
	Issue: Warning Sign #1 has degraded .			
	Recommendation: Replace sign. Replacement of the sign by KCD will be planned for FY 15 during the vegetation clearing event.			
Affect Current Protectiveness	Affect Future Protectiveness	Implementing Party	Oversight Party	Milestone Date
No	No	KCD	MDNR	CY 2014
Protectiveness Statement(s)				
Operable Unit: Site	Protectiveness Determination: Protective.		Addendum Due Date (if applicable):	
Protectiveness Statement: <i>The removal action at the Former Jefferson Barracks Post Dumping Ground Site is protective of human health and the environment.</i>

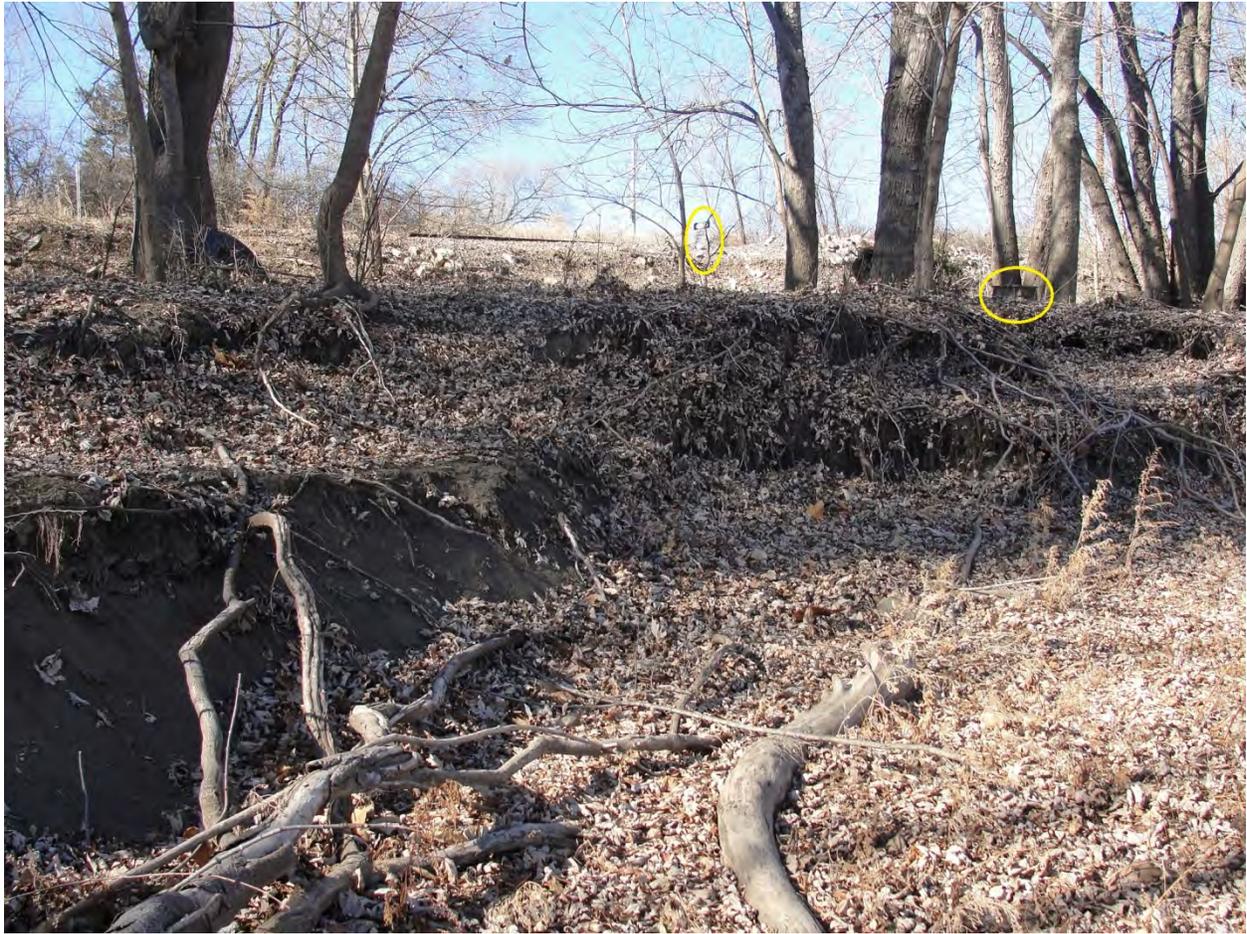
Description: View is towards the west (toward railroad tracks) as taken from a location believed to have been between warning signs #7 and #8, near top of escarpment; however, upon close inspection of the photo, a warning sign is visible near the center top of photo, and based upon the sign's orientation and placement on the east side of railroad tracks, it appears likely to be Warning Sign No. 7 – which would mean that the subject matter of this photo is beyond (south) of where riprap had been placed. Also present in the photo is what appears to be a metal manhole structure located approximately right of center. A vertical erosion face is present along the center of the photo as tree roots are visible. No evidence of post dumping was observed at the erosion face.

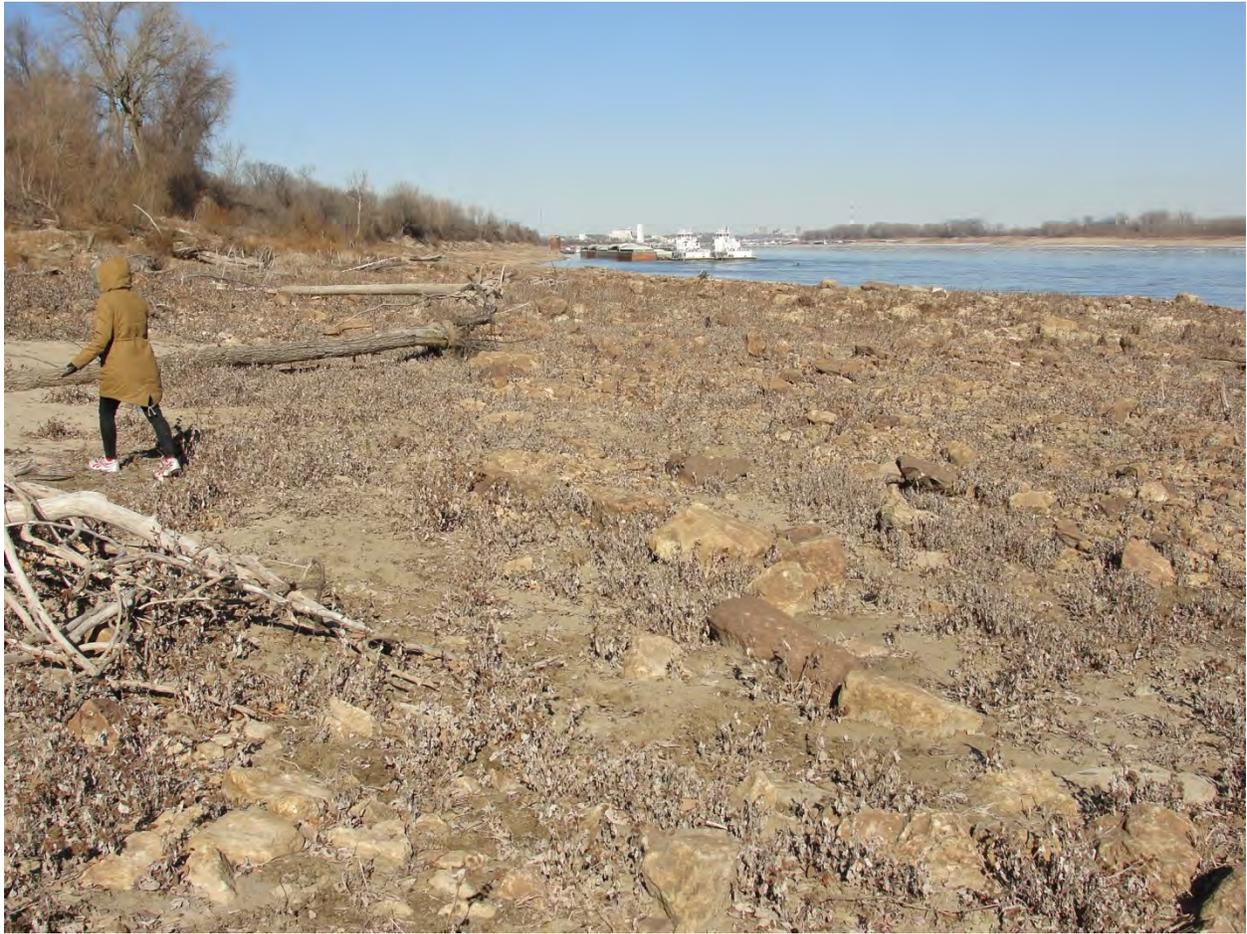
Description: Riprap as viewed to the north from a location between warning signs #7 and #8; note the presence of sediment.

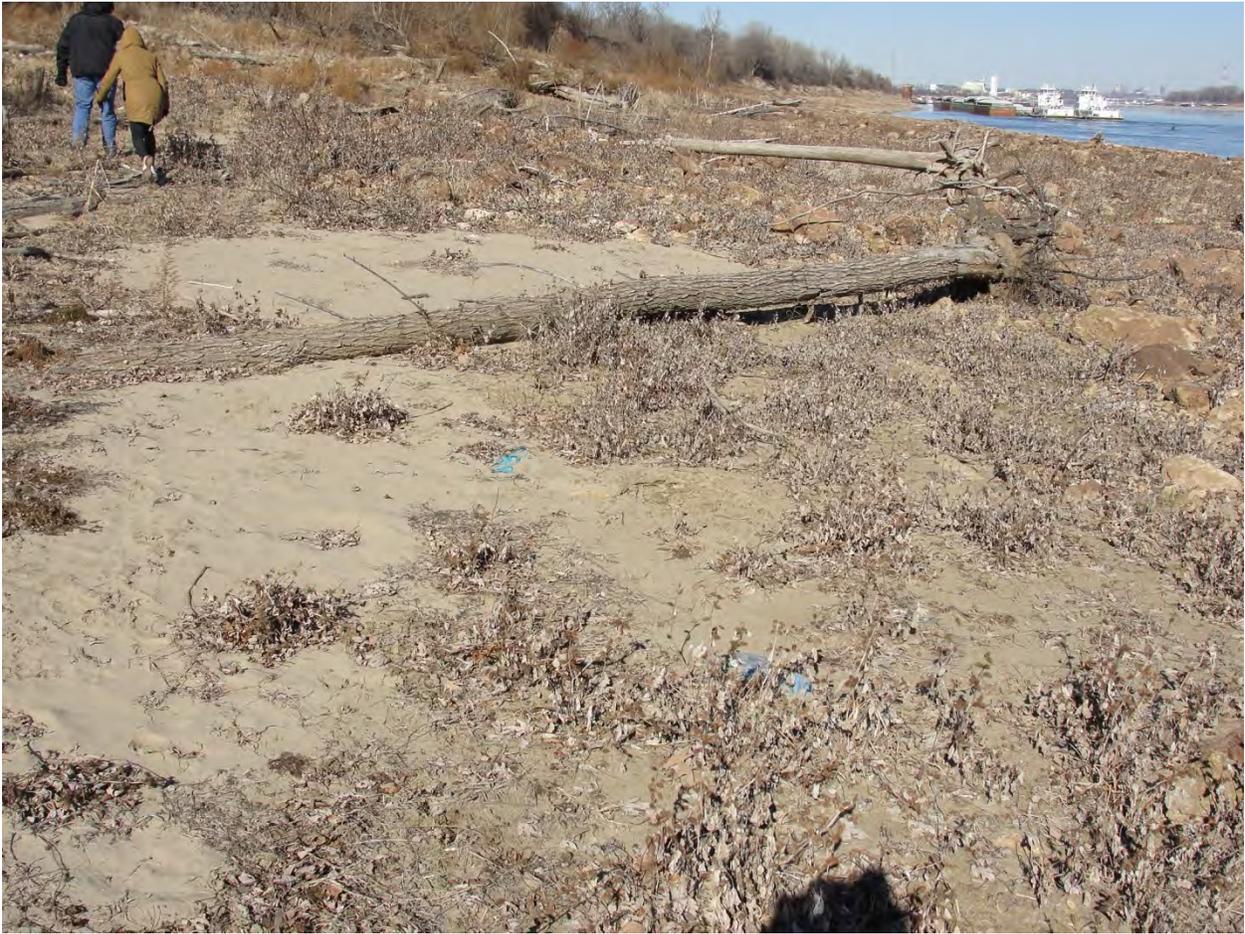
Description: View is towards the north and is focused upon an area where sediment is a more predominant feature; subject matter is the center left edge of Photo No. 14.

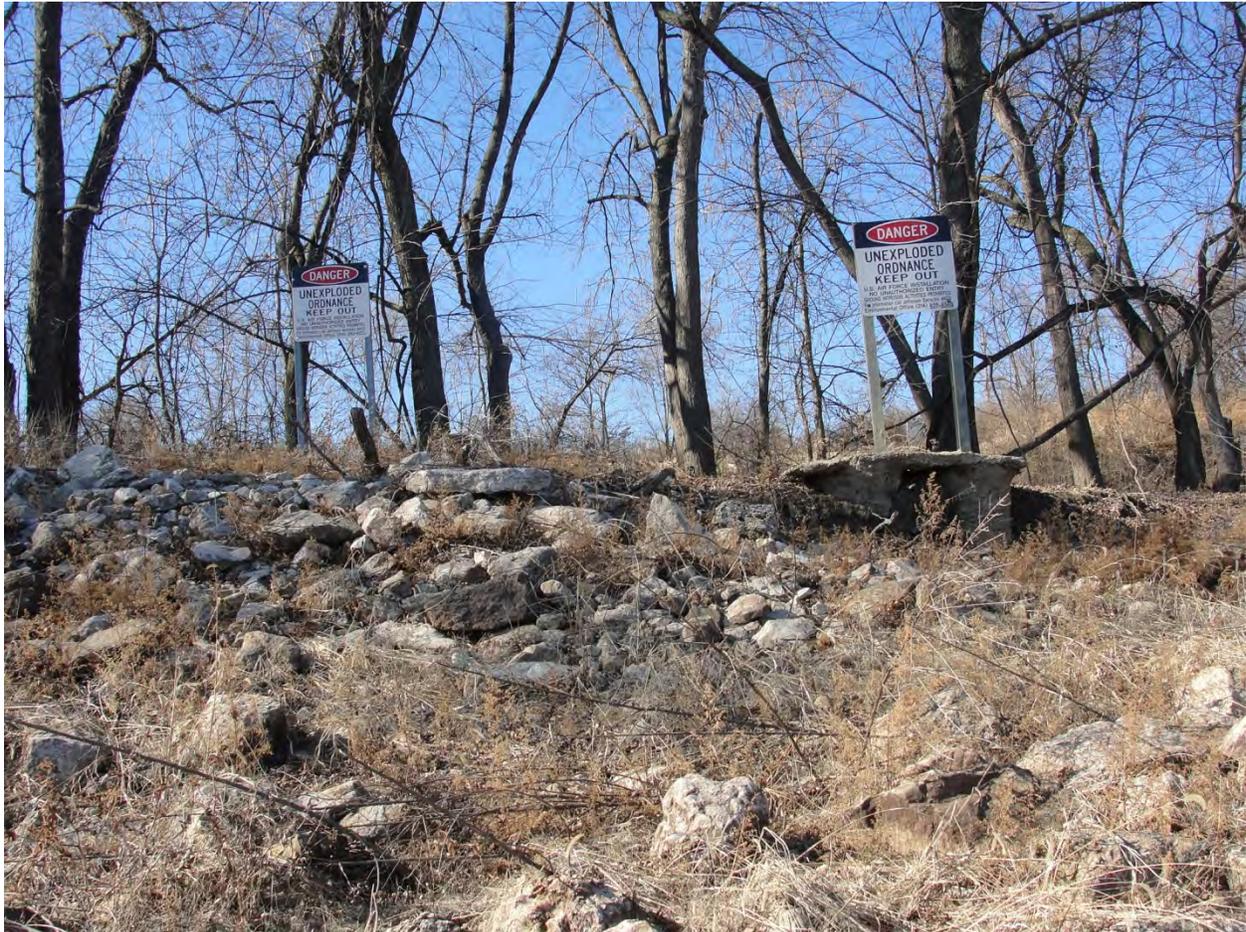
Description: View is towards the west, looking at Warning Sign No. 8. Note that the right sign has been severely undercut and its replacement has been erected in close proximity. Riprap is present.

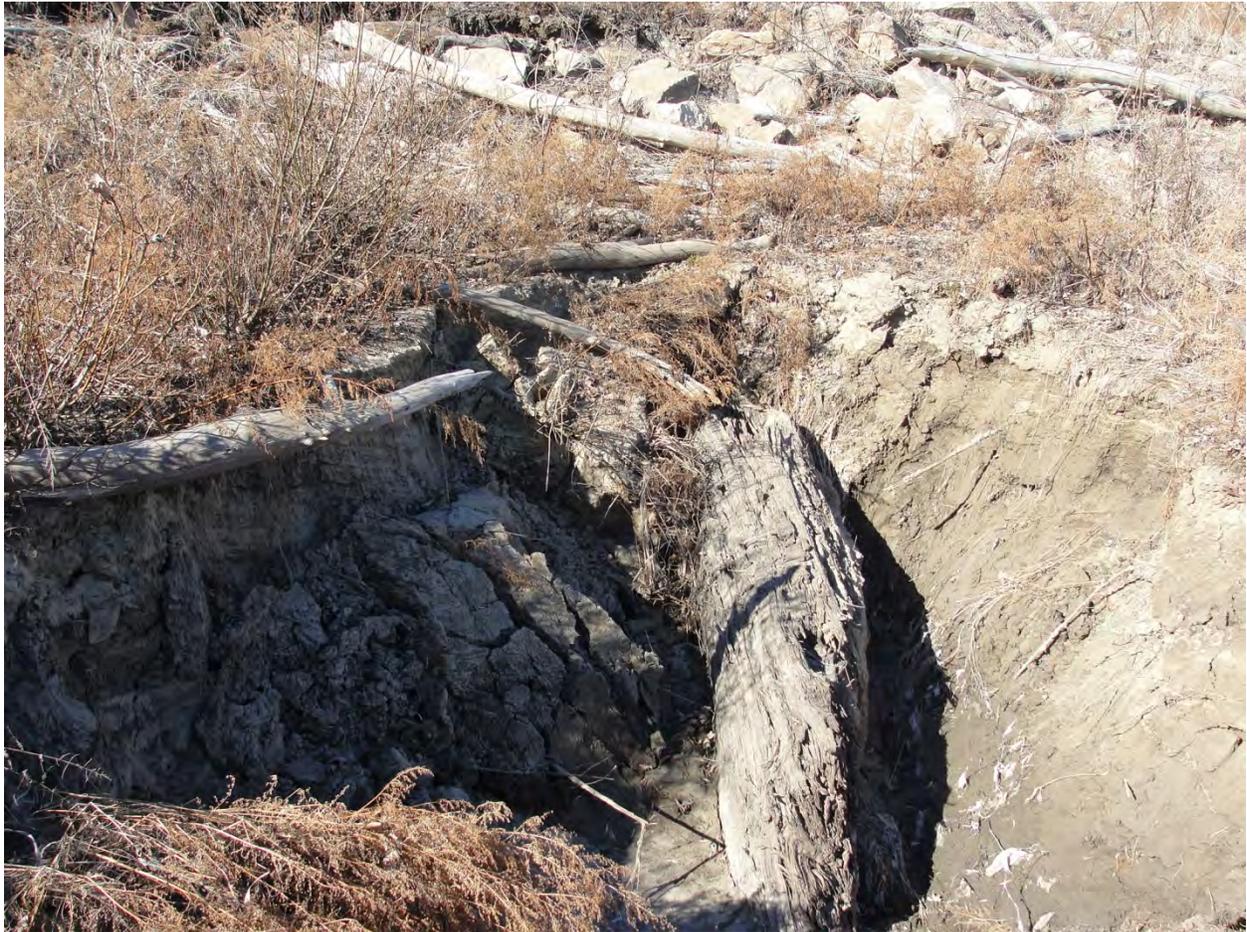
Description: Significant erosion, located between warning signs #8 and #9; depth of erosion estimated at between 4 to 5 ft.; sidewalls did not exhibit rip-rap; length is estimated at 12 to 15 ft; large tree trunk is present in the eroded area.

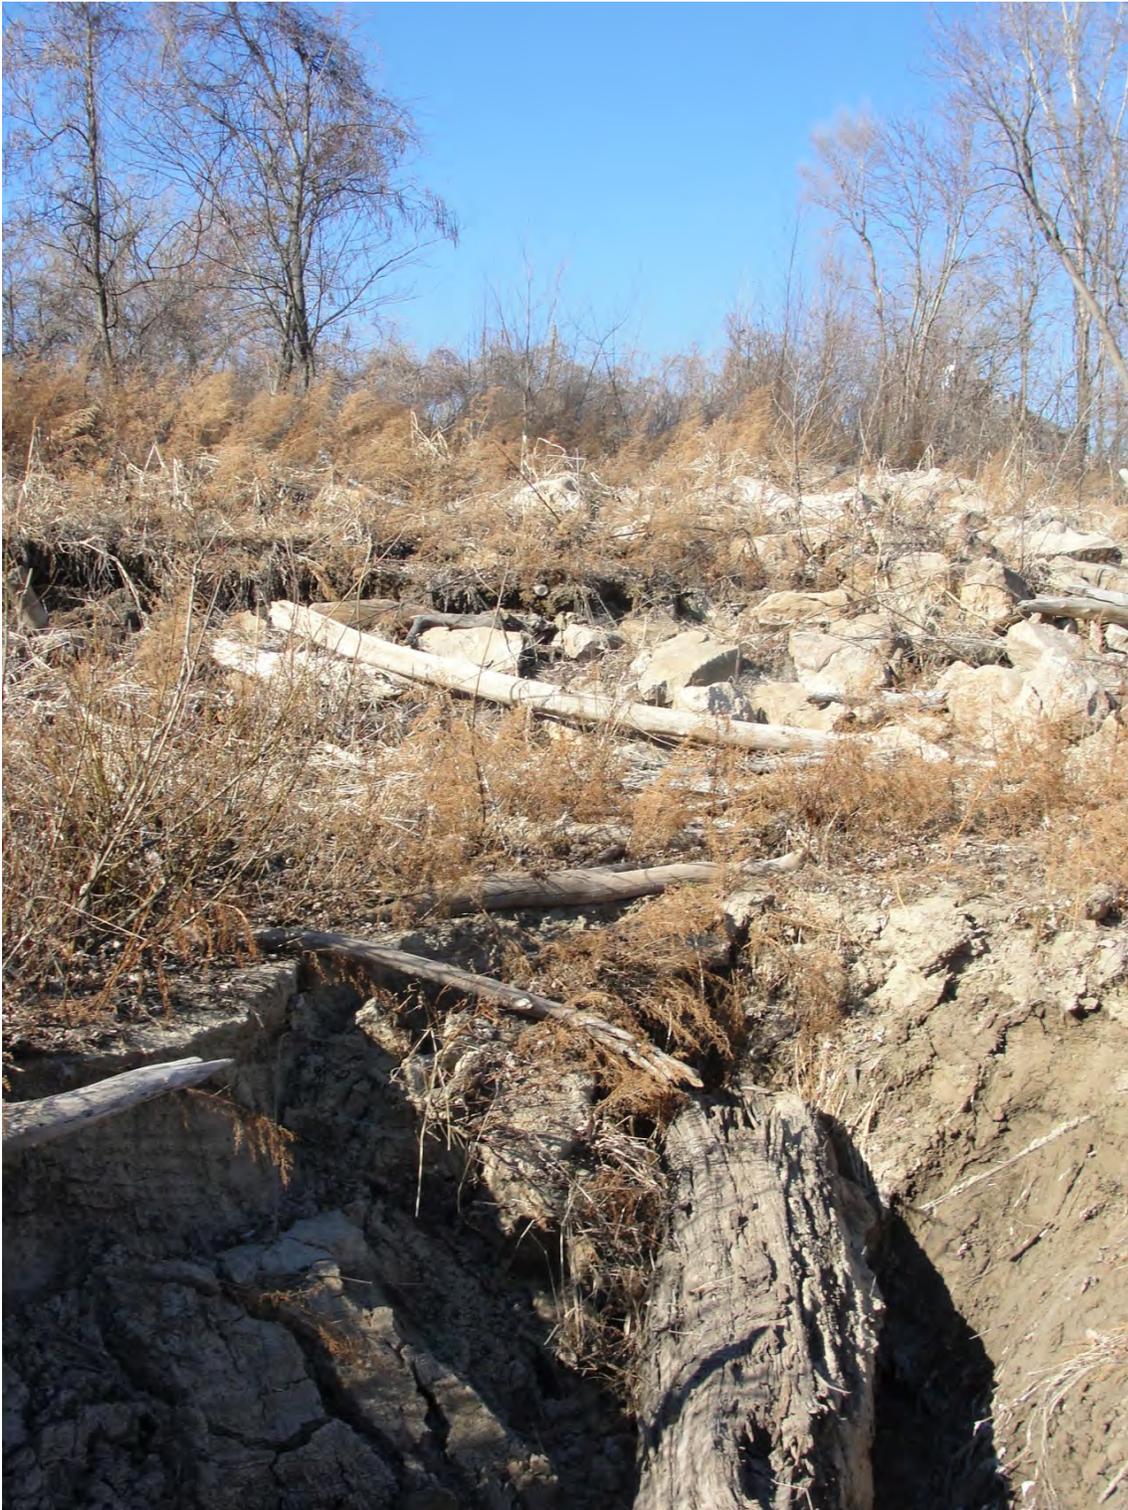
Description: Subject is eroded area depicted in Photo No. 18, view is to the west – towards the escarpment; riprap is present in area between escarpment and the eroded area.

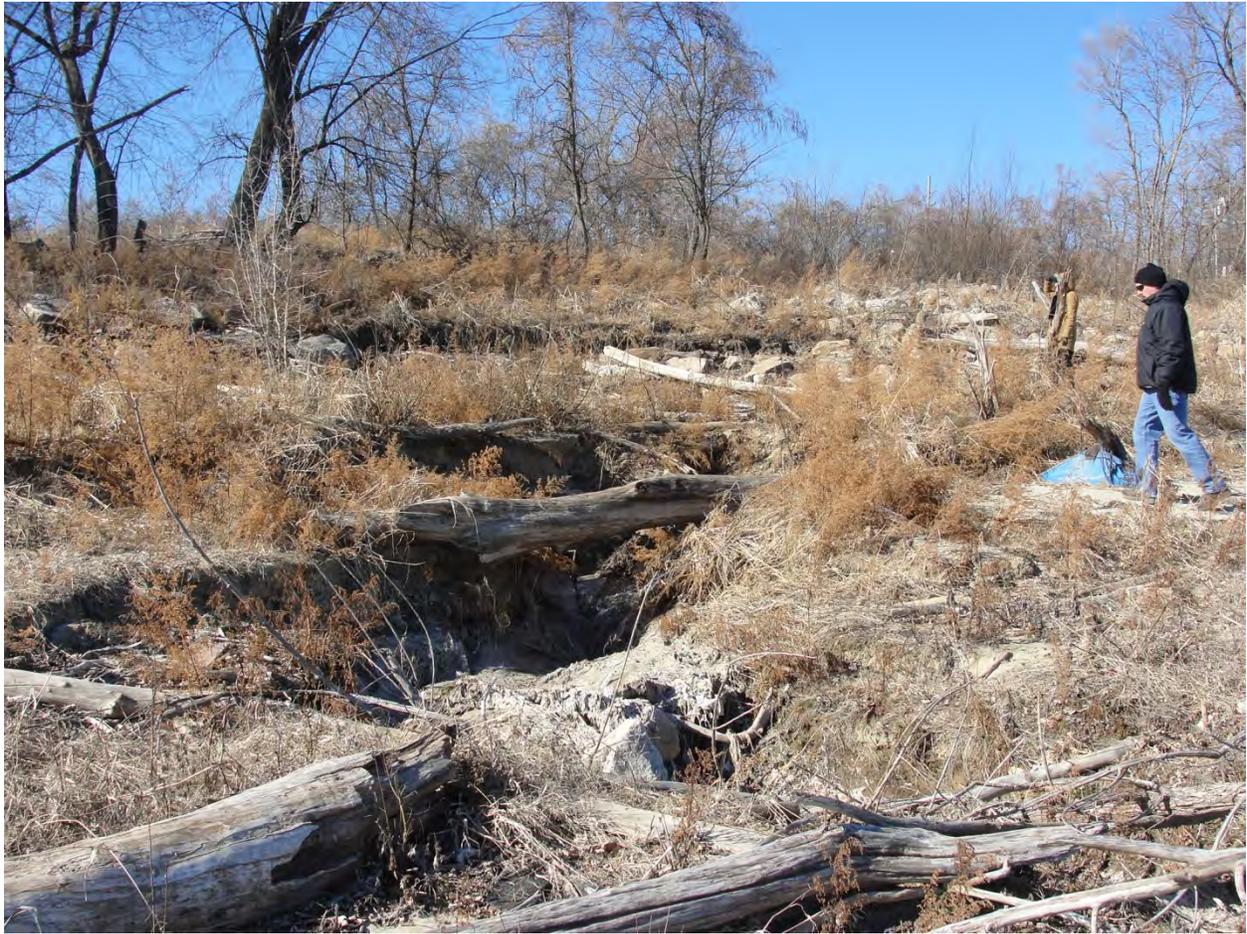
Description: Erosion ravine (subject of Photos #18 and #19); looking west towards escarpment. Note the riprap present near top of escarpment; possible undercutting depicted in photo, just above mid-photo, left-half.

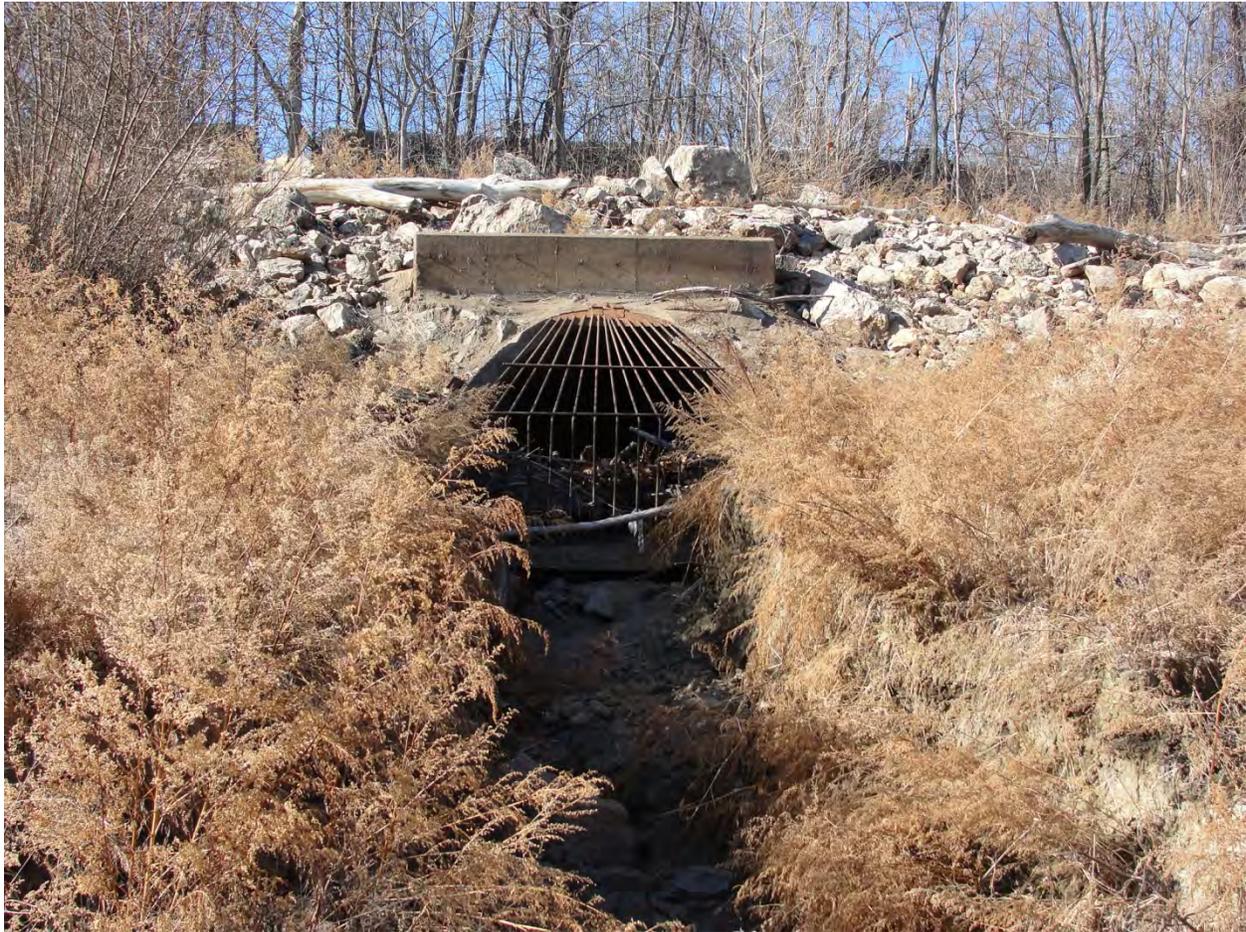
One surface water collection system drainage outlet structure is present at the east edge of the escarpment, approximately in alignment with Kearney Street. Photos 28 through 30 depict this outlet and its discharge channel. The photos document that this outlet's drainage channel has been rock lined, is relatively shallow, and that no significant erosion is present. The second outlet is a combined storm drain that is depicted in Figure 2 as the 4-ft diameter concrete storm sewer. This outlet was replaced in September 2008 with a 52-inch outlet (Appendix I). The discharge channel for this outlet is lined with geotextile and riprap. Photos 18 through 21 depict the condition at this outlet during the Recurring Review Site inspection. A Site inspection conducted in April 2014, provided in Appendix I, further depicts conditions resulting from this outlet's discharges.

Description: Storm drain outfall, believed to be in alignment with Kearney Street.

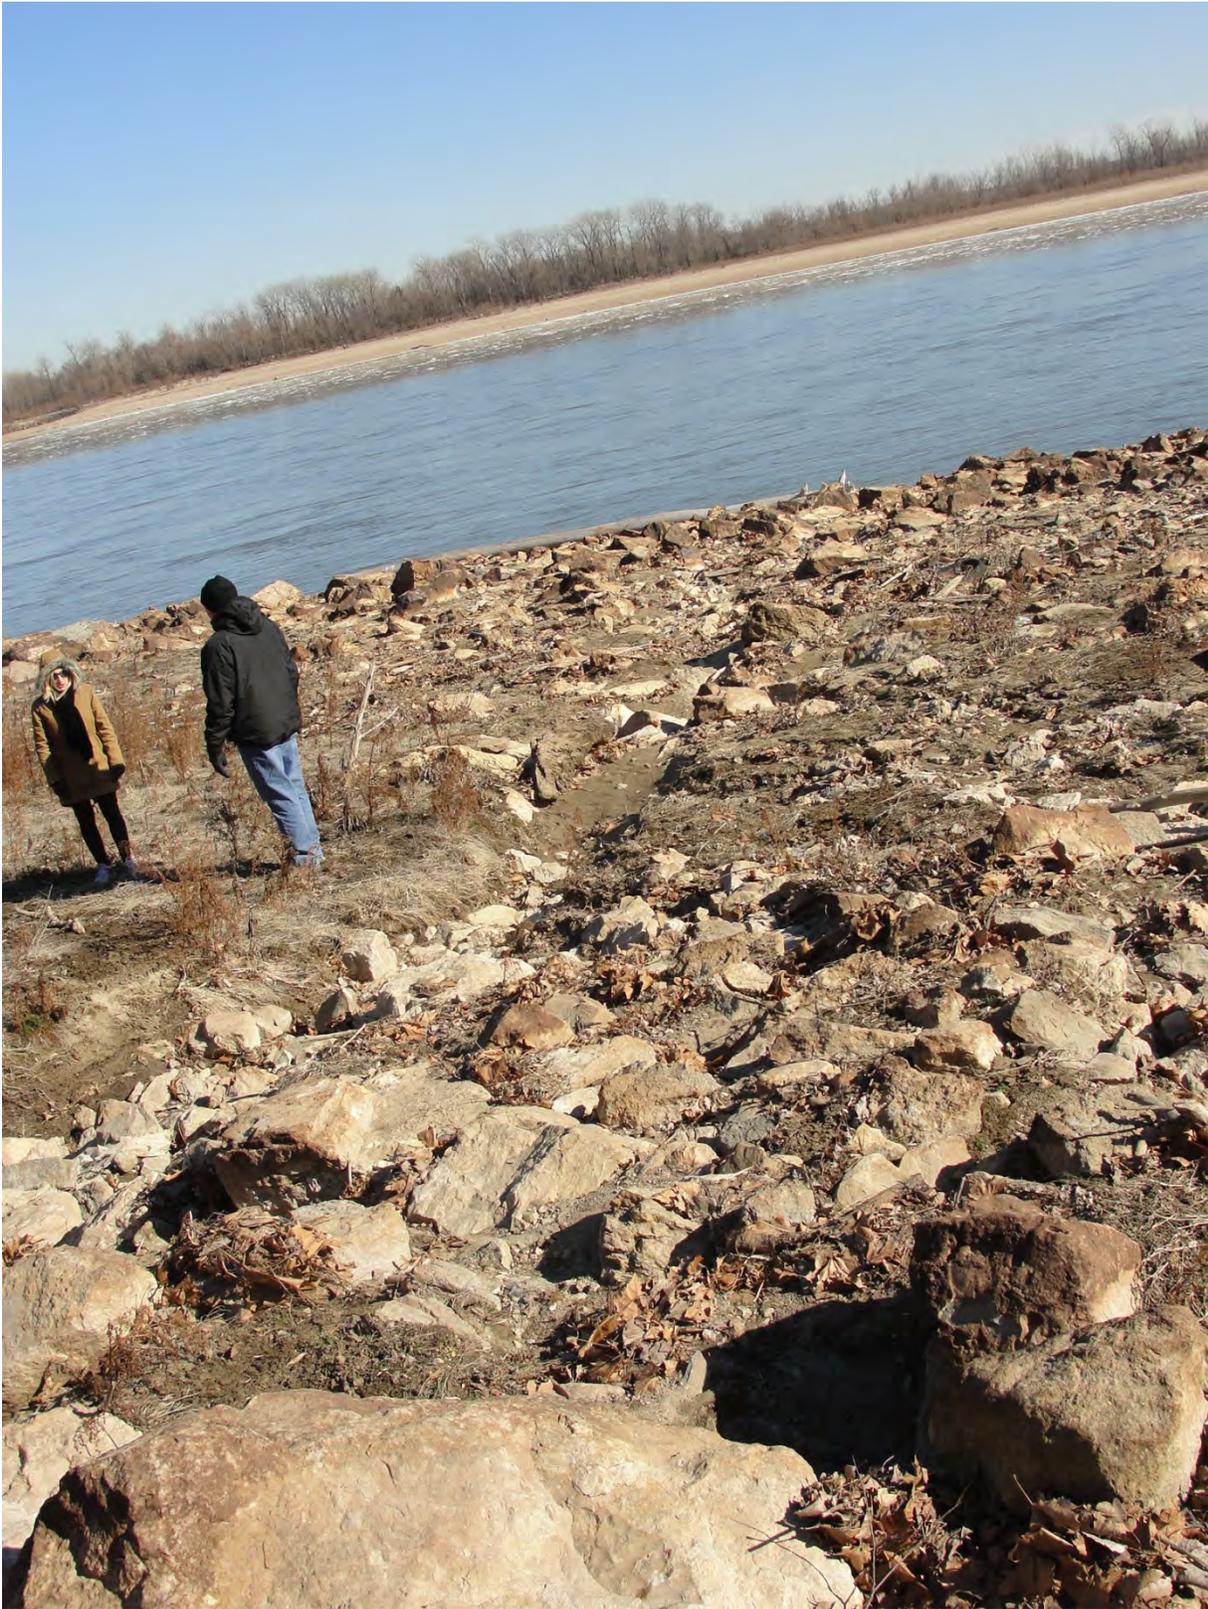
Description: Drainage way from the outfall depicted in Photo No. 28, lined with stone.

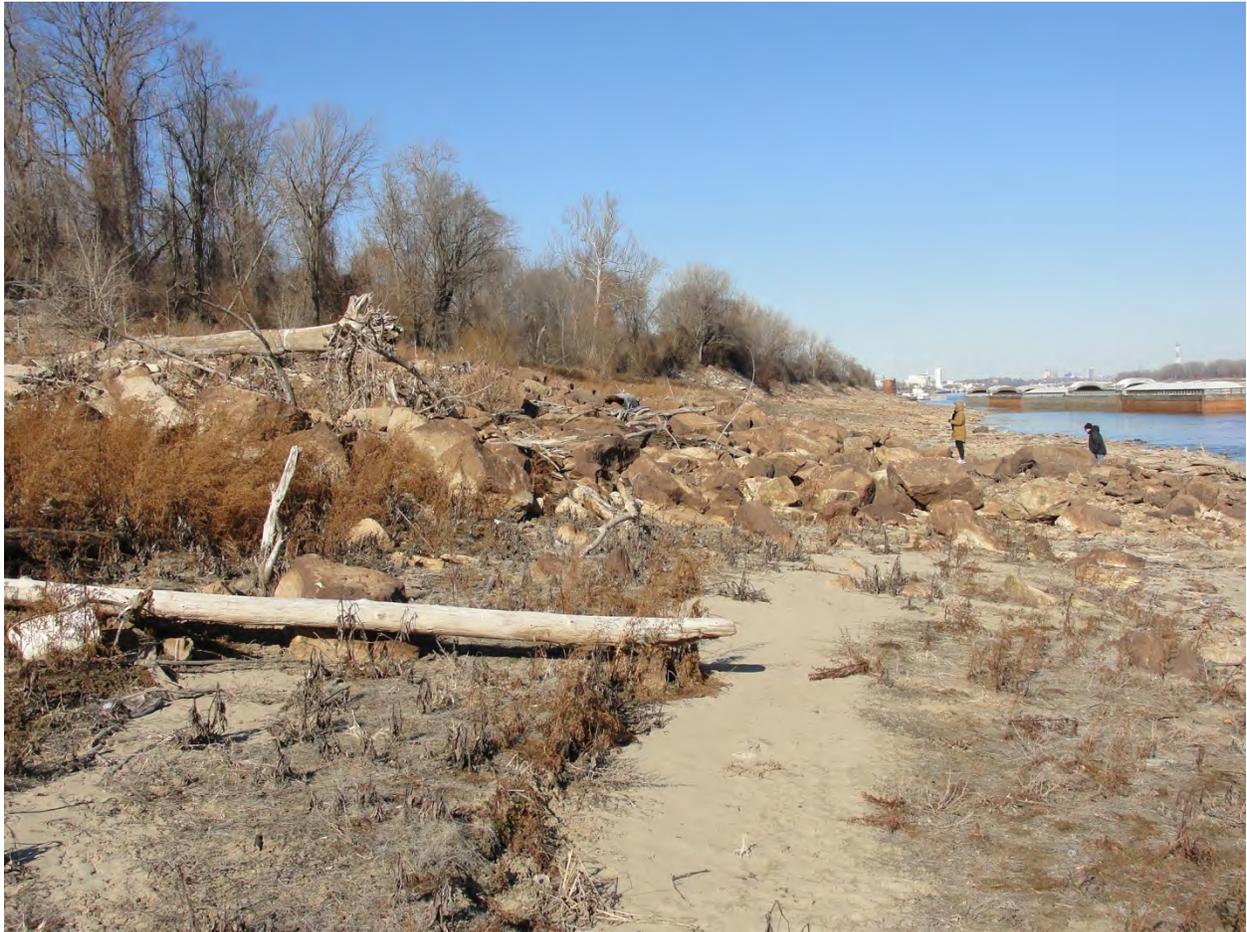
Description: Photo taken from an area that has less visible surface riprap than adjacent and surrounding area – view is to the north; Photo No. 39 is a second photo taken from this location, which is panned towards the river (eastward).

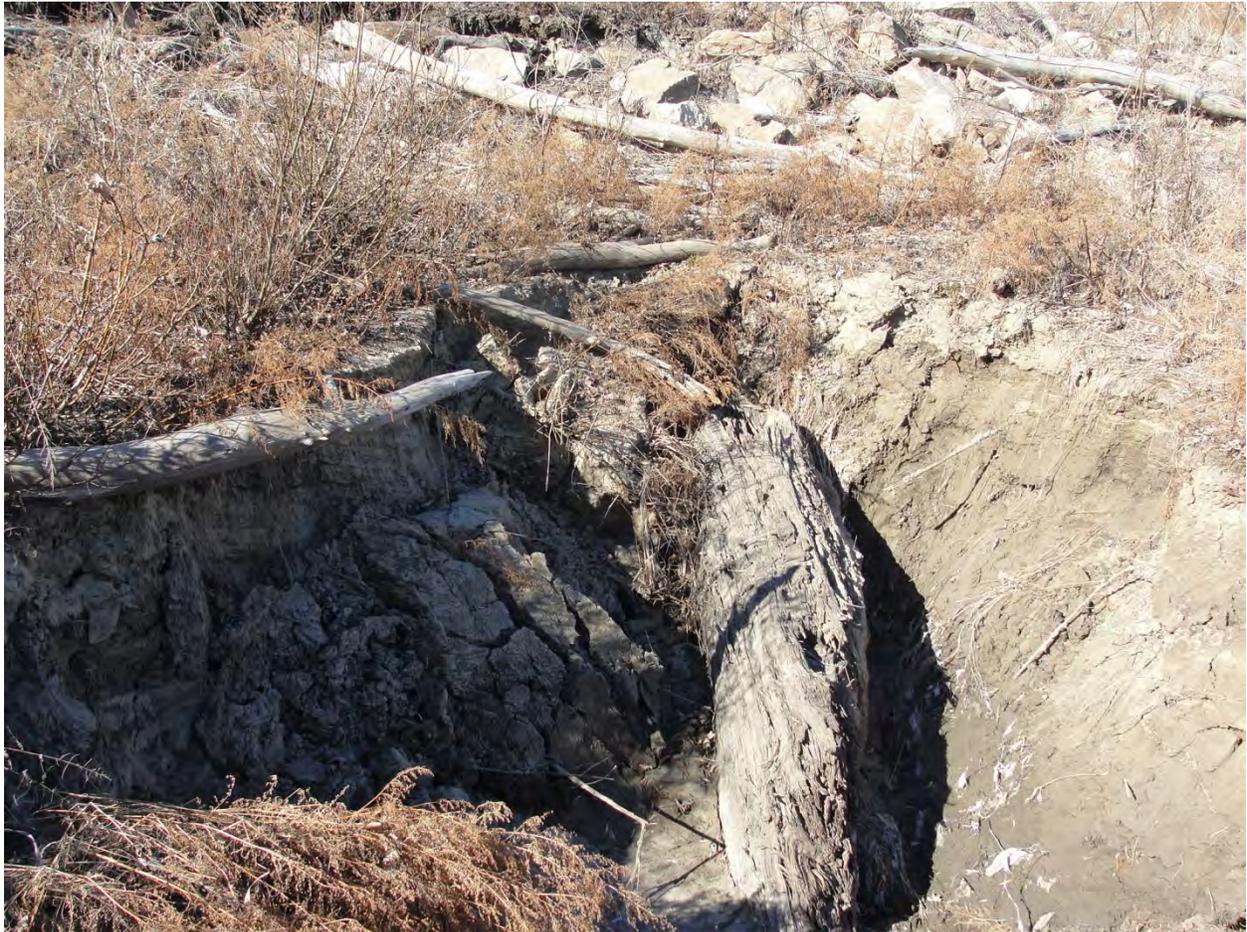
Description: Significant erosion, located between warning signs #8 and #9; depth of erosion estimated at between 4 to 5 ft.; sidewalls did not exhibit rip-rap; length is estimated at 12 to 15 ft; large tree trunk is present in the eroded area.

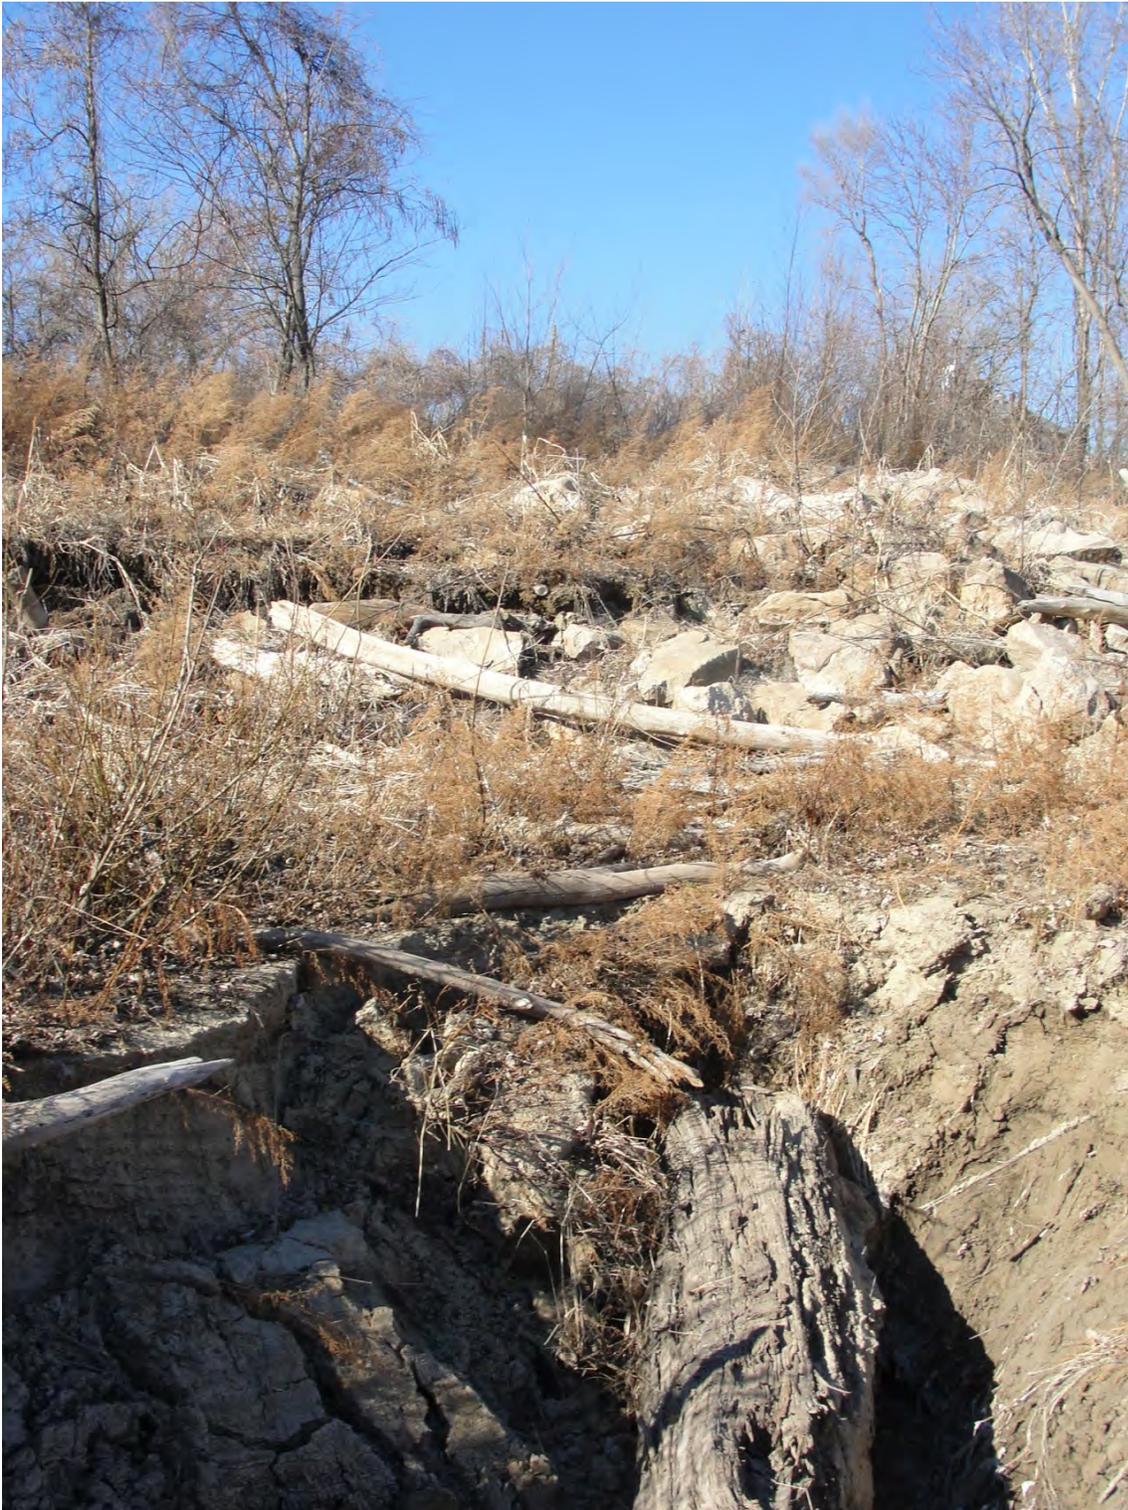
Description: Subject is eroded area depicted in Photo No. 18, view is to the west – towards the escarpment; riprap is present in area between escarpment and the eroded area.

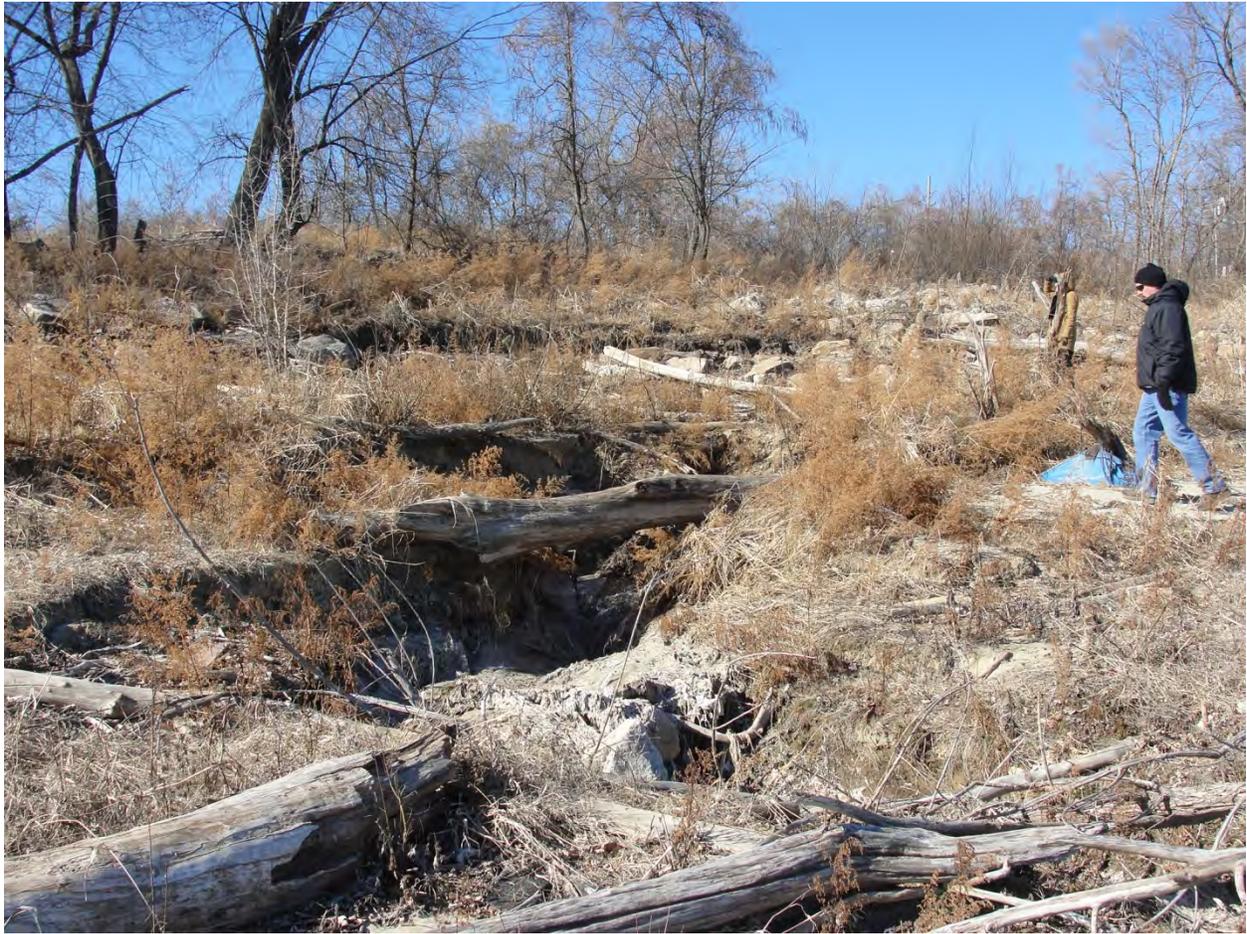
Description: Erosion ravine (subject of Photos #18 and #19); looking west towards escarpment. Note the riprap present near top of escarpment; possible undercutting depicted in photo, just above mid-photo, left-half.
