RECURRING REVIEW REPORT
Former Jefferson Barracks Post Dumping Grounds
St. Louis County, Missouri

Defense Environmental Restoration Program
Formerly Used Defense Site
Site ID: B07MO0143

September 2014

U.S. Army Corps of Engineers
Kansas City District
Kansas City, Missouri

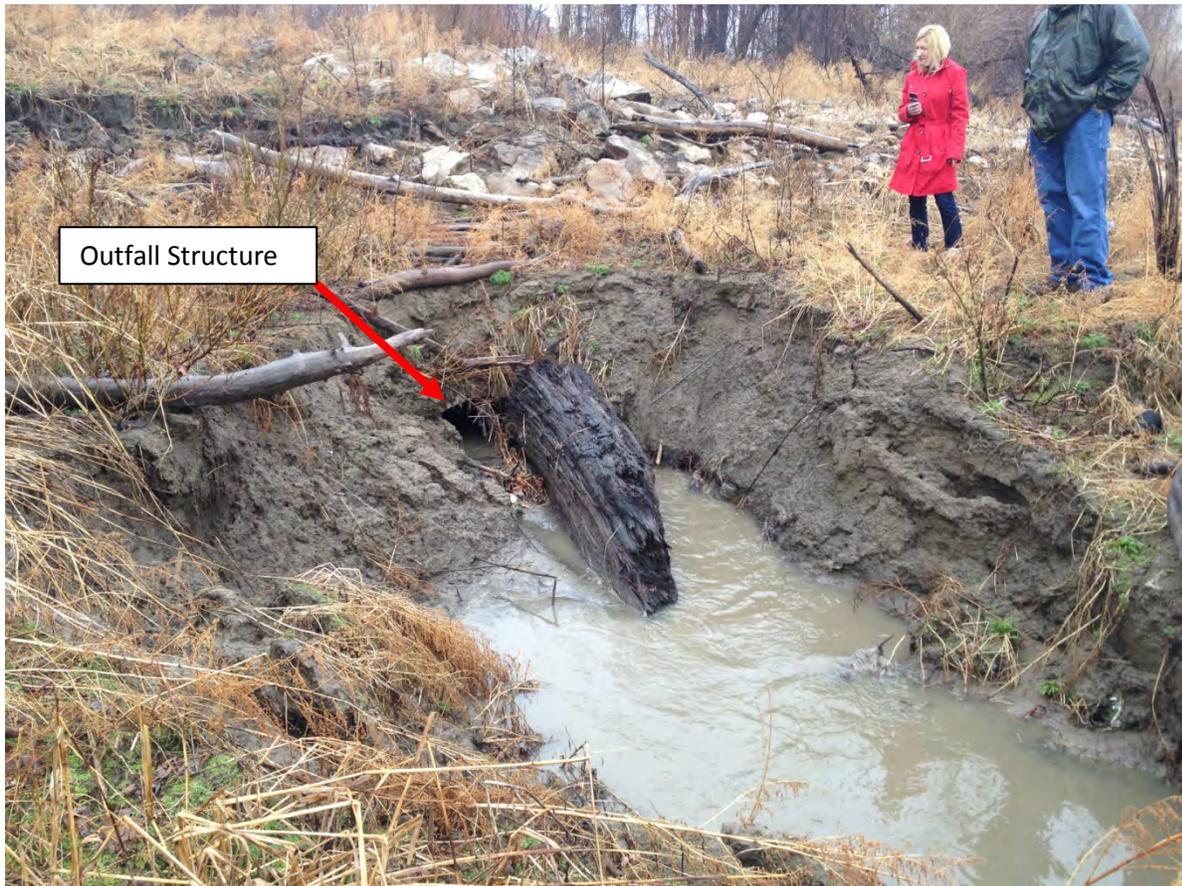
Erosion issues are directly related to an MESD outfall structure buried in the bankline. Only a small portion of the outfall structure was visible above the water line flowing out of the pipe from recent storms. It is estimated that it is a 54" concrete outfall pipe.

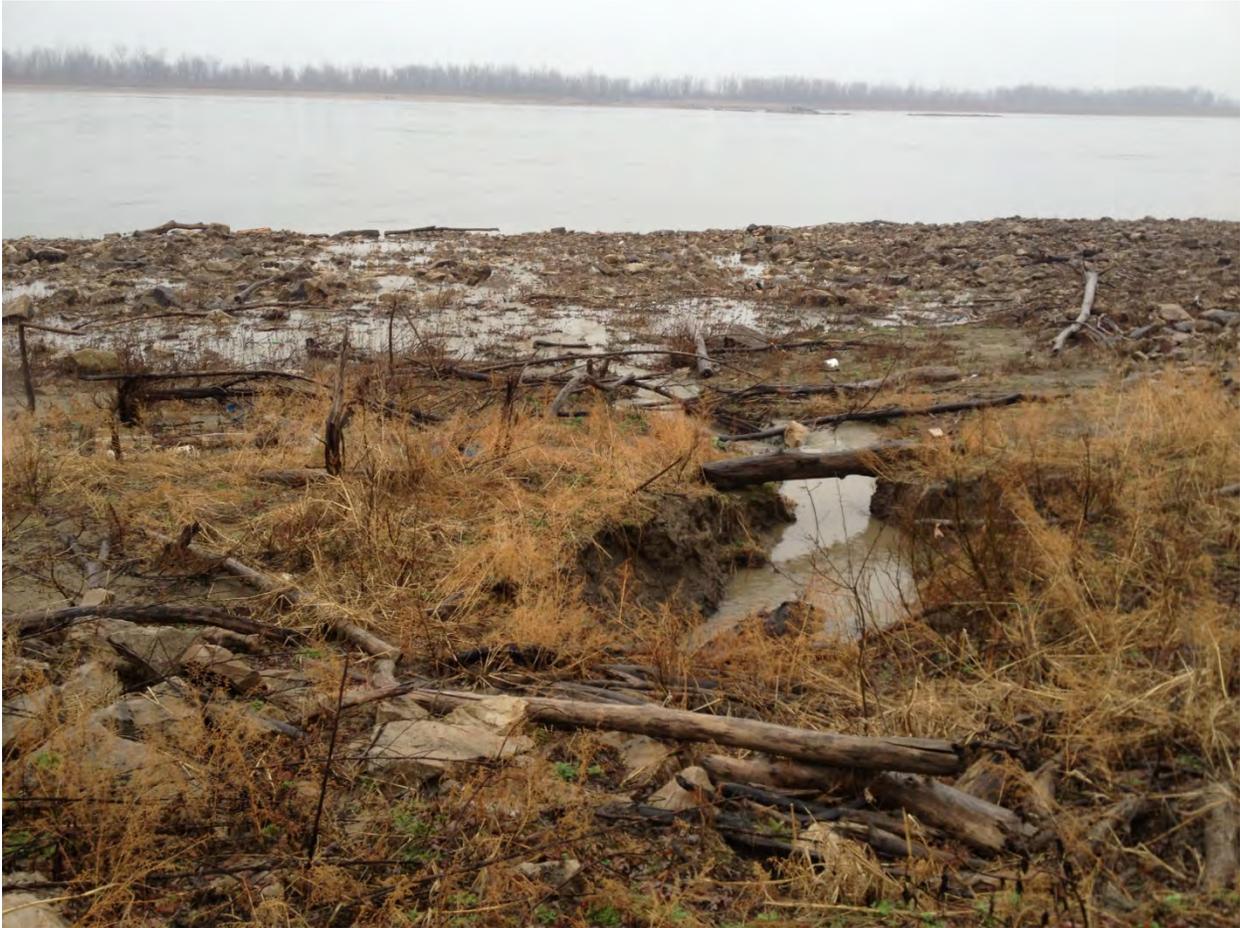
The drainage channel for the outfall appeared to have filled in and the outfall pipe was no longer exposed and was forgotten. It is assumed that the original outfall channel was lined with stone but

during subsequent flooding events it has filled in with sediment. During a January 28, 2014 inspection, it was observed that some erosion was occurring but the forgotten outfall pipe did not become exposed until recent storm events. The outfall channel was thought to be bankline erosion possible in need of repair.
