WATER DISTRICT NO. 1
OF
JOHNSON COUNTY, KANSAS

**KANSAS RIVER INTAKE
JETTY IMPROVEMENTS STUDY**

PROJECT NO. 99409.108

May 20, 2005

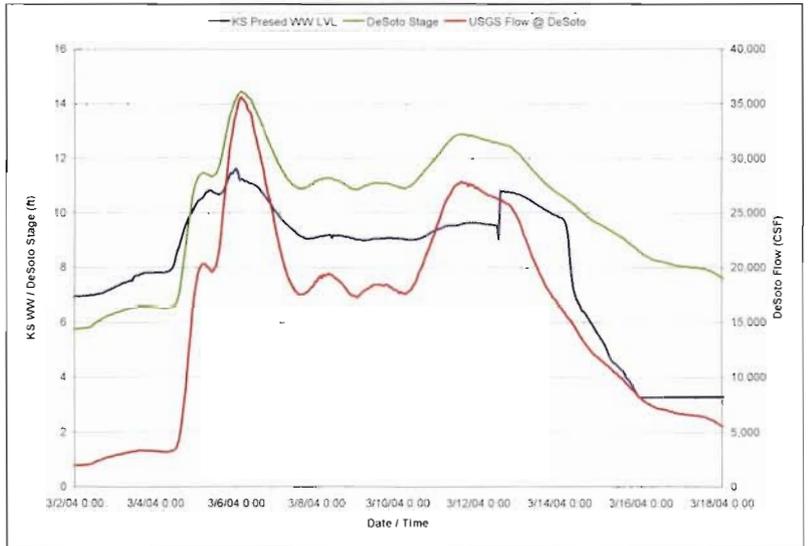
Figure 1. Kansas River Stages and Estimated Flows between 3/2/2004 and 3/18/2004

A breach of the jetty occurred sometime during March 14 - 15, 2004. Prior to the breach, the US Army Corps of Engineers (COE) made a large release of flow (approximately 20,000 cfs) from Tuttle Creek Reservoir because the lake level had risen 11 feet from rainfall. This release, plus added inflows from rainfall in other portions of the Kansas River basin, caused the total flow in the Kansas River at DeSoto to rise from approximately 1,500 cfs to over 35,000 cfs in about one day around March 5th. The flow diminished to about 17,000 cfs around March 7 and remained there until March 10. From March 10 to March 12, the flow increased to about 27,000 cfs and the jetty breach appears to have occurred with a flow of about 26,000 cfs as shown on Figure 1. Using the rating curve shown in Figure 2, the flow appears to have been at least 2 to 3 feet over the top of the jetty.

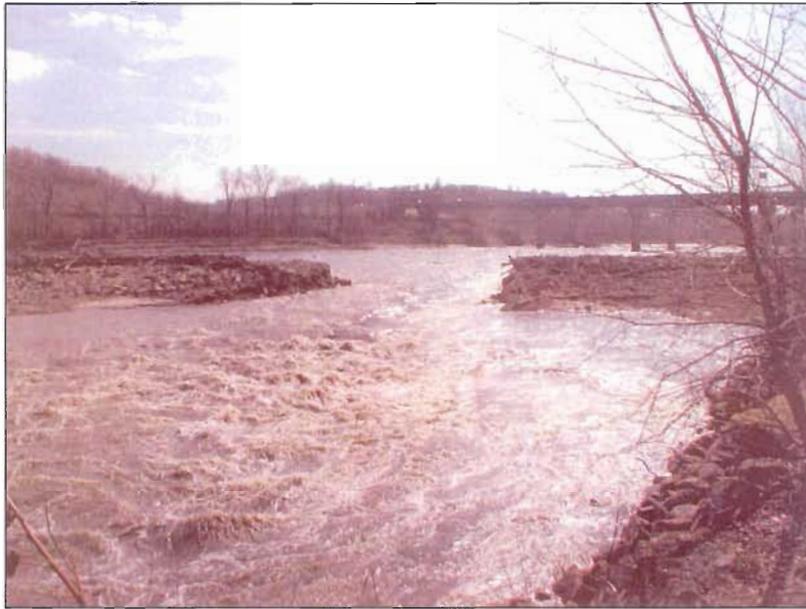
Figure 3. WaterOne Jetty Breach

The breach appeared to be about 50 feet wide at its narrowest point shown in Figure 3. The bottom of the breach was at about elevation 720, which is roughly 20 ft below the top of the jetty. Debris consisting of tree trunks and branches was observed on the top of the jetty from the breach to the northern bank of the river. Some debris was also located on the south side of the breach. The majority of the rest of the jetty was relatively free of debris.

The structural integrity of the jetty immediately prior to the breach and the exact nature of the breach are not known. The walls of the breach above the water level were nearly vertical. The riprap exposed in the breach was a mixture of rock approximately 3 feet in its longest dimension mixed with smaller riprap. Fine-grained soils filled the voids between stones. Downstream from the breach, the flow was very turbulent and some erosion occurred on the north end of the jetty. On the upstream side, sediments were exposed and water level was lower than the sill elevation of 732 ft. It appears that a significant amount of sediment that had collected on the upstream side of the breach was eroded and carried past the jetty through the breach. During a field visit on March 17, the velocity through the breach appeared to be greater than 10 feet per second at a flow of about 7,000 cfs, according to USGS gauge information. The flow in the river diminished to about 5,000 cfs on March 18.

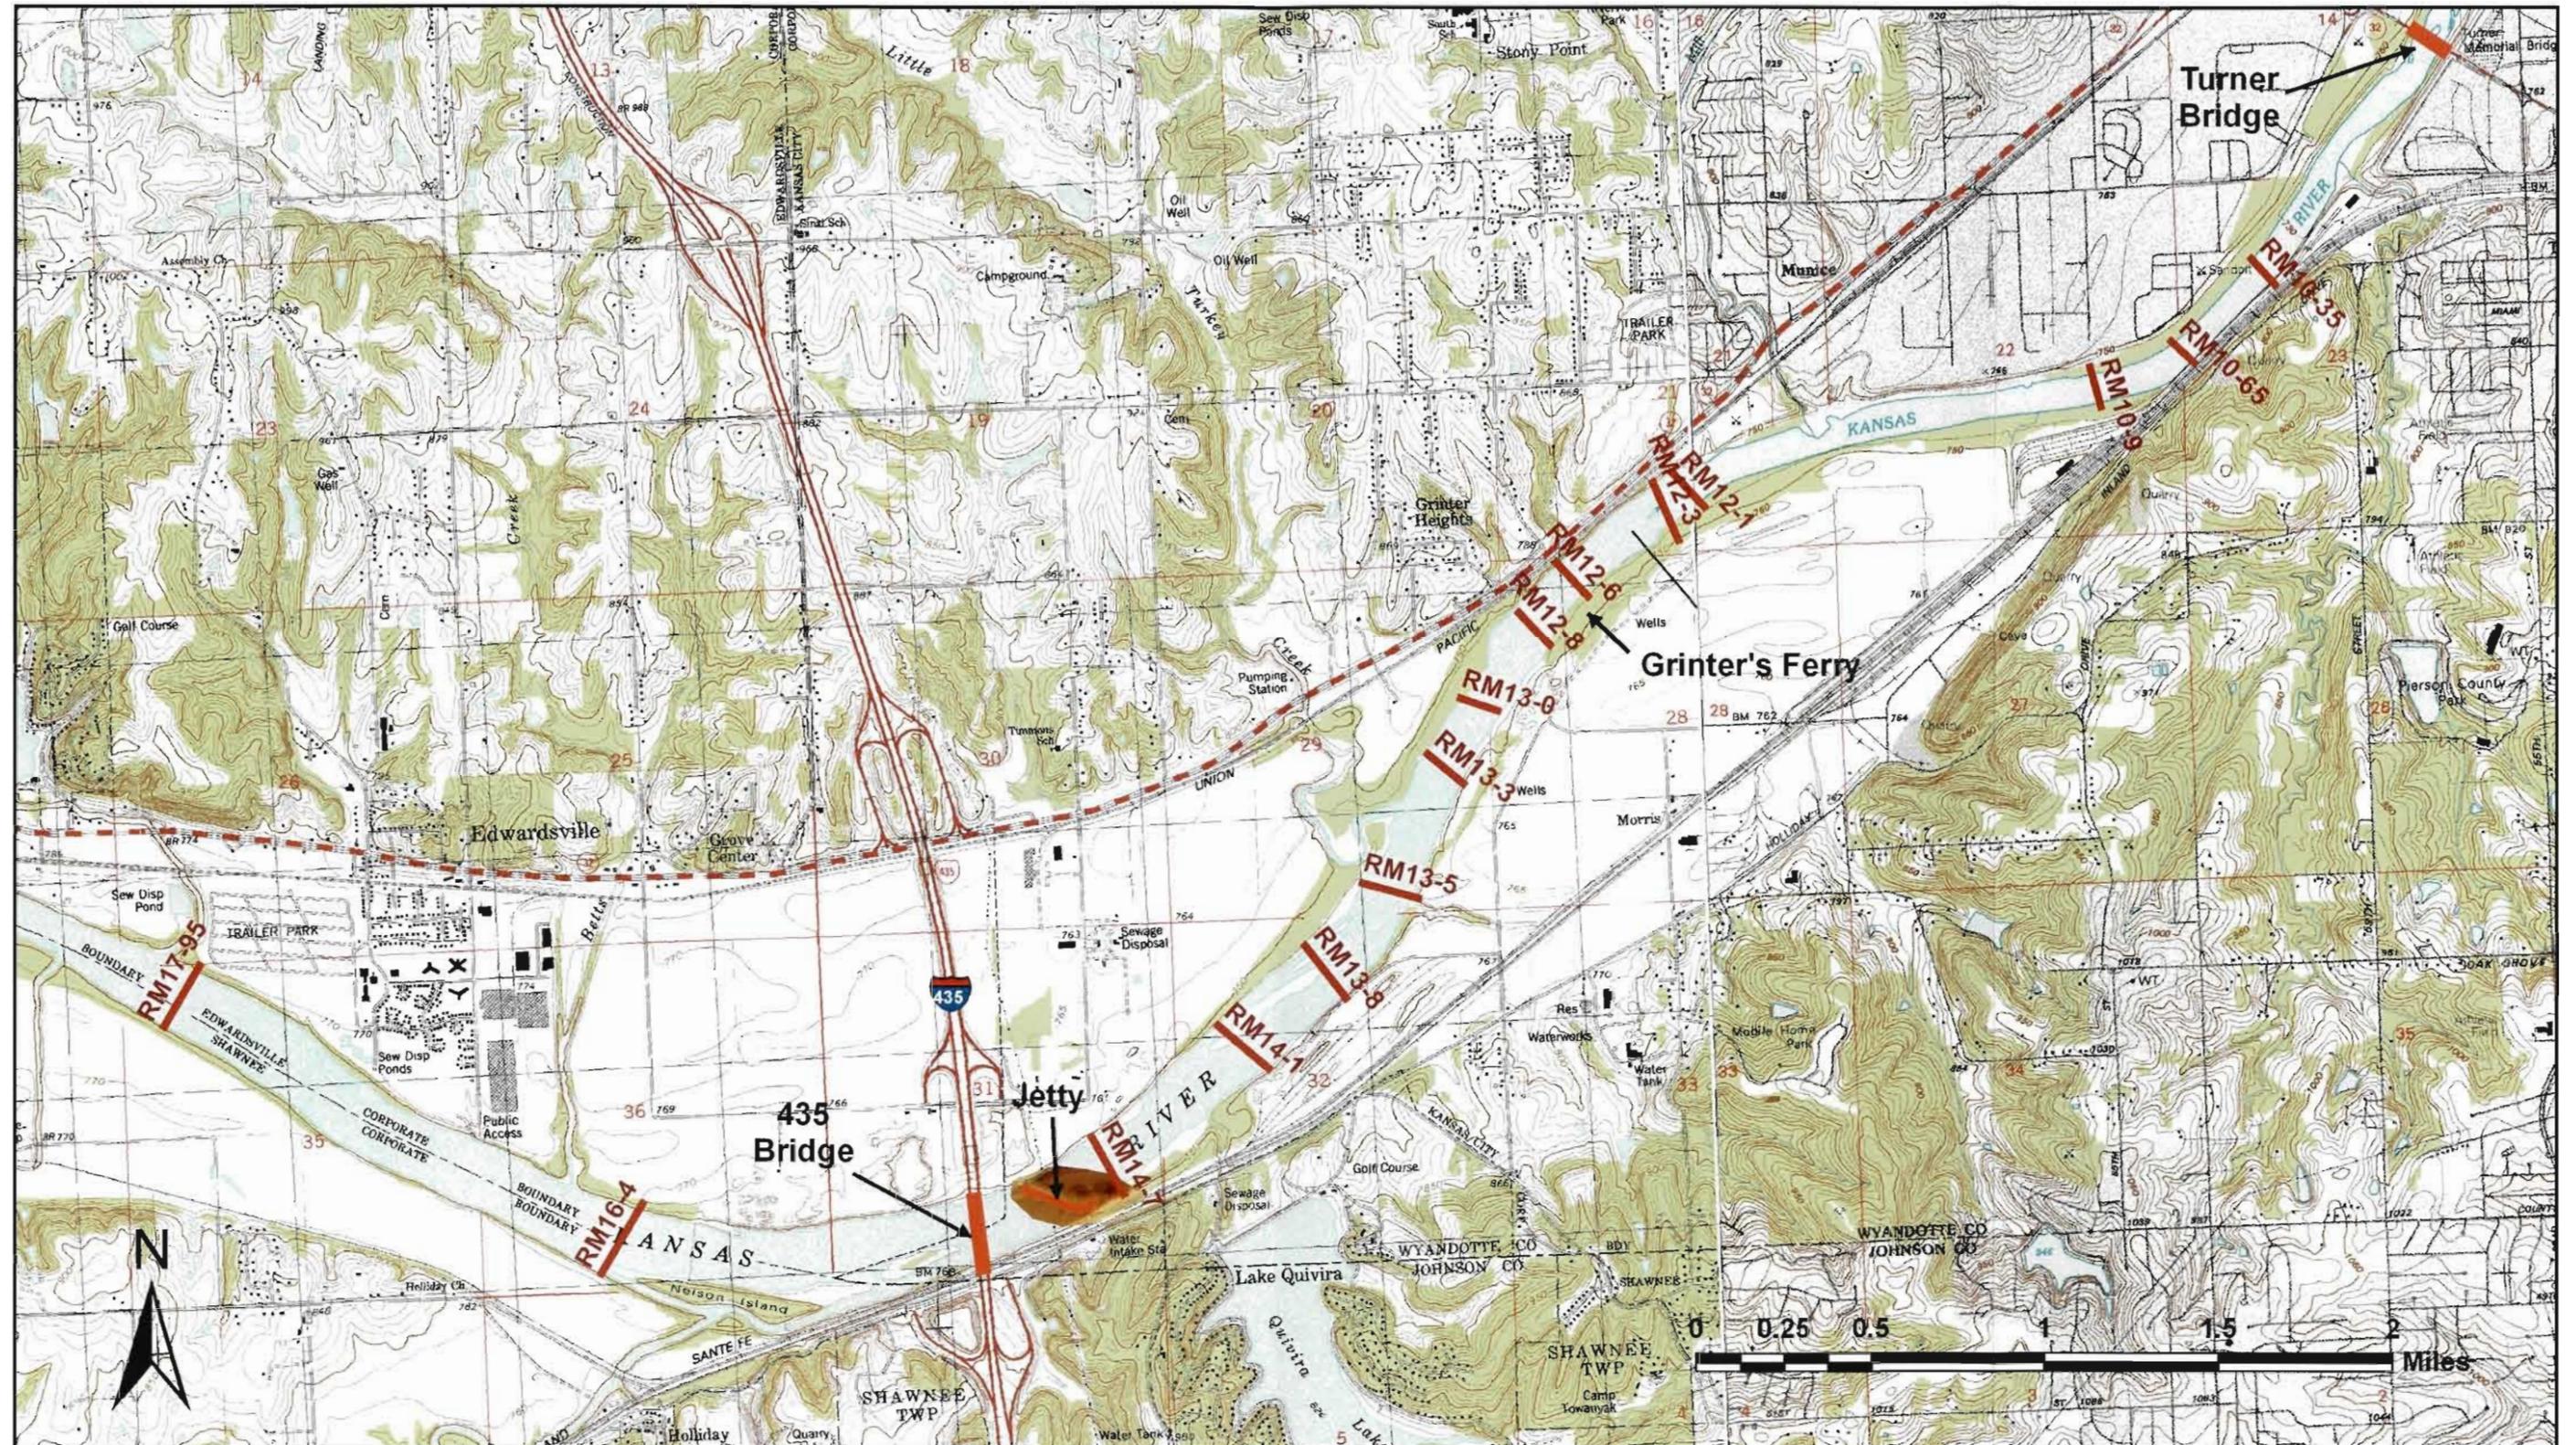
Figure 8. Kansas River Jetty
Jetty Location and Cross Sections

Recent findings indicate that degradation of the channel bed may be an enduring phenomenon. Comparison of cross section surveys obtained for 1999 and 2003 indicate an average reduction in bed elevation of more than two feet for RM 14-1 and RM 13- 8; with thalweg (lowest point of a river bed) reductions of 3.8 ft and 8.9 ft respectively. RM 14-1 is located approximately half a mile downstream from the jetty and RM-13-8 is located about one mile downstream from the jetty.

Ongoing degradation has two main effects on the jetty. The first effect is a reduction in tailwater. Tailwater elevation estimates presented in the 1988 Black & Veatch draft report and estimates from a hydraulic model for current conditions were compared. The results indicate that tailwater elevation decreased between 5 ft and 4 ft for flows between 5,000 cfs and 25,000 cfs respectively from 1988 to present. A reduced tailwater increases the head differential at the jetty; this condition produces an increase in the velocities and the shear stress at the downstream slope of the structure. The increase in velocity and shear stress would make the downstream slope of the structure more susceptible to undercutting. The 4 to 5 ft reduction in tailwater elevation estimates represents further evidence that degradation is still an ongoing process in the Kansas River.

The second effect is related to the structural stability of the jetty. As the degradation approaches the jetty and the sandy riverbed material is removed, it allows the stones in the jetty to settle. This could have been happening prior to the breach.

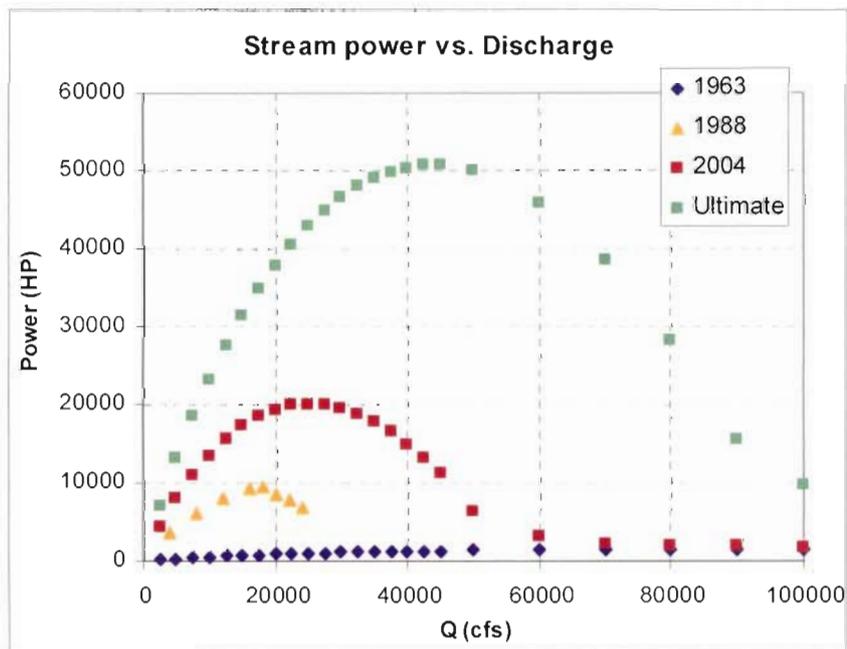
Figure 9. Stream Power vs. Discharge

Analyses were conducted of the available stream power, which is the driving force behind rock movement and jetty breaching. Figure 9 compares the stream power when the jetty was first constructed, what it was in 1988, what it is currently, and what it will be when ultimate degradation occurs. The stream power has increased significantly since the jetty was first constructed. The breach and near breach both occurred when the stream power was approximately 20,000 Hp corresponding to a flow of between 15,000 and 35,000 cfs. The chart shows that stream power equal to or exceeding 20,000 Hp will occur much more frequently in the future over a much wider range of flows. Therefore, the probability of failure will increase.

The jetty does not breach or need significant repairs every time flows occur that create stream power of 20,000 Hp or more. Two other factors appear to be impacting the likelihood of major damage. During both events this year, a major debris jam occurred. This was apparently caused by high flows moving the debris down the river. Following

the high flows, the flow diminished for a period of a few days allowing the debris to build up on the top of the jetty. The flows then increased. Damage occurred some time during this process. It is possible that the second period of high flows removed the debris over a relatively narrow width on the top of the jetty. This may have caused the flow to be concentrated where the debris was removed which focused the power of the water on a small area of the jetty leading to a breach.
