CHAPTER 1

PROJECT AUTHORIZATION

1-01. Construction Authorization. The construction of Tuttle Creek Dam and Reservoir, one unit in the general comprehensive plan for flood control and other purposes in the Missouri River Basin, was authorized by the Flood Control Act of 1938, approved 28 June 1938 (Public Law 761, Seventy-fifth Congress, first session) as modified by the Flood Control Act of 1941, approved 18 August 1941 (Public Law 228, Seventy-seventh Congress, first session) and expanded by the Flood Control Act of 1944, approved 22 December 1944 [Public Law 534, Seventy-eighth Congress, second session (House Document No. 475 and Senate Documents Nos. 191 and 247, Seventy-eighth Congress, second session)].

2-01. General. Tuttle Creek Dam is located on the Big Blue River, 12.3 miles above its confluence with the Kansas River and approximately 6 miles north of Manhattan, Kansas in Riley County. The dam consists of a rolled earthfill and hydraulic fill embankment with a gated, concrete chute spillway on the left abutment and gated twin 20 feet diameter conduits near the right abutment. The pertinent data that characterize the Tuttle Creek Multiple-Purpose Project are presented in

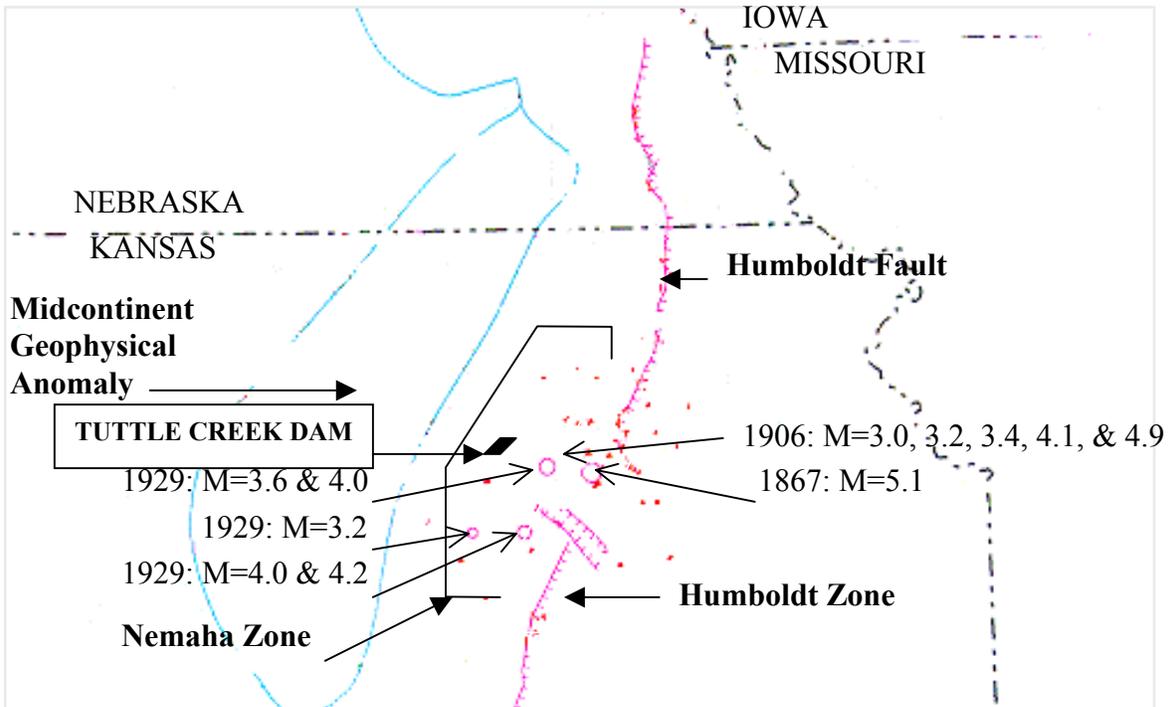
b. A detailed seismologic analysis identified a “hot spot” (Humboldt seismic zone, along the middle part of Humboldt fault) capable of generating an earthquake with a magnitude (Moment Magnitude) of 6.6 at a minimum epicentral distance of 20 km (12.5 miles) from the dam site. The seismic zones in the vicinity of Tuttle Creek Dam are presented in Figure 2.1.

Fig. 2.1. Seismic zones and historic seismic activity in the vicinity of Tuttle Creek Dam.

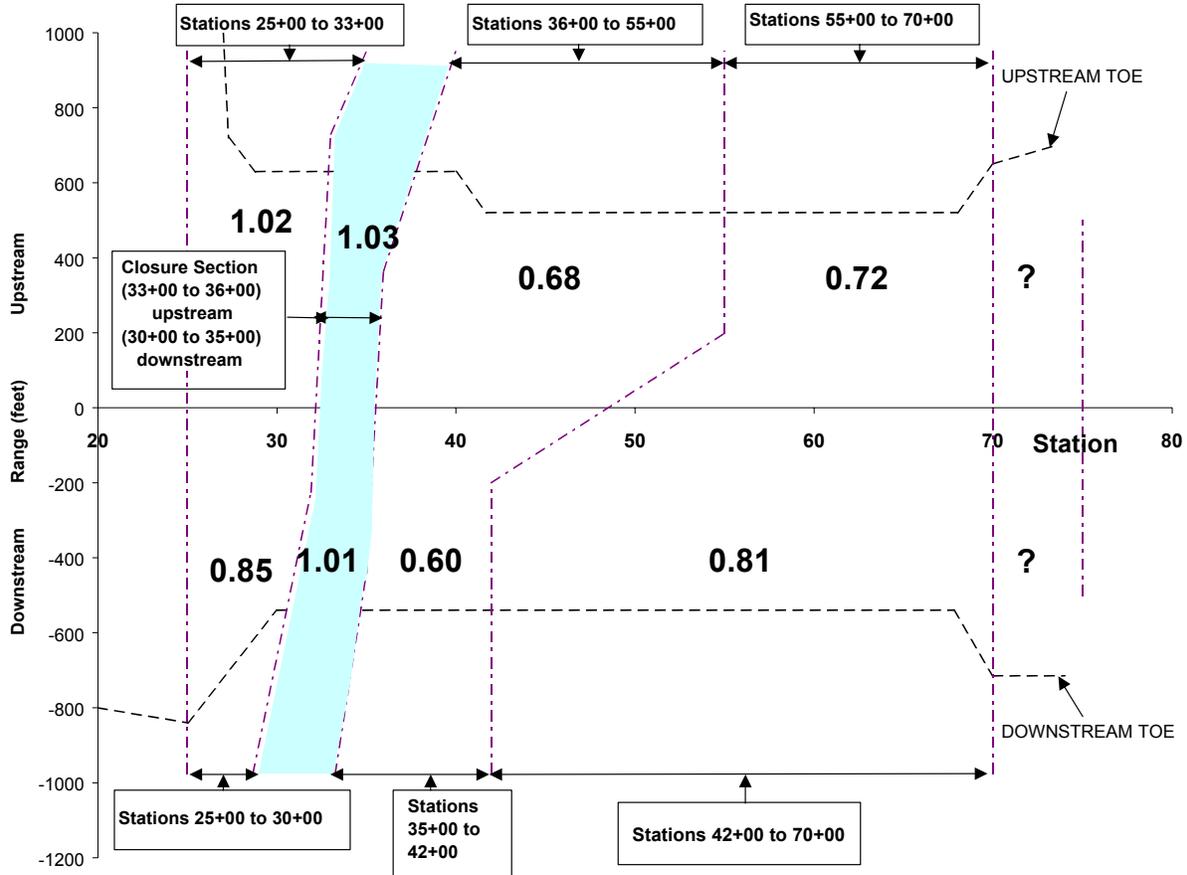
<u>Stations</u>	<u>Factor of Safety for Post Earthquake Condition</u>	
	<u>Failure Mostly Thru Clay</u>	<u>Failure Mostly Thru Sand</u>
<u>Upstream Slope:</u>		
25+00 to 33+00	1.02	N/A
33+00 to 36+00	N/A	1.03
36+00 to 55+00	0.68	0.84
55+00 to 70+00	0.72	N/A
<u>Downstream Slope:</u>		
25+00 to 30+00	1.33	0.85
30+00 to 35+00	N/A	1.01
35+00 to 42+00	0.68	0.60
42+00 to 70+00	0.83	0.81

Figure 3.1 shows the problem zone and the minimum factors of safety. The plan on Figure 3.1 is not to scale; for the plan showing also the appurtenant structures and other related features see Appendix XII.

Fig. 3.1. Plan view of dam and minimum factors of safety (large figures in bold) for limit equilibrium after seismic liquefaction.

(6) It is considered that stabilization methods should be applied everywhere the factor of safety for limit equilibrium was found to be less than 1.0. (It is noted that the factor of safety $FS = 1.0$ was accepted for evaluation of the current condition, as very conservative assumptions were considered; for the design of remediation work based on average soil conditions $FS = 1.2$ was required.) However, in the first two reaches (closure section and the portion to west of it) there is only one boring in each of the characteristic locations (toes and mid-slopes). Also, there are no borings with SPT data between station 70+00 and the edge of the terrace, station 75+00; therefore, at the current level of investigation it is safe to consider the entire reach, between stations 25+00 and 75+00 (5,000 feet long), a problem zone. The presence of terrace deposits at about station 25+00 should be verified. Additional investigation in Phase III may justify elimination from the problem zone of the portions between stations 25+00 and 36+00 (1,100 feet) upstream and between 25+00 and 35+00 downstream (1,000 feet) and between stations 70+00 and 75+00 for both slopes.
