Post 2019 Flood Area of Concern (AOC)
Repairs CONCEPT DESIGN MAPS for
3 Phase Approach

21 AOC Sites

4 Additional MRRP Sites

U.S. ARMY ENGINEER DISTRICT
CORPS OF ENGINEERS
KANSAS CITY, MISSOURI

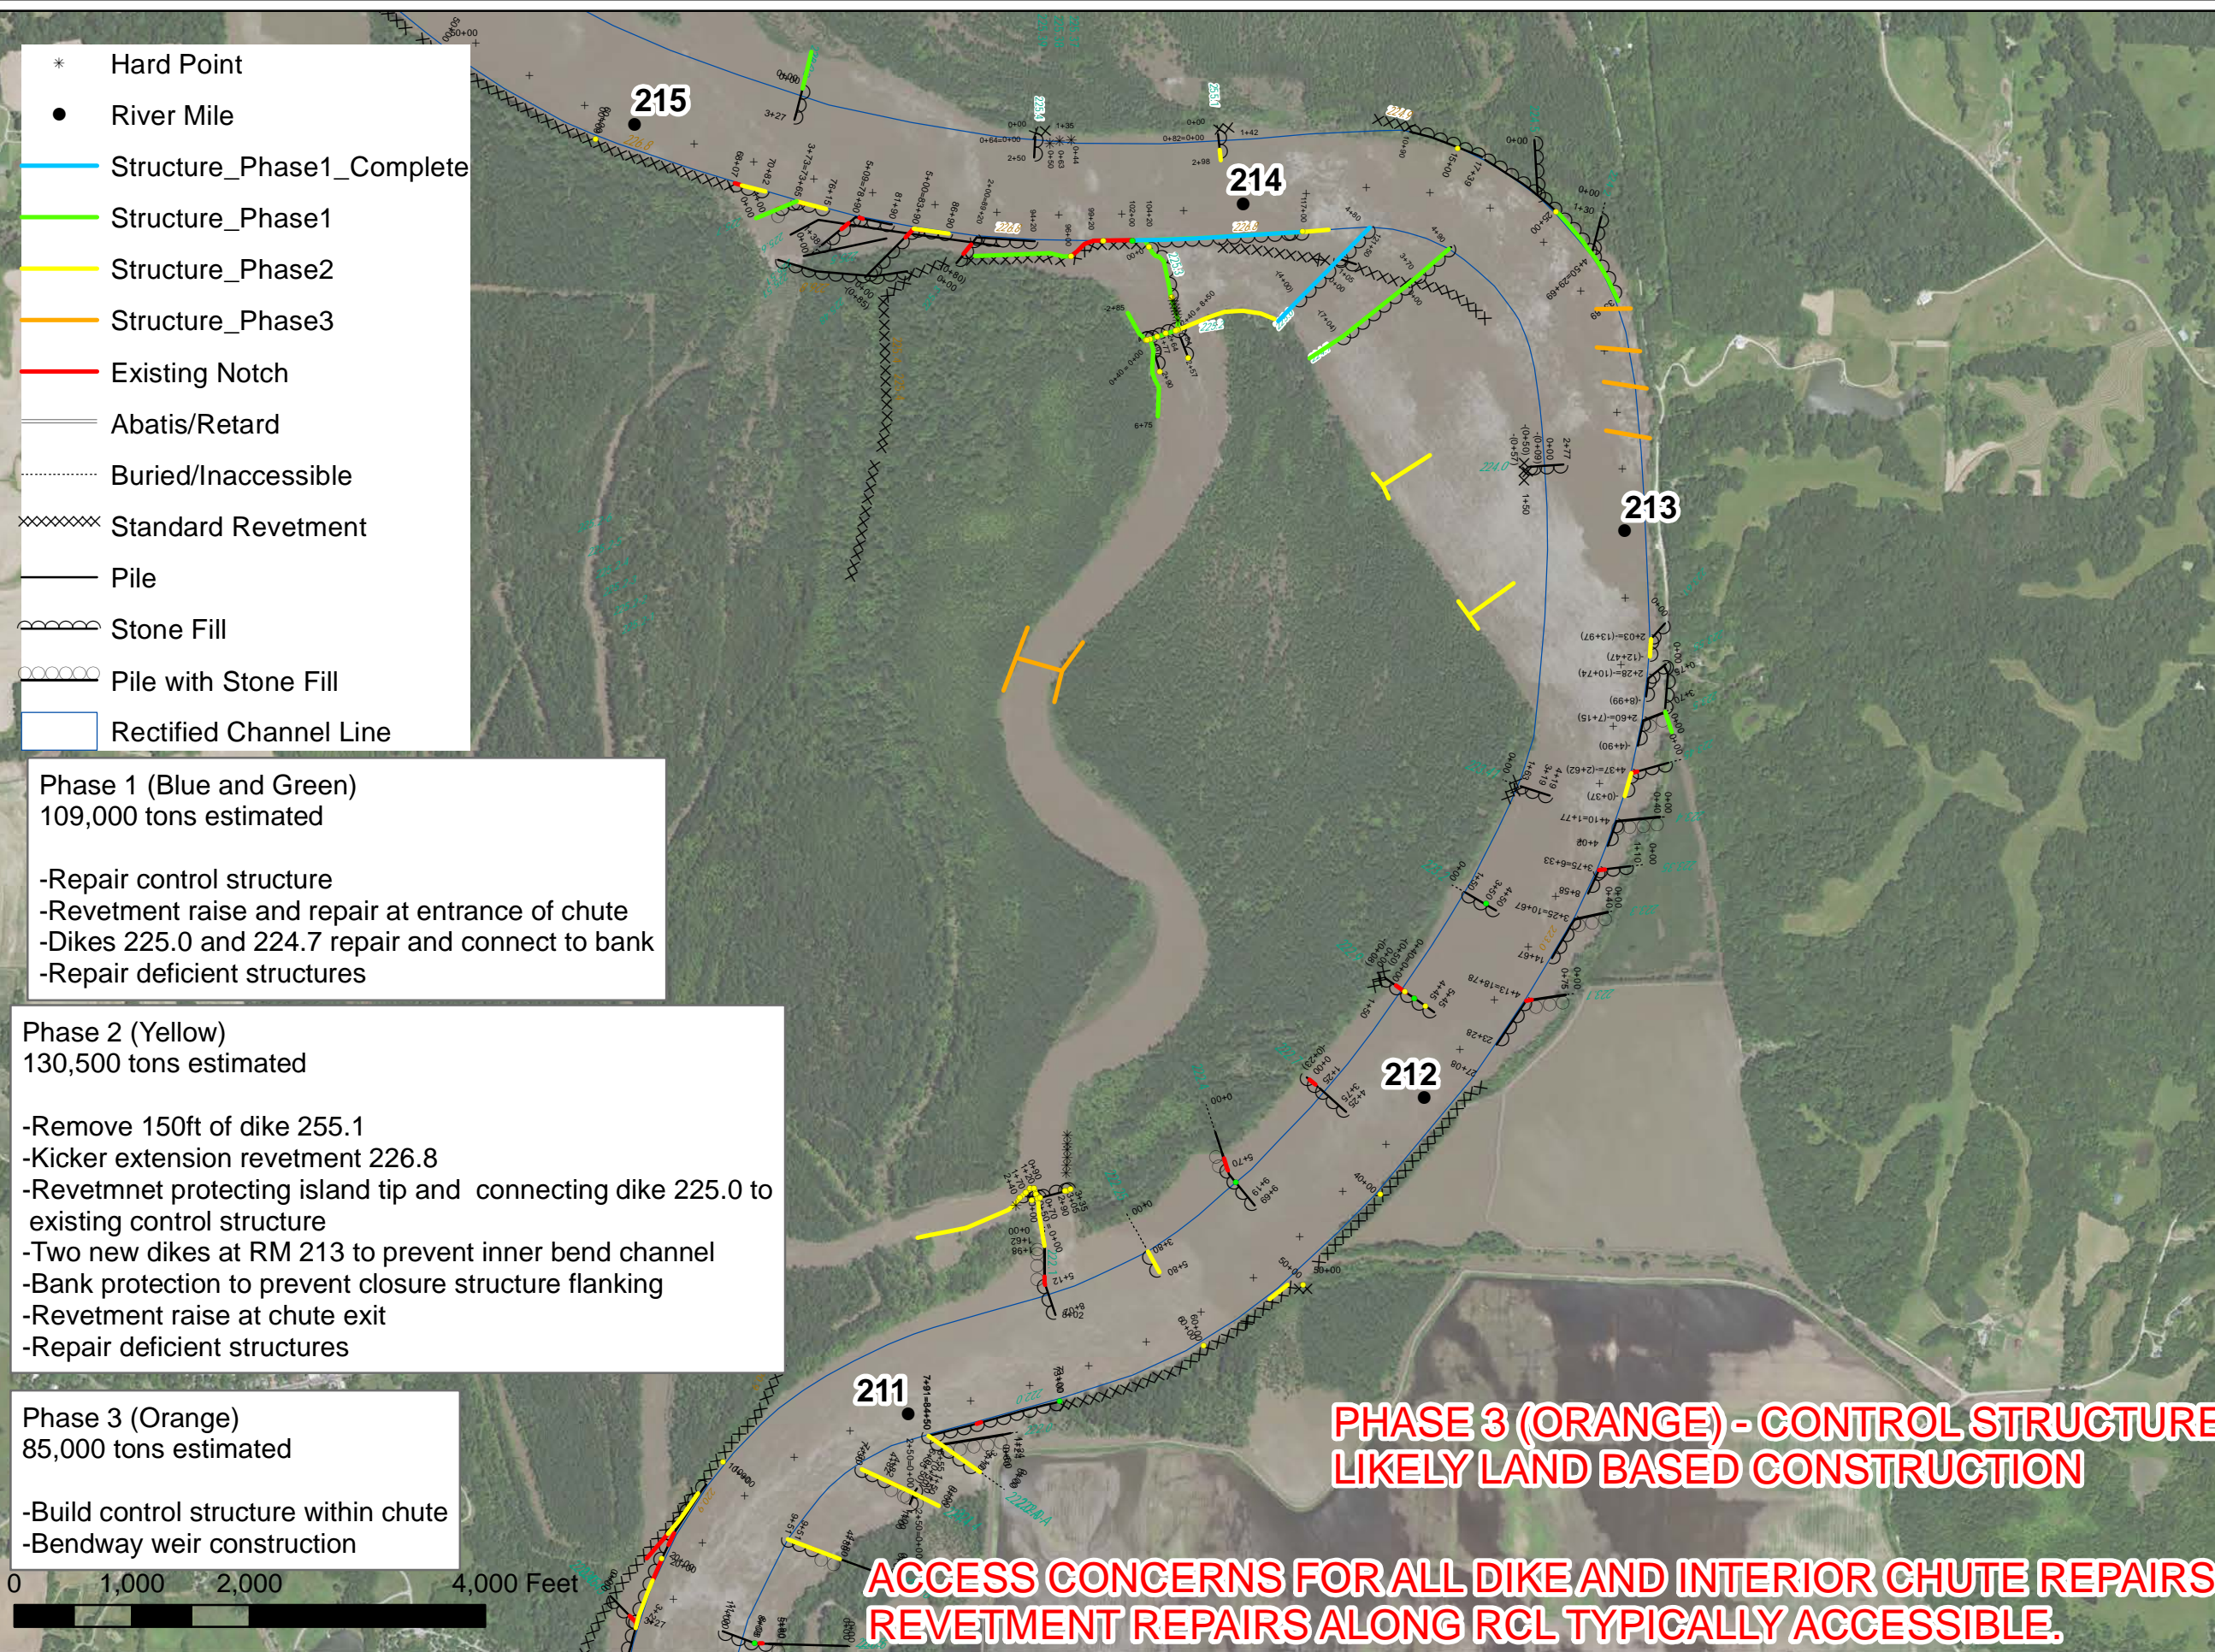
POST FLOOD AOC REPAIR
 RM213 - JAMESON ISLAND

PHASE 3 (ORANGE) - CONTROL STRUCTURE LIKELY LAND BASED CONSTRUCTION

ACCESS CONCERNS FOR ALL DIKE AND INTERIOR CHUTE REPAIRS. REVETMENT REPAIRS ALONG RCL TYPICALLY ACCESSIBLE.

Phase 1 (Blue and Green)
 109,000 tons estimated

- Repair control structure
- Revetment raise and repair at entrance of chute
- Dikes 225.0 and 224.7 repair and connect to bank
- Repair deficient structures

Phase 2 (Yellow)
 130,500 tons estimated

- Remove 150ft of dike 255.1
- Kicker extension revetment 226.8
- Revetment protecting island tip and connecting dike 225.0 to existing control structure
- Two new dikes at RM 213 to prevent inner bend channel
- Bank protection to prevent closure structure flanking
- Revetment raise at chute exit
- Repair deficient structures

Phase 3 (Orange)
 85,000 tons estimated

- Build control structure within chute
- Bendway weir construction
