# Rock Creek Watershed Planning Final Feasibility Report

United States Army  
Corps of Engineers  
Northwestern Division  
Kansas City District  
700 Federal Building  
Kansas City, MO 64106

Black & Veatch  
6601 College Boulevard  
Overland Park, KS 66211

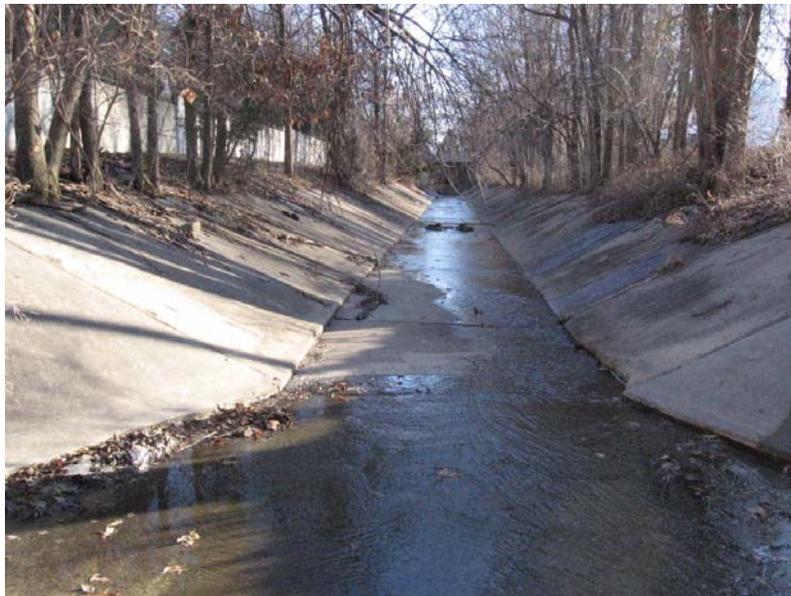
**Figure 1: City of Mission Reach 77 Looking Downstream**

The highest quality aquatic habitat was found along the main channel of Rock Creek and in some tributaries. Example reaches include 4, 46, 95, and 117, represented in the Appendix B-2 map. This is likely due to the length of each reach, the relatively natural state, and the variety of macro-habitat types available including pools and riffle areas. The lowest aquatic scores are associated with concrete and grouted stone walls where habitat structure is virtually nonexistent. Reach 77, located along the Birch Creek tributary, is an example.

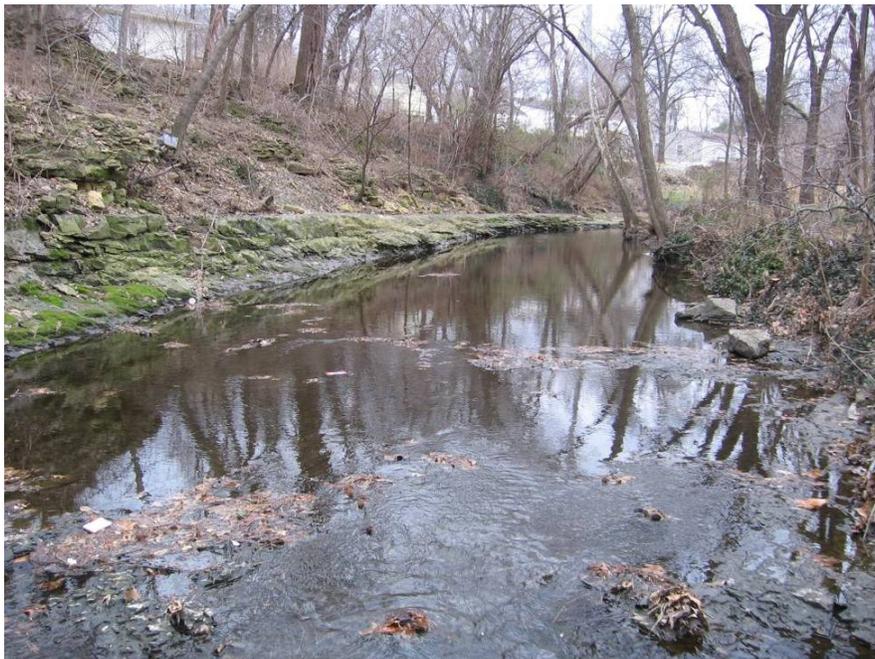
**Figure 2: City of Fairway Reach 32 Looking Upstream**

Some commercial and business districts have constructed parking lots up to the banks of the stream network. Native plant species have not been able to compete with the introduction of winter creeper euonymus (*euonymus fortunei*), english ivy (*hedera helix*), and shrub honeysuckle (*lonicera tatarica*). These invasive plants, commonly used in residential landscaping, have spread to cover much of the bank and provide little erosion protection. The highest quality terrestrial habitat was found in reach 80 where the corridor widened with numerous trees and shrubs. Reach 32 along the main channel in Fairway provides an example of this wide corridor (Appendix B-3 map). The lowest quality was adjacent to reaches 140–147, an area representative of the proximate parking areas and the absence of stream corridor.

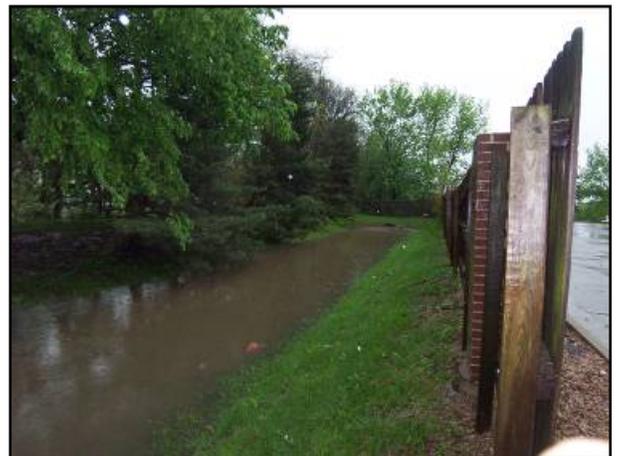
Project 1

- Some signs of erosion and instability.
- Channelized flow path.
- Existing swale is planted with turf grass, limited infiltration capacity.
- Degrading pipe and inlet infrastructure for downstream half of channel.

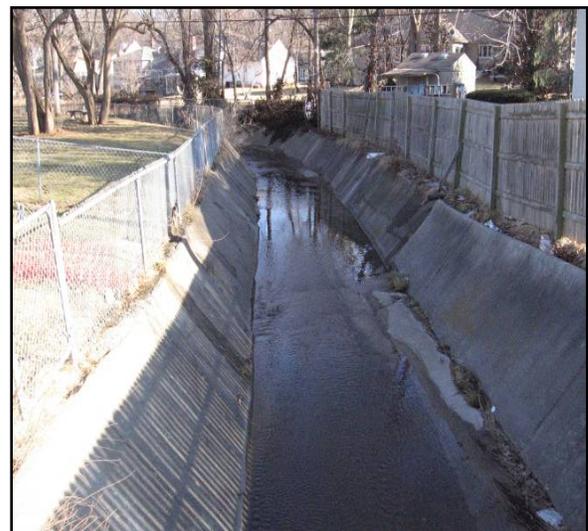
**Project 3**

- Right and left bank wall requires repair
- Concrete structure provides little habitat or water quality value, increases flow velocities and possibly contributes to downstream flooding concerns.

- Remove concrete channel
- Replace walls on right and left banks as necessary.
- Limited vegetation of banks
- Provide rip rap/bank protection of channel

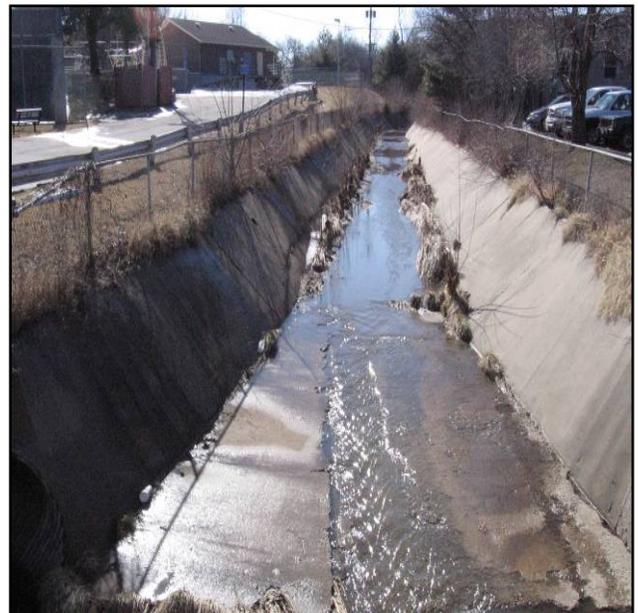
**Project 7**

- Existing concrete channel is degrading.
- A stream buffer corridor is not present.
- Concrete structure provides little habitat or water quality value, increases flow velocities and possibly contributes to downstream flooding concerns.

- Replace wall on right and left bank, allowing an appropriate width to integrate flood benches.
- Provide rip rap/bank protection of channel

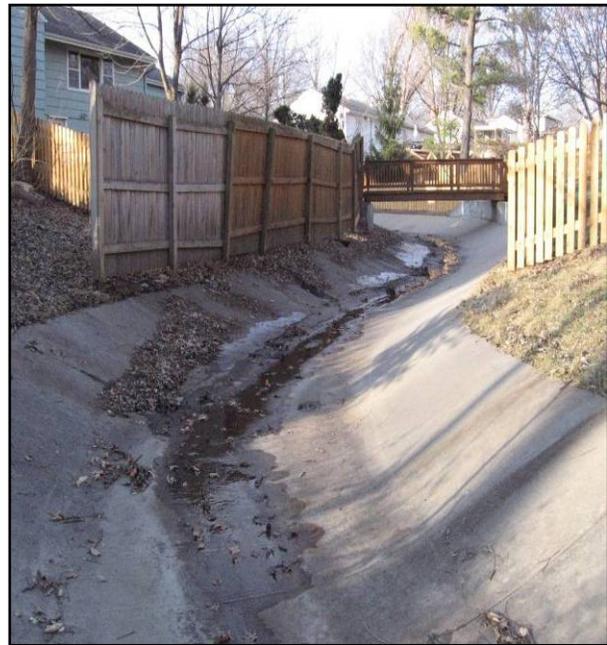
**Project 9**

- Concrete and grouted rock channels are in various conditions.
- Concrete structure provides little habitat or water quality value, increases flow velocities and possibly contributes to downstream flooding concerns.
- Lack of native vegetation and stream corridor
- Lack of public education about stream.

- Replace concrete and grouted rock channels with natural slopes and flood benches.
- Limited vegetation to create corridor
- Provide rip rap/bank protection of channel as necessary

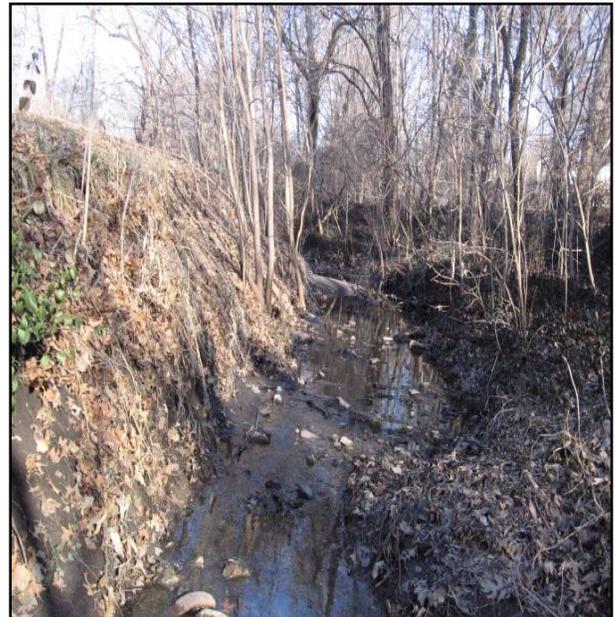
**Project 16**

- Observed instability and erosion on left and right banks
- Substrate is not well graded, consisting of mostly silts.

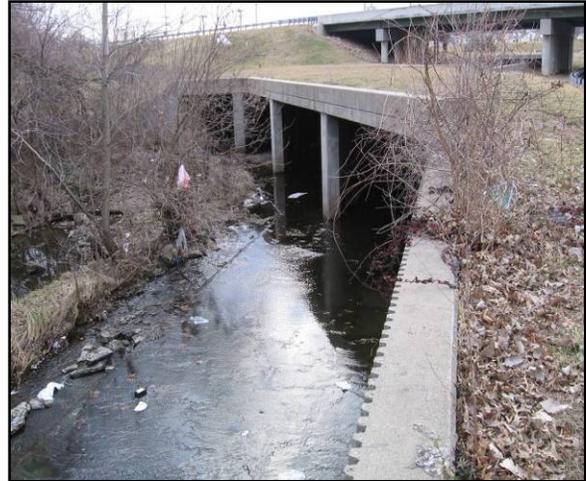
**Project 33 – Segment 1**

- Limited infrastructure is degrading
- Some signs of erosion on both banks
- Concrete channels provide little habitat or water quality value, increase flow velocities and possibly contribute to downstream flooding concerns.

- Replace left and right channel wall with sufficient width to develop low flow channel and flood benches.
- Provide rip rap/bank protection of channel

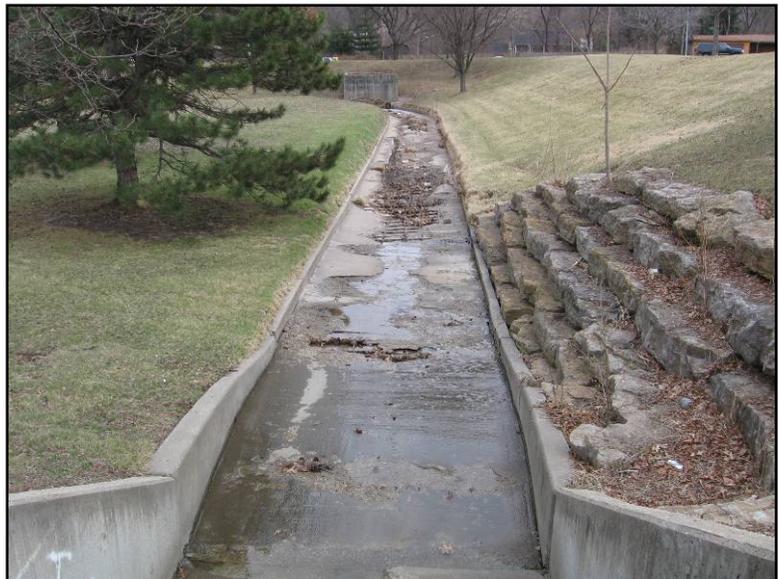
**Project 18**

- Existing channel experiencing degradation.
- Concrete channels provide little habitat or water quality value, increase flow velocities and possibly contribute to downstream flooding concerns.

- Replace concrete channel with stable cross section
- Limited vegetation of banks
- Provide rip rap/bank protection of channel

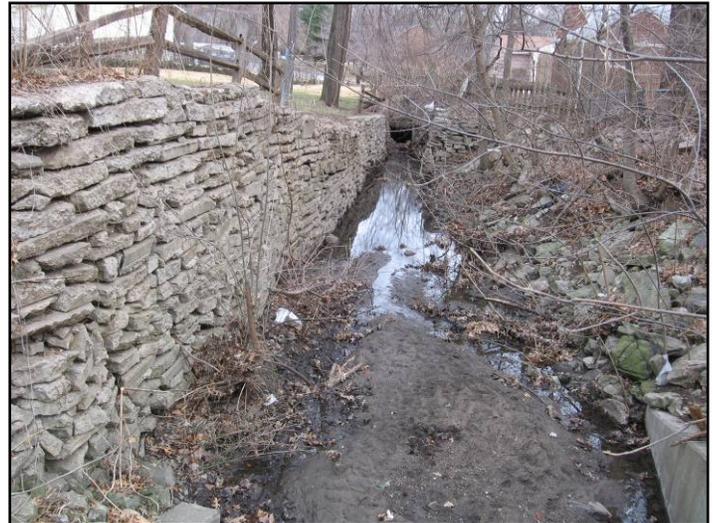
Project 20

- At upstream end, right bank should be stabilized.
- At downstream end, both right and left bank stabilization is deteriorating.
- Overwidened upstream section allows excessive sediment deposition.

- Replace right bank wall as necessary.
- Incorporate vegetation and stream buffer.
- Provide rip rap/bank protection of channel

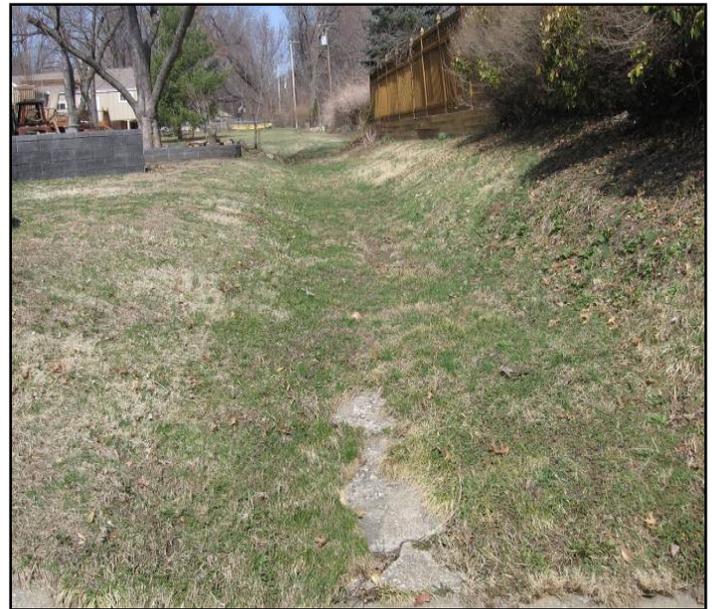
**Project 25**

- Some signs of erosion and instability.
- Channelized flow path.
- Existing swale is planted with turf grass, limited infiltration capacity.

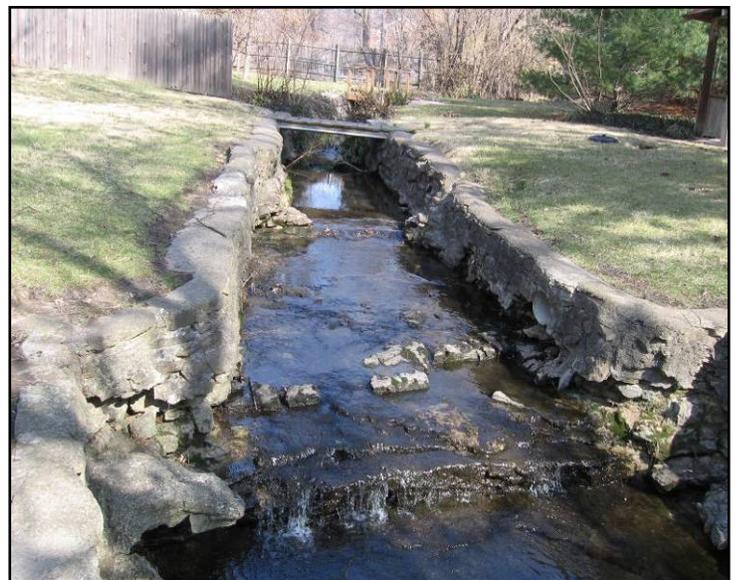
Project 29 – Segment 1

- Channel infrastructure degrading
- Lack of stream buffer between lawns and tributary

- Limited vegetation of banks
- Provide rip rap/bank protection of channel

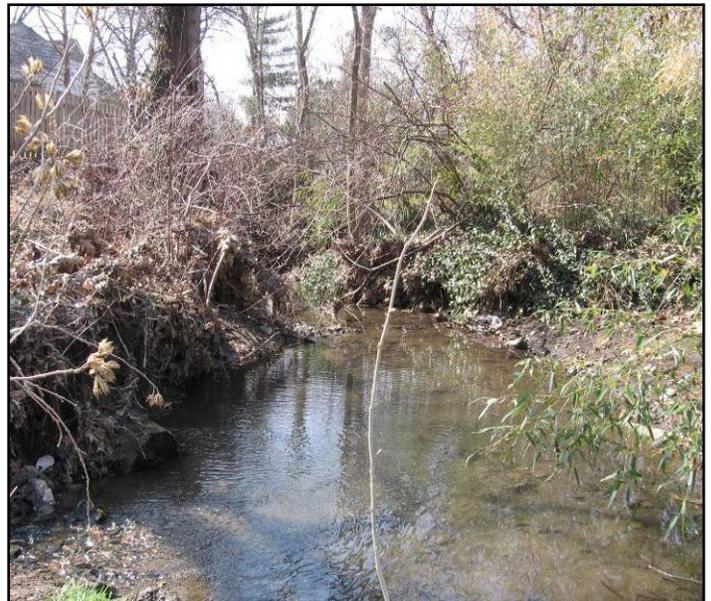
**Project 29 – Segment 2**

- Observed instability and erosion on both banks

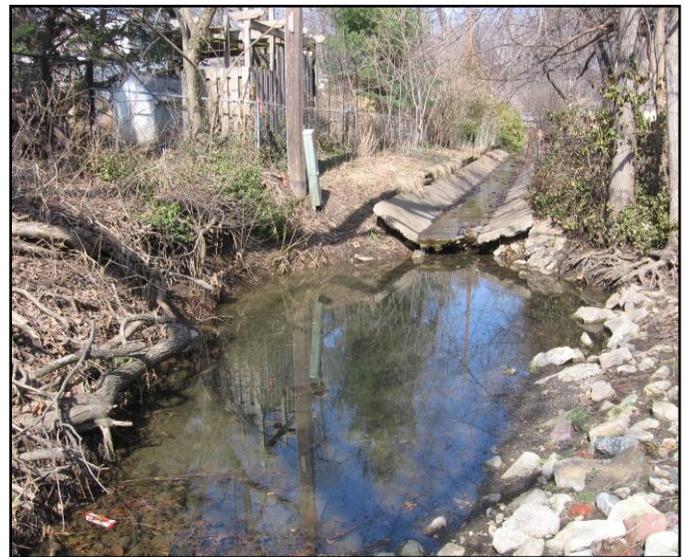
**Project 31 – Segment 2**

- Large scour hole at end of concrete channel.
- Observed erosion and lack of stream buffer
