U.S. Army Corps of Engineers, Kansas City District

Final Feasibility Report

APPENDIX D

HAZARDOUS, TOXIC, AND RADIOLOGICAL WASTE

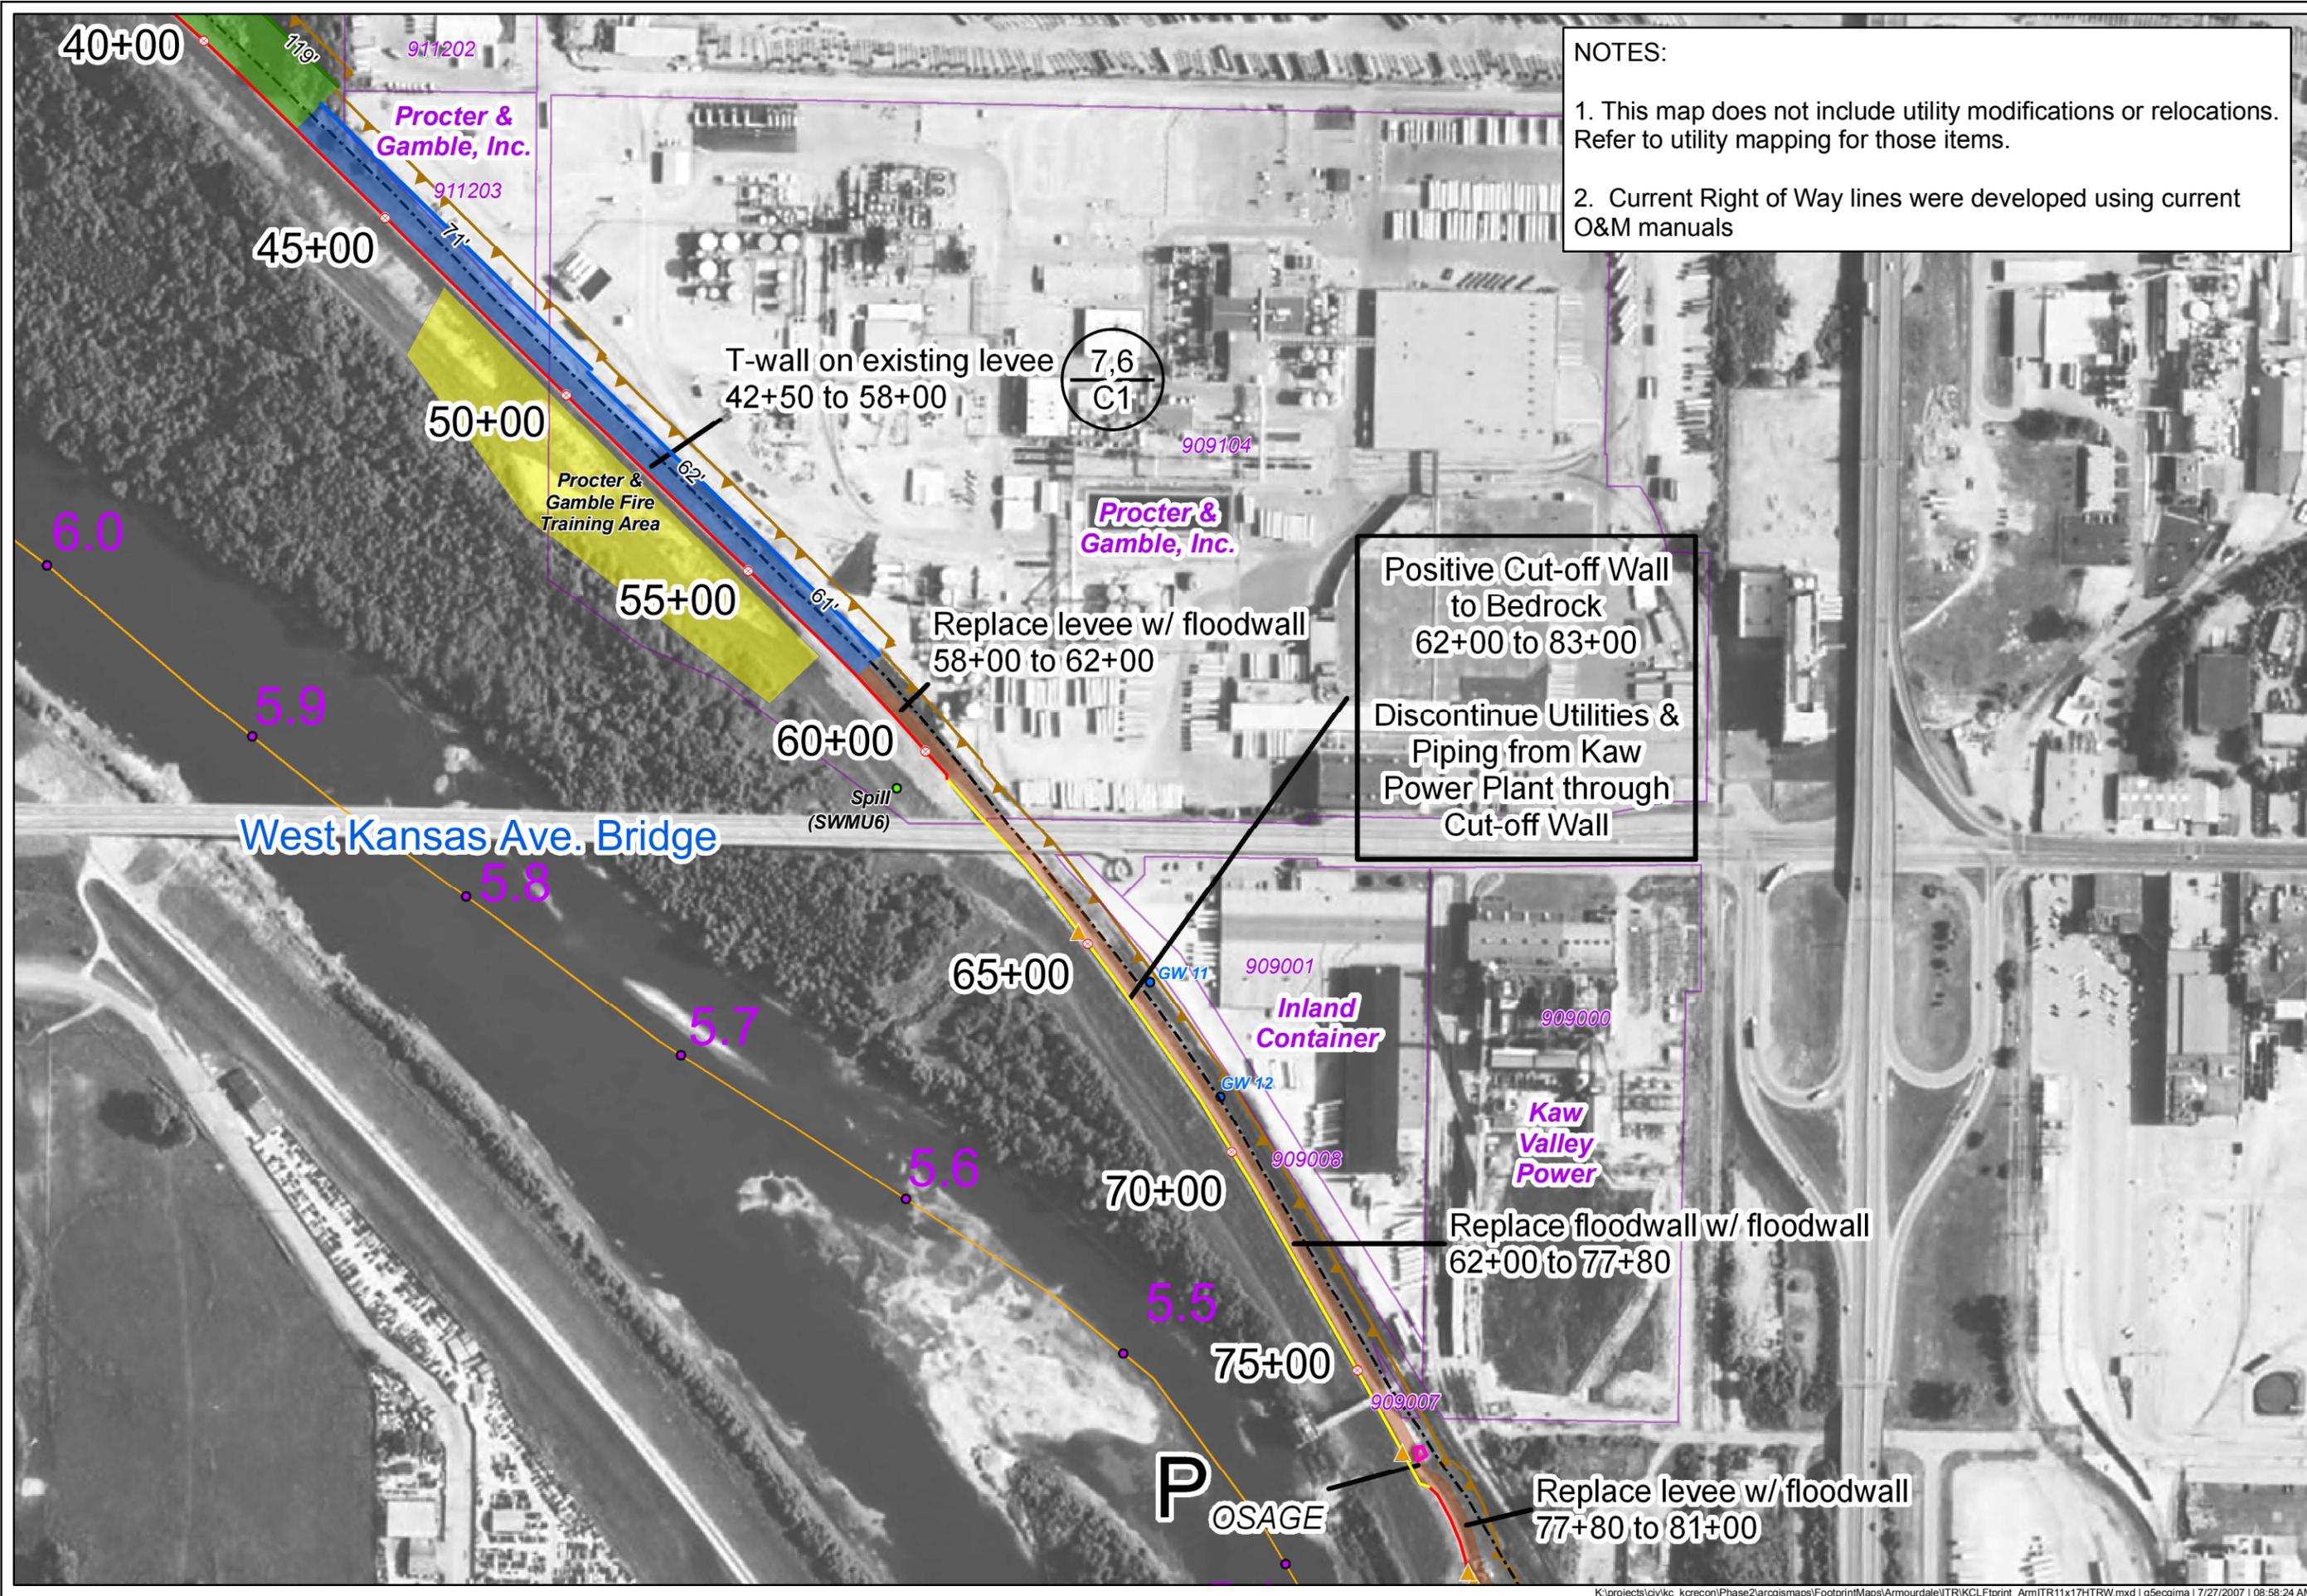
Fig. 3.0

The Procter & Gamble facility has been in operation since 1911. A portion of the western property boundary lies within the construction limit established for this assessment for the Armourdale levee. Procter & Gamble manufactures various types of soaps, detergents, cleaning products, and

industrial organic chemicals. Procter & Gamble is a RCRA permitted hazardous waste treatment, storage, and disposal facility. A RCRA Facility Assessment completed in May 1998 identified 13 Solid Waste Management Unit (SWMUs) and eight Areas of Concern (AOCs) and identified evidence of releases of hazardous waste and hazardous constituents. Only one SWMU and one AOC are located within the area affected by the levee improvements. A fire-fighting practice area (see Figure 3.0) is located on the riverward side of the levee and is listed as SWMU 7. One spill from a storm drain into the Kansas River is identified as AOC 6 and is located at an outfall to the River. No other SWMUs are located within the area required to complete the levee improvements. No RCRA corrective action has occurred at the facility at this time.

Groundwater beneath P&G travels to the south-southwest and discharges to the Kansas River. Beginning in 1919, P&G drilled a number of wells for industrial use for the facility. Two wells, #11 and #12, were located within the levee easement, (see Figure 3.0). During an investigation of the Kansas Groundwater Quality Monitoring Network in 1988 by KDHE, both of these wells were found to contain concentrations of volatile organic chemicals (VOCs) significantly above Kansas Action Levels (KALs) and MCLs. Both wells had a large turbine pump head on a concrete pump base. Small containers of lubricant or solvents were located next to the wellhead turbine and spilled oil was present in the cracks of the concrete pad and this was considered as one but not the sole source of the groundwater contamination. These wells were sampled again in 1990, 1991, and 1992 as part of Preliminary Assessment of Well #11 (1990), Screening Site Assessment (1991) and Site Inspection Prioritization (1994) by KDHE. On-site monitoring wells were found to have much lower concentrations. The chemical concentrations above action levels are found in the below table.

Based on the groundwater data collected by KDHE, the installation of relief wells as underseepage controls between station 45+00 and 75+00 may result in the discharge or migration of VOC contaminated groundwater and should be avoided. Since the plume has not been clearly identified, a smaller restrictive area could be established with additional investigations if relief wells are required. Since the 500+3 alternative does not require relief wells, no additional testing is recommended at this time. A few ASTs on the southern portion of the property are very close to the 40-foot construction limits. They may require removal and, depending on their contents, tank closure procedures may be required before construction commences. Also, if construction occurs on the riverward side near the SWMU 7 at approximately Station 50+00, the debris and dumped solid waste should be removed and replaced with suitable fill material. All waste should be sampled and characterized prior to disposal. The material is likely either construction or solid waste and must be taken to a solid waste landfill or appropriate disposal locations based on sampling results.

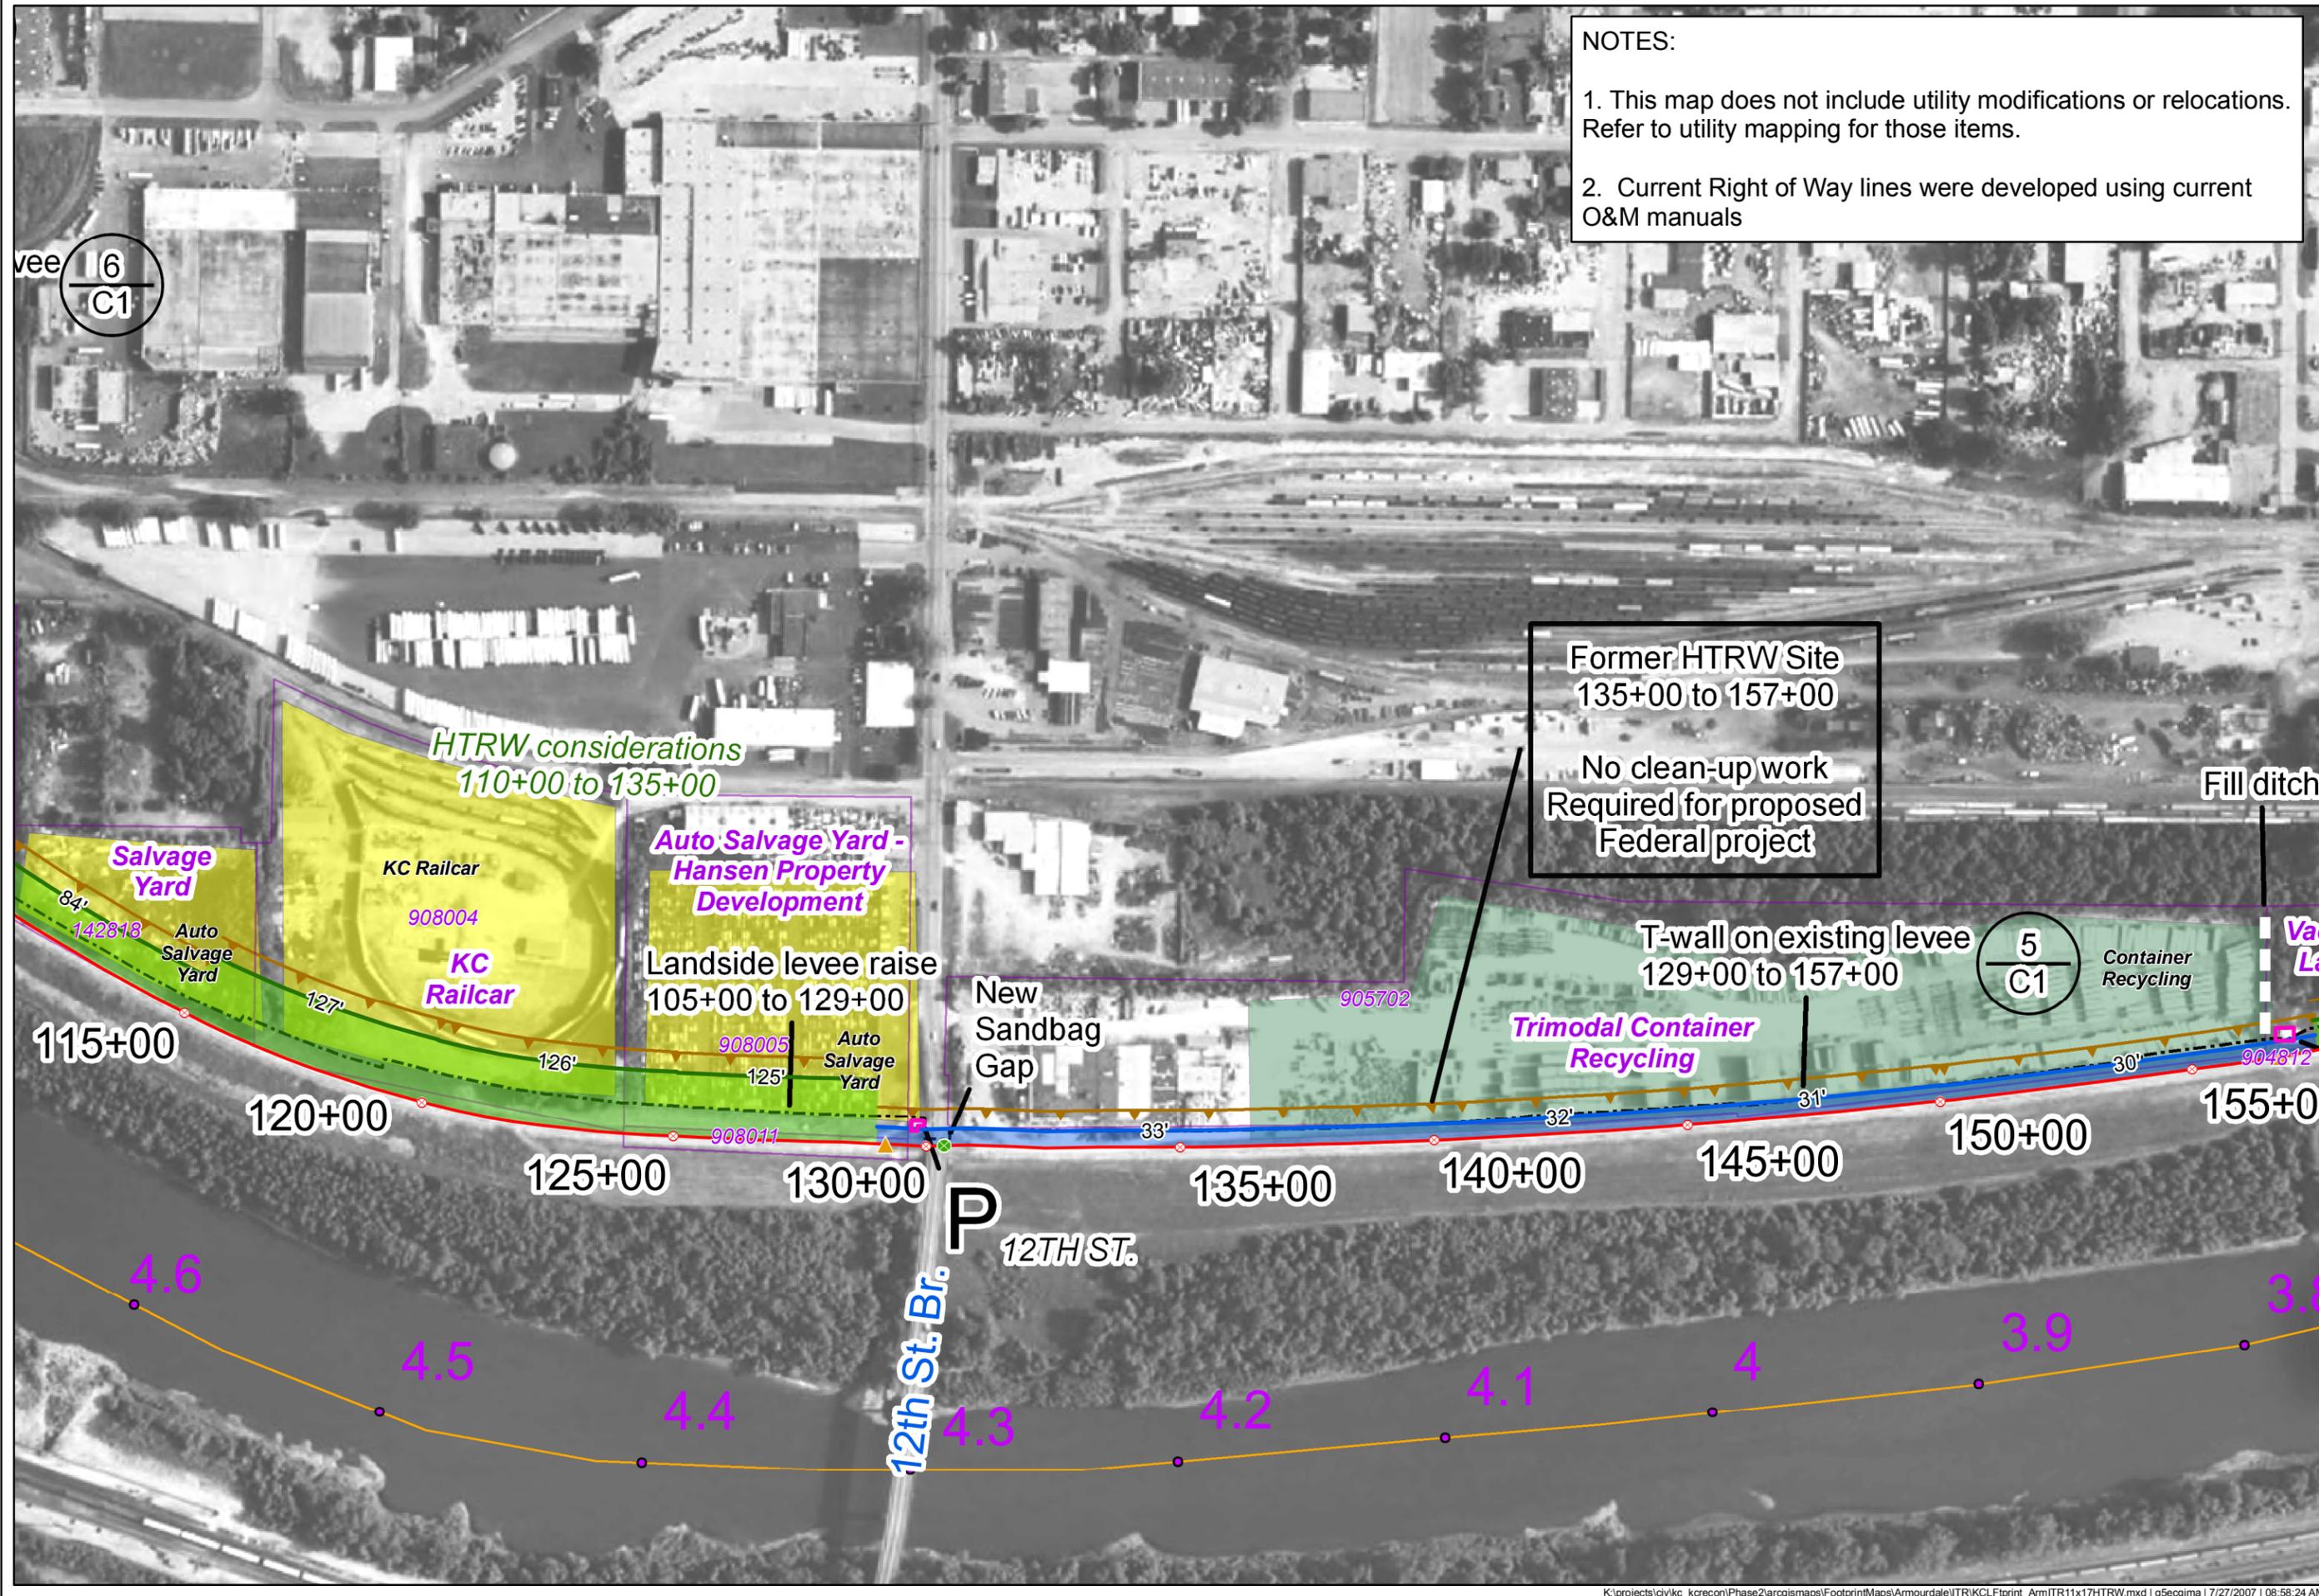
Fig. 4.0

The auto salvage yards lie next to the levee toe. A portion of the property will be used for construction of a new levee section. The Reconnaissance Report and Follow-Up Investigation did not contain any information on these sites. They were not listed as areas of concern in any EPA or KDHE databases. Aerial photographs show the auto salvage yards have been at their current location since 1970. Their operation had not moved beyond the property boundaries. Property which falls into the limits of disturbance for the selected alternative should be more fully investigated during the Design Stage to ensure that the surface and subsurface soil are not contaminated and to determine how to dispose of any contaminated soil.

A review of the aerial photographs from 1970 and the following years shows that the site had some form of industrial activity, with the exception of the 1993 photo when the property was vacant during the flood. Following the cleanup of A to Z plating operations, the site was used as a salvage yard. During the site visit, the salvage yard was completely cleared and an asphalt lot was placed over the top of the whole yard.

Aerial photographs give an excellent representation of the widespread placement of drums and trailers over the site. Buildings present during 1960 photographs have been removed. By 1970 photographs the Great Lakes Container Corporation is active. Drums were seen covering the entire site, right up to the levee embankment. In the 1978 photos, some drums were seen near the 7th St. Bridge. By the 1983 photos, they are gone. Drums and trailers were still seen in the 1995 photographs.

As previously stated, the property is a Superfund site. When Container Recycling shut down operations in 1996, drums and trailers were left in place. The EPA led clean up actions at the site. The initial investigation showed elevated lead concentrations in the soil. Additional investigations of the drums were performed. From the KDHE database for the identified sites list, abandoned drums were found out in the elements as wells as stored in trailers. According to an EPA action memorandum from 1999, over 4,100 buried drums were found on-site. An estimate by the owner in 1997 had over 30,000 drums being stored on the property. Another 90 semi trailers were on site as well. The conditions of the drums varied from rusty and partially crushed to excellent. Surface soils were visibly stained with a petroleum-like substance. Inside the process building, process waste was present in floor drains. Caustic solids from the drum cleaning process were found on the floor in piles. Previous attempts to remove contaminated soils were visible at the site. From the Phase I assessment, concrete chunks were also found on the north side of the site. In 2000, a time-critical removal action was performed to remove all the drums and to remediate the site. Due to the larger than expected number of buried drums, plans to remove the soil was halted. Instead, the site was capped to prevent exposure to the contaminants remaining onsite.

According to the KDHE documents and conversations with EPA personnel, automobile fluff, which is a mixture of shredded plastic, foam, textiles, rubber, and glass, was placed as the sub grade fill over the contaminated natural soil. Subsurface drainage piping and stormwater drains were installed throughout the site to collect surface water and channel it off-site. On top of the autofluff sub grade, nonwoven geotextile fabric was placed. The cap extends up to the levee itself. A foot of crushed limestone gravel with a large percentage of fines was installed over the geotextile. In 2004, a restrictive covenant agreement was placed prohibiting excavations at the property. It states: “Except for minor excavations necessary to install, maintain or repair utility poles, fence posts, sidewalks, paving, and other comparable activities, as well as minor excavations necessary to maintain or repair existing underground utilities, the Property owners shall not engage in any excavation activities on the cap area that may damage the cap, without the previous written permission of KDHE such permission not to be unreasonably withheld or delayed.” The property owner also agreed to restrict use to industrial or commercial use, notify the appropriate agency if construction occurs, to place no wells for any purpose on the site, and to have inspections of the cap. In August of 2004, an inspection found only minor problems with erosion and siltation at the drains of the drainage system. The site is currently used to store shipping containers and semi trailers.

Due to past use as a salvage yard, the property which falls into the limits of disturbance for the selected alternative should be more fully investigated during the Design Stage to ensure that the surface and subsurface soil are not contaminated and to determine how to dispose of any contaminated soil.

From EPA reports and letters, it is evident that some soil contamination from lead and PCBs still exists beneath the Container Recycling Corp. property. Any excavation on the property would require excavation of the cap and into the fill and would require KDHE approval due to the restrictive covenant. It is recommended any type of excavation or installation of relief wells for

subsurface underseepage control be avoided. The current 500+3 alternative has no construction activity occurring outside the existing right of way. Rick Bean, a section chief in KDHE Bureau of Environmental Remediation stated KDHE would allow a construction easement through the property provided no excavation would occur and any damage to the existing cap is repaired. Coordination with the KDHE and EPA is recommended for any work on site.

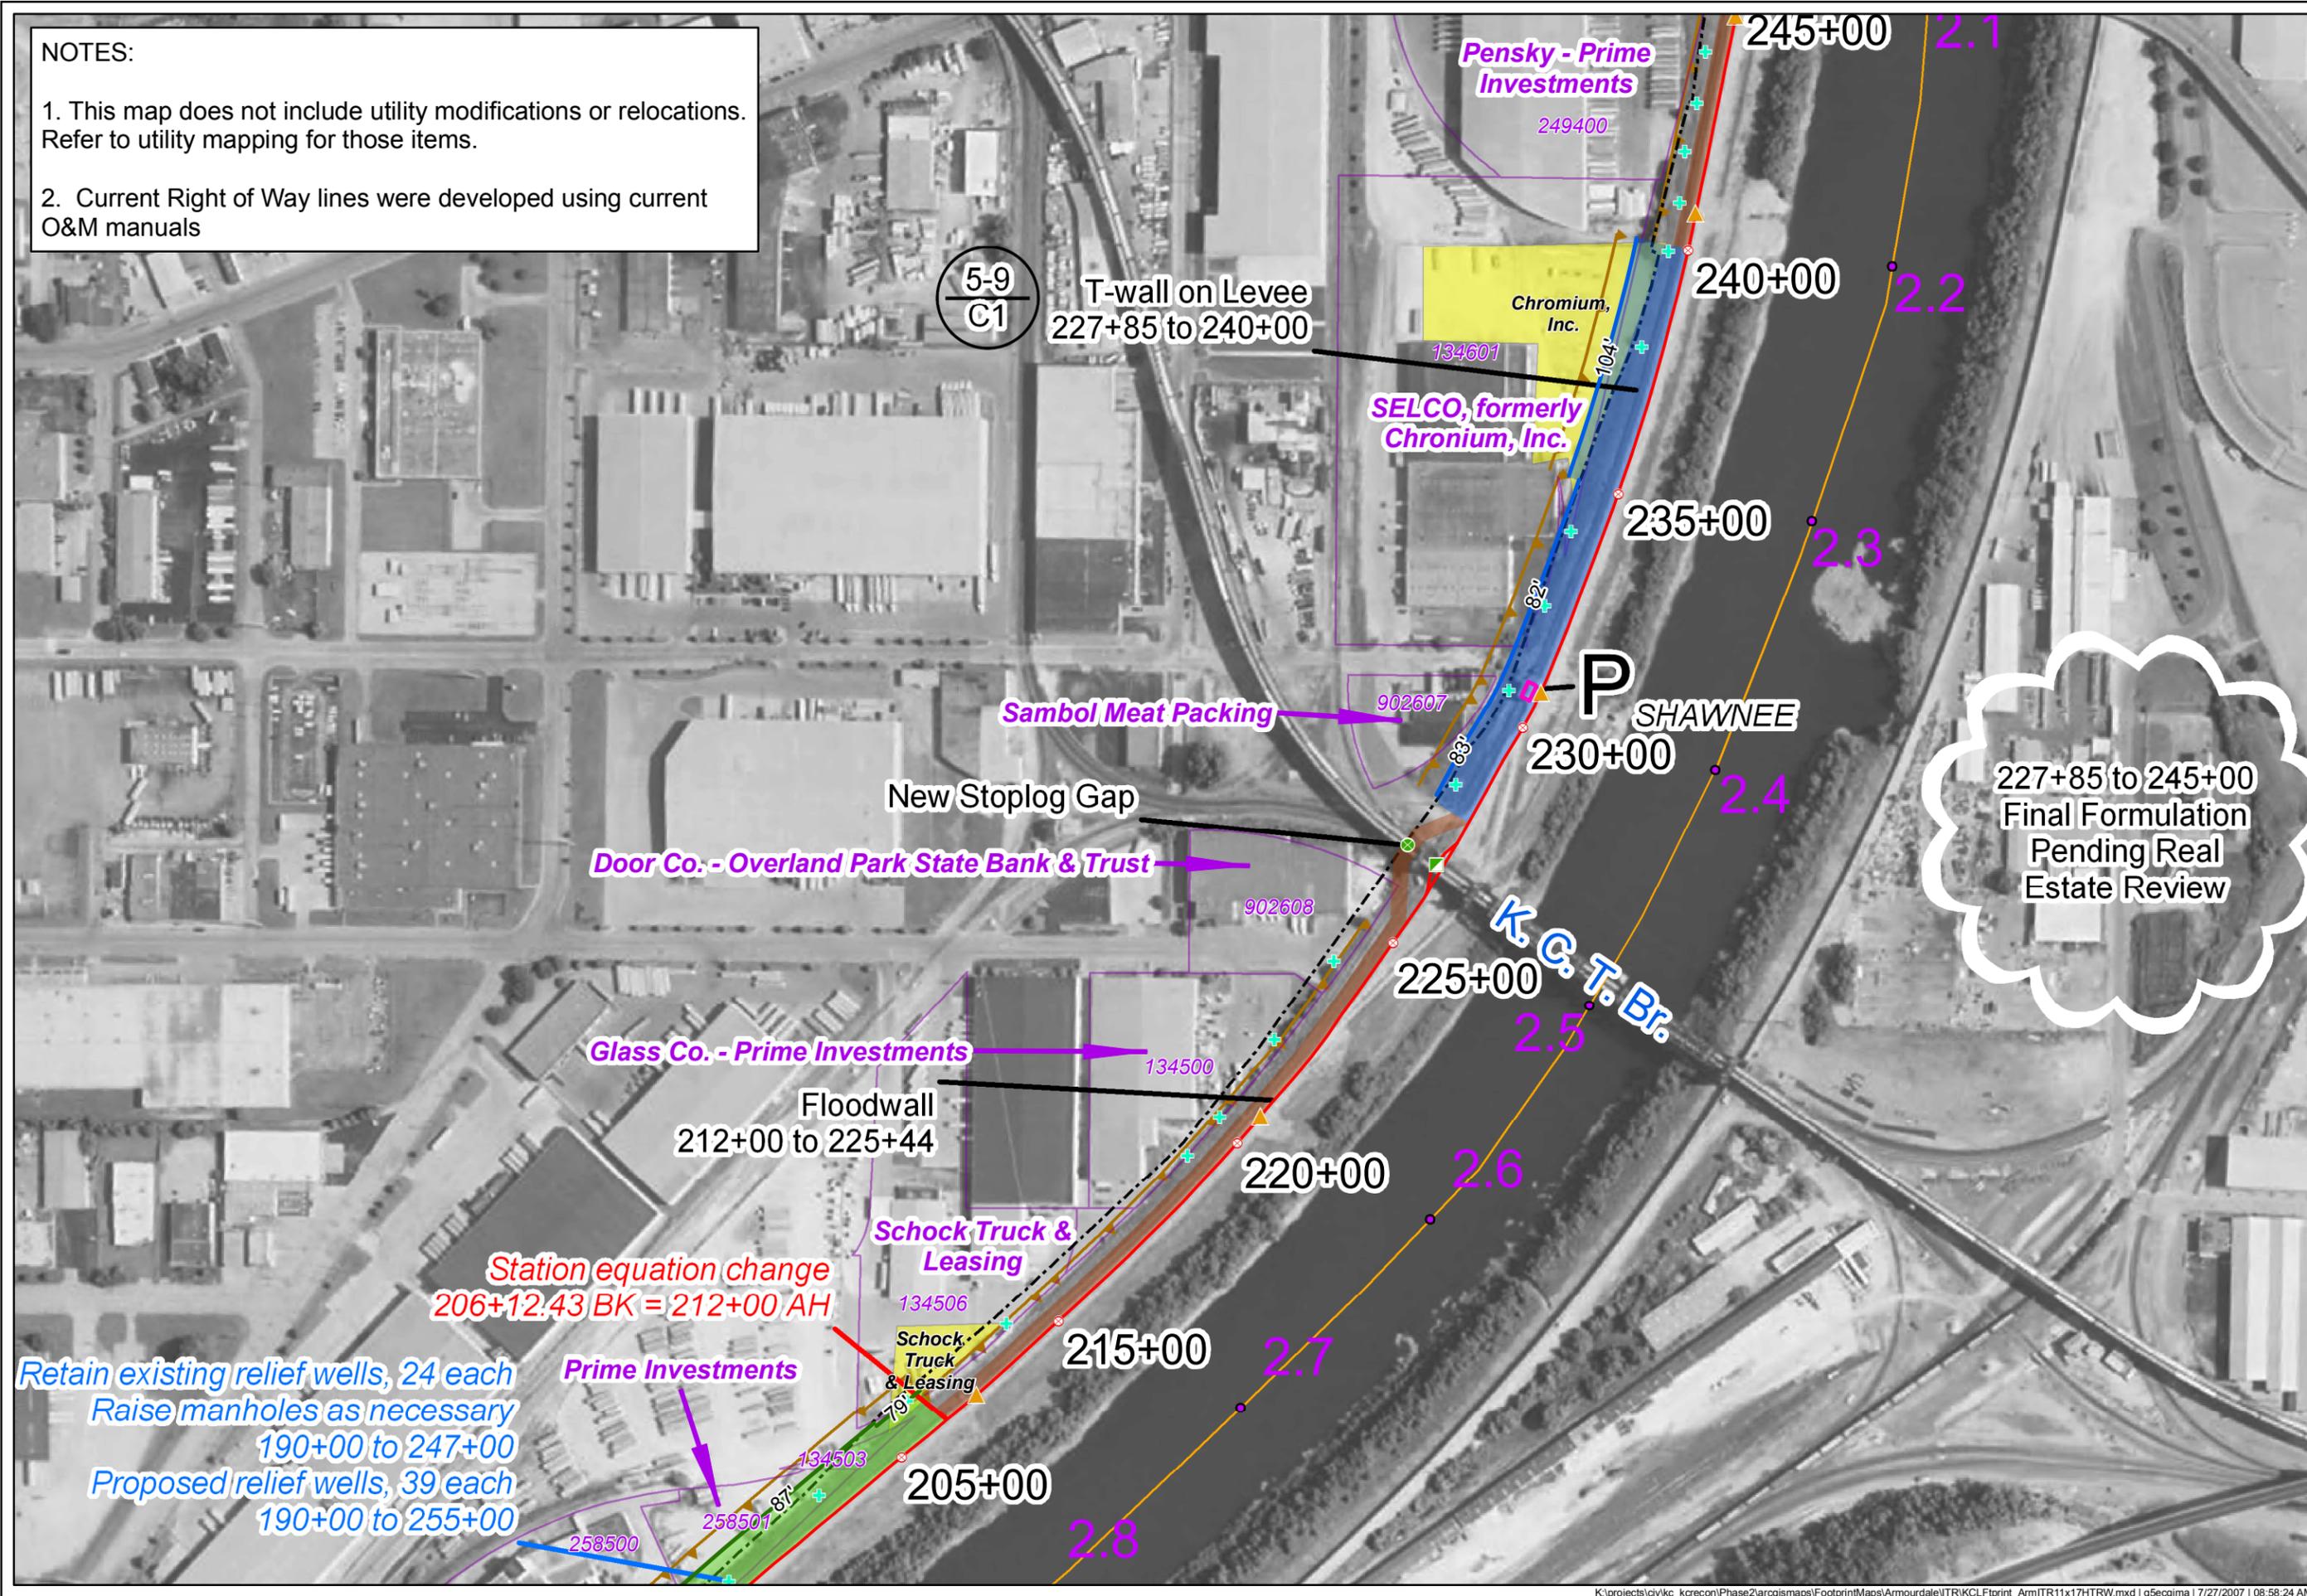
Fig. 5.0

Schock Truck & Leasing is located outside the construction limits but may be impacted by temporary construction easements. The facility repairs semi-trailer trucks. While no information was found for this property in the Reconnaissance Report or the Follow-Up Investigation, the KDHE LUST database did have a listing. KDHE also corroborated the database information in an interview. A diesel fuel spill in November of 2004 brought the tank to KDHE's attention. After the lines failed a tightness test for a fuel tank, the pipes and tank were removed. Stained soil was found to have a concentration of 5500 mg/kg and subsequently removed. The tank was considered closed by KDHE in 2004.

SELCO currently occupies the former Chromium, Inc. property. The property lies partially within the construction limits of the proposed alternative. SELCO manufactures car parts. It is not a permitted RCRA facility. No known contamination is associated with the current company. Chromium Inc. was listed as a KDHE Identified Site. A Preliminary Assessment (PA) was performed in 1994. Chromium Inc. operated from 1952 to 1972. The company allegedly disposed of chromium wastes in on-site lagoons and directly discharged wastes into the Kansas River. Before the Flood of 1951, the site was the Cudahy Packing Plant. The construction debris from both Chromium, Inc. and Cudahy demolition was buried approximately 10 to 15 feet below the surface. Past disposal practices at Chromium, Inc include the pumping of lagoons into the Kansas River. By the late 1960s, the City of Kansas City ordered Chromium Inc. to cease the discharge of its industrial wastes into the sewer system and to close the lagoons with backfill. Subsequently, Chromium Inc. began discharging the industrial waste into Cudahy's former lard pit. It too was backfilled with demolition debris and soil before the facility closed. In 1990, an investigation of the subsurface soils found detectable levels of lead and chromium. Eight borings were drilled. Levels

were below Kansas' action levels. These results did not warrant further soil investigation. A groundwater sample was taken from a monitoring well on-site and showed only low concentrations of barium and cadmium. Again in 1994, KDHE collected another groundwater sample. In this sample, chromium, 1,2-DCE and 1,1-DCA were all detected below the MCLs. Geoprobe samples were collected near the former surface impoundments to a depth of approximately 33 feet. These soil samples were also below the action levels. KDHE's recommendation was no further action was warranted at this site. There appears to be no immediate threat to the soil or groundwater from the site's past practices.

The aerial photographs show the site was industrialize before 1951, as KDHE records had said. The current building for SELCO was in existence by 1983. The site visit did not indicate any current hazardous waste issues occurring at the site. As only very low concentrations of metals and VOCs below KDHE action levels exist at the site, no further investigation is required at this location. The previous buried construction debris, if excavated, may be taken to a solid waste landfill.

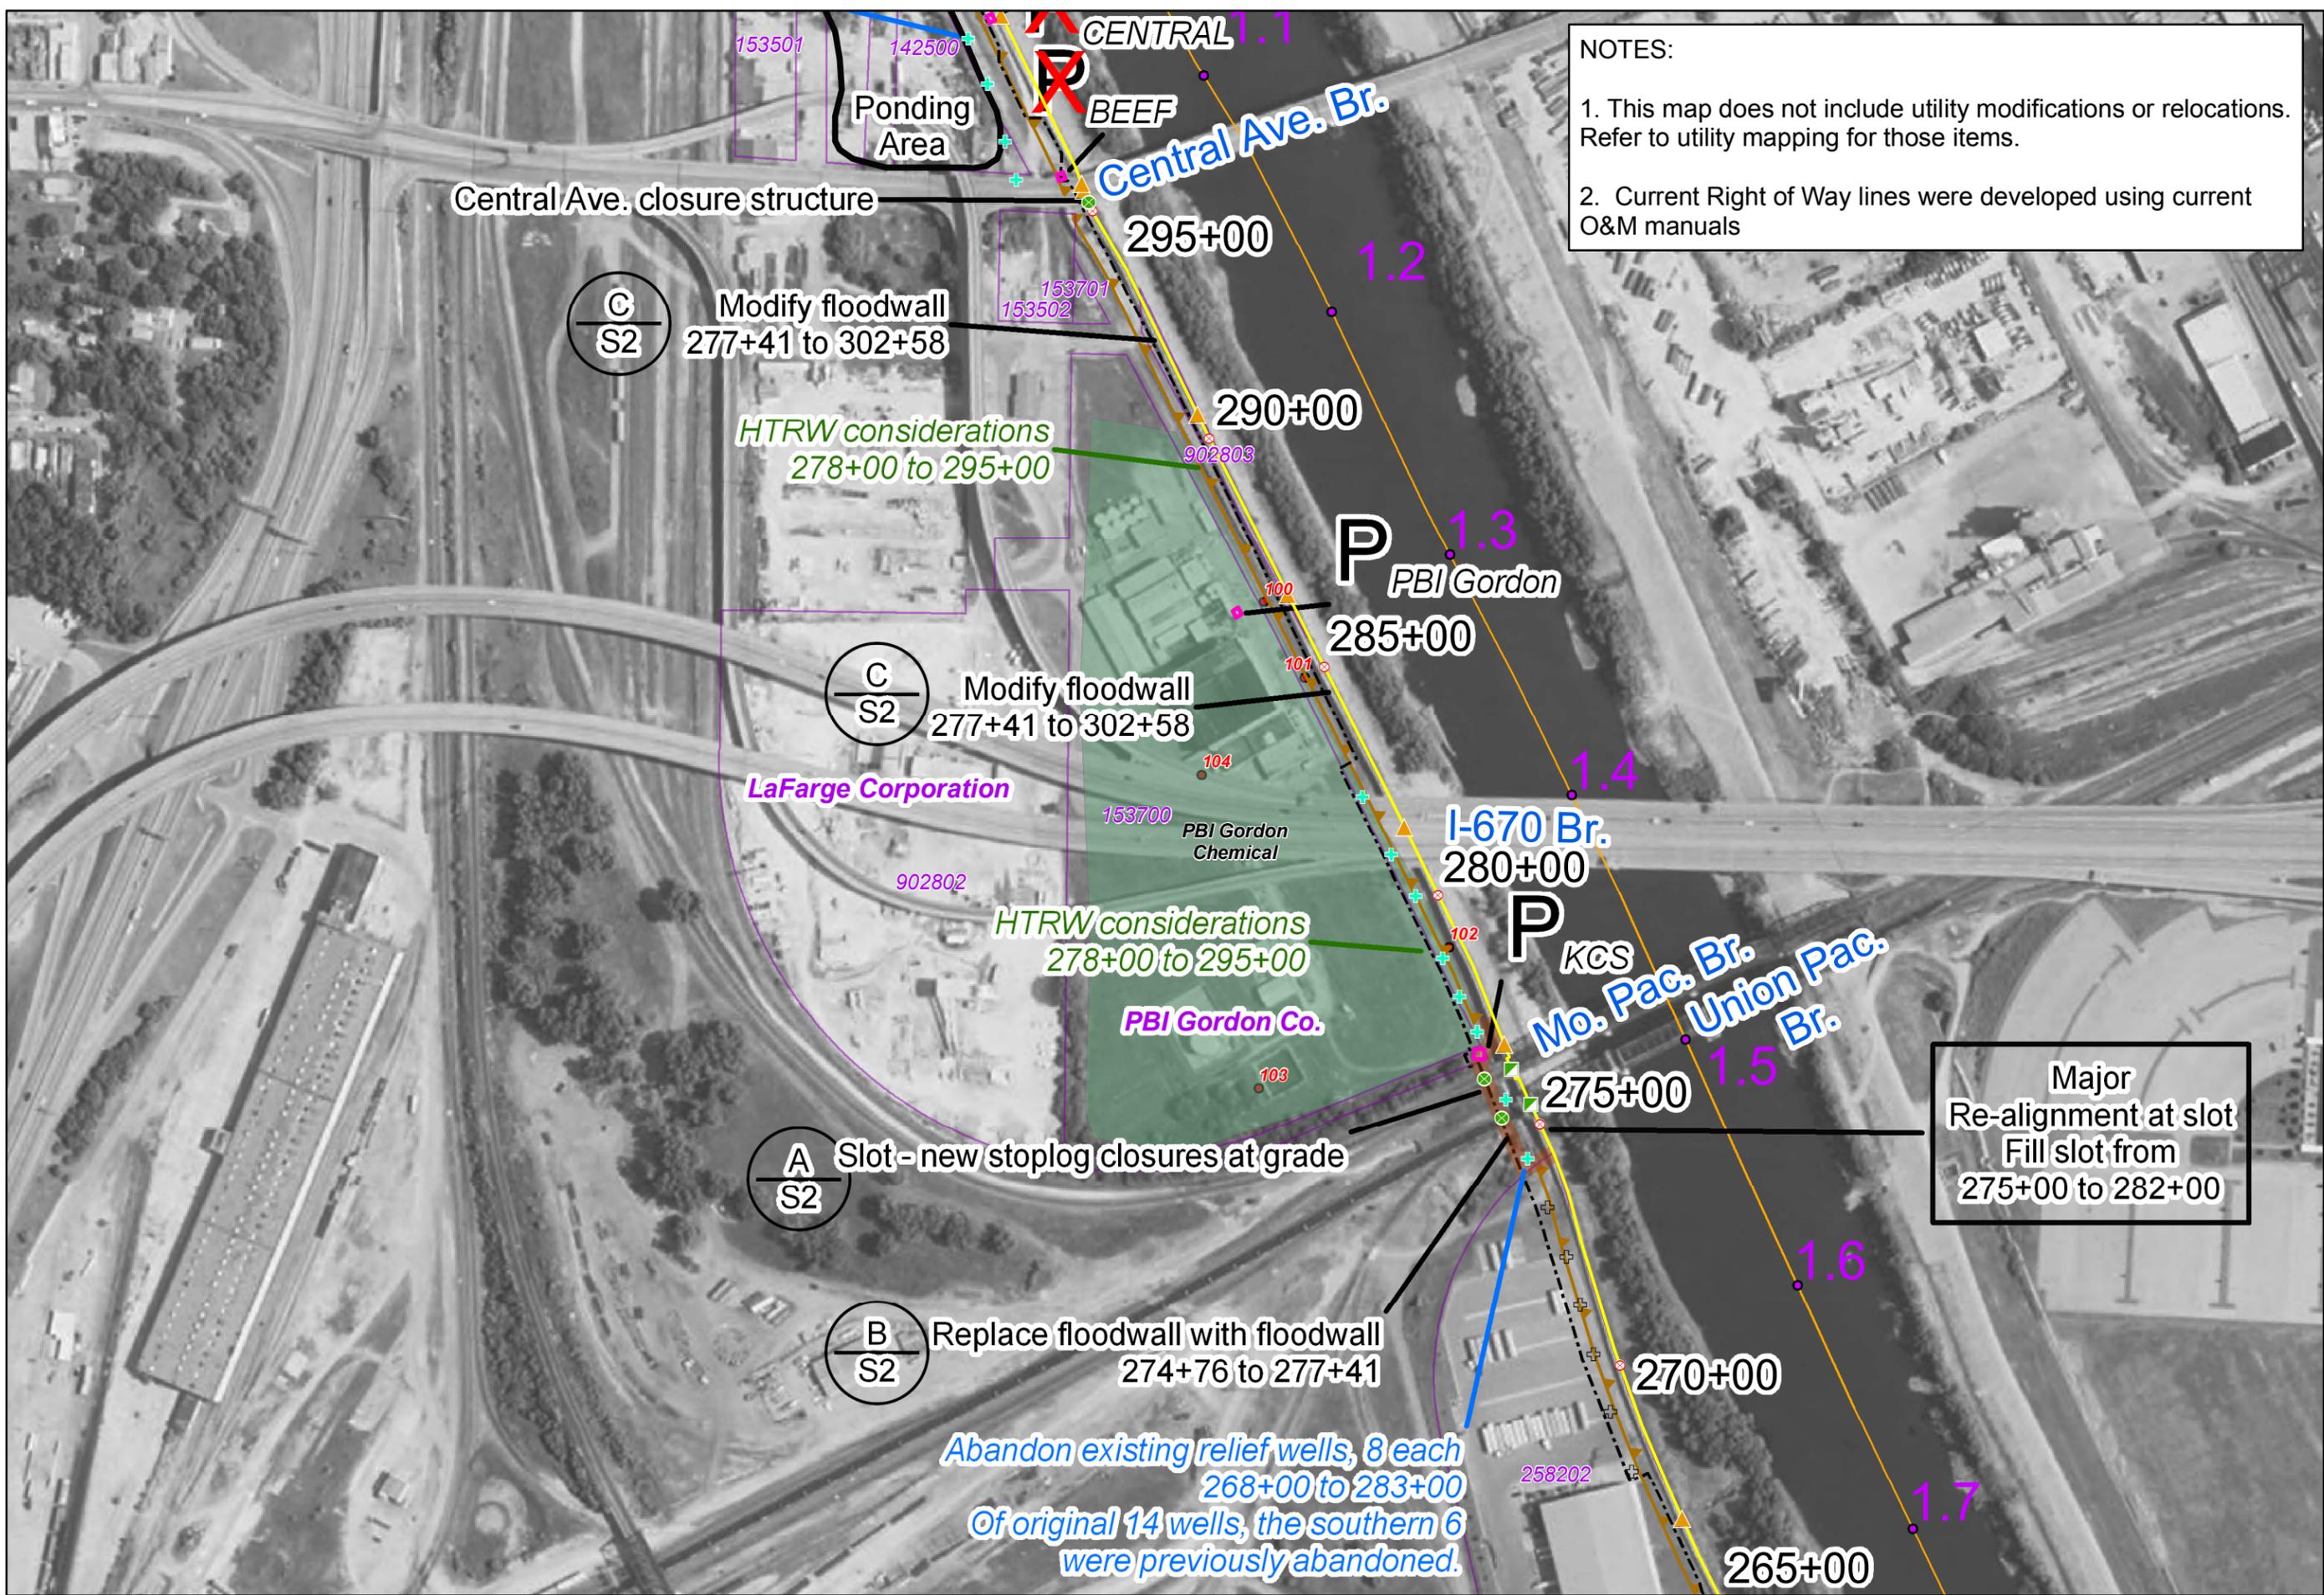
Fig. 6.0

PBI Gordon is adjacent to the current floodway. The facility manufactures various pesticides and other agricultural chemicals, as wells as clay and brick products. Neither the Reconnaissance Report nor the Follow-Up Investigation had any information regarding the property. The EPA databases list it as permitted RCRA hazardous waste treatment, storage and disposal facility. Numerous air releases occurred between 1987 and 2003, according to the Toxic Release Inventory System (TRIS).

In 1990, approximately 250 pounds of xylene spilled into the Kansas River. No further information was given in the EPA database. Another spill listed in the EPA RCRA Facility Assessment Final Sampling Summary Report occurred in 1980. Over 11,000 gallons of dimethylamine (DMA) were spilled. The Kaw Valley Drainage District was asked to shut their floodgates to prevent migration to the Kansas River. The Kansas City, Kansas Fire Department flushed the chemical into a deep ditch. A 7,000-gallon transport truck was used to pump the fluids into the collection lagoons. Some water did discharge through the storm water sewer system and into the river. The EPA attempted to strip the effluent before it reached the river by placing 2 bags of activated carbon at the entrance to the storm drain. It was estimated that 500 gallons per minute of diluted chemicals were discharged over a 3-hour period.

Sample 100 and 101 are located close to a set of railroad tracks that run adjacent to the facility. The status of corrective action for the soil contamination has not progressed past the completion of the RFA. Also, the RFA recommended a groundwater investigation be conducted at the site. No groundwater sampling has occurred. Although groundwater contamination has not been identified at this location, based on past activities, the potential for such contamination exists.

It is recommended that ground disturbance in this area be avoided if possible. The current proposed alternative does not involve excavation at PBI Gordon. However, if soil excavation is required from this area during the construction phase, soil testing will be required prior to disposal. Some of the soil may require disposal of hazardous waste. Additional groundwater investigation is warranted prior to the any expansion of the existing subsurface relief well system.
