Proposed Plan

Naval Auxiliary Air Station Quillayute

DERP-FUDS Site No. F10WA0121

U.S. Army Corps of Engineers
Kansas City District (CENWK)
Seattle District (CENWS)

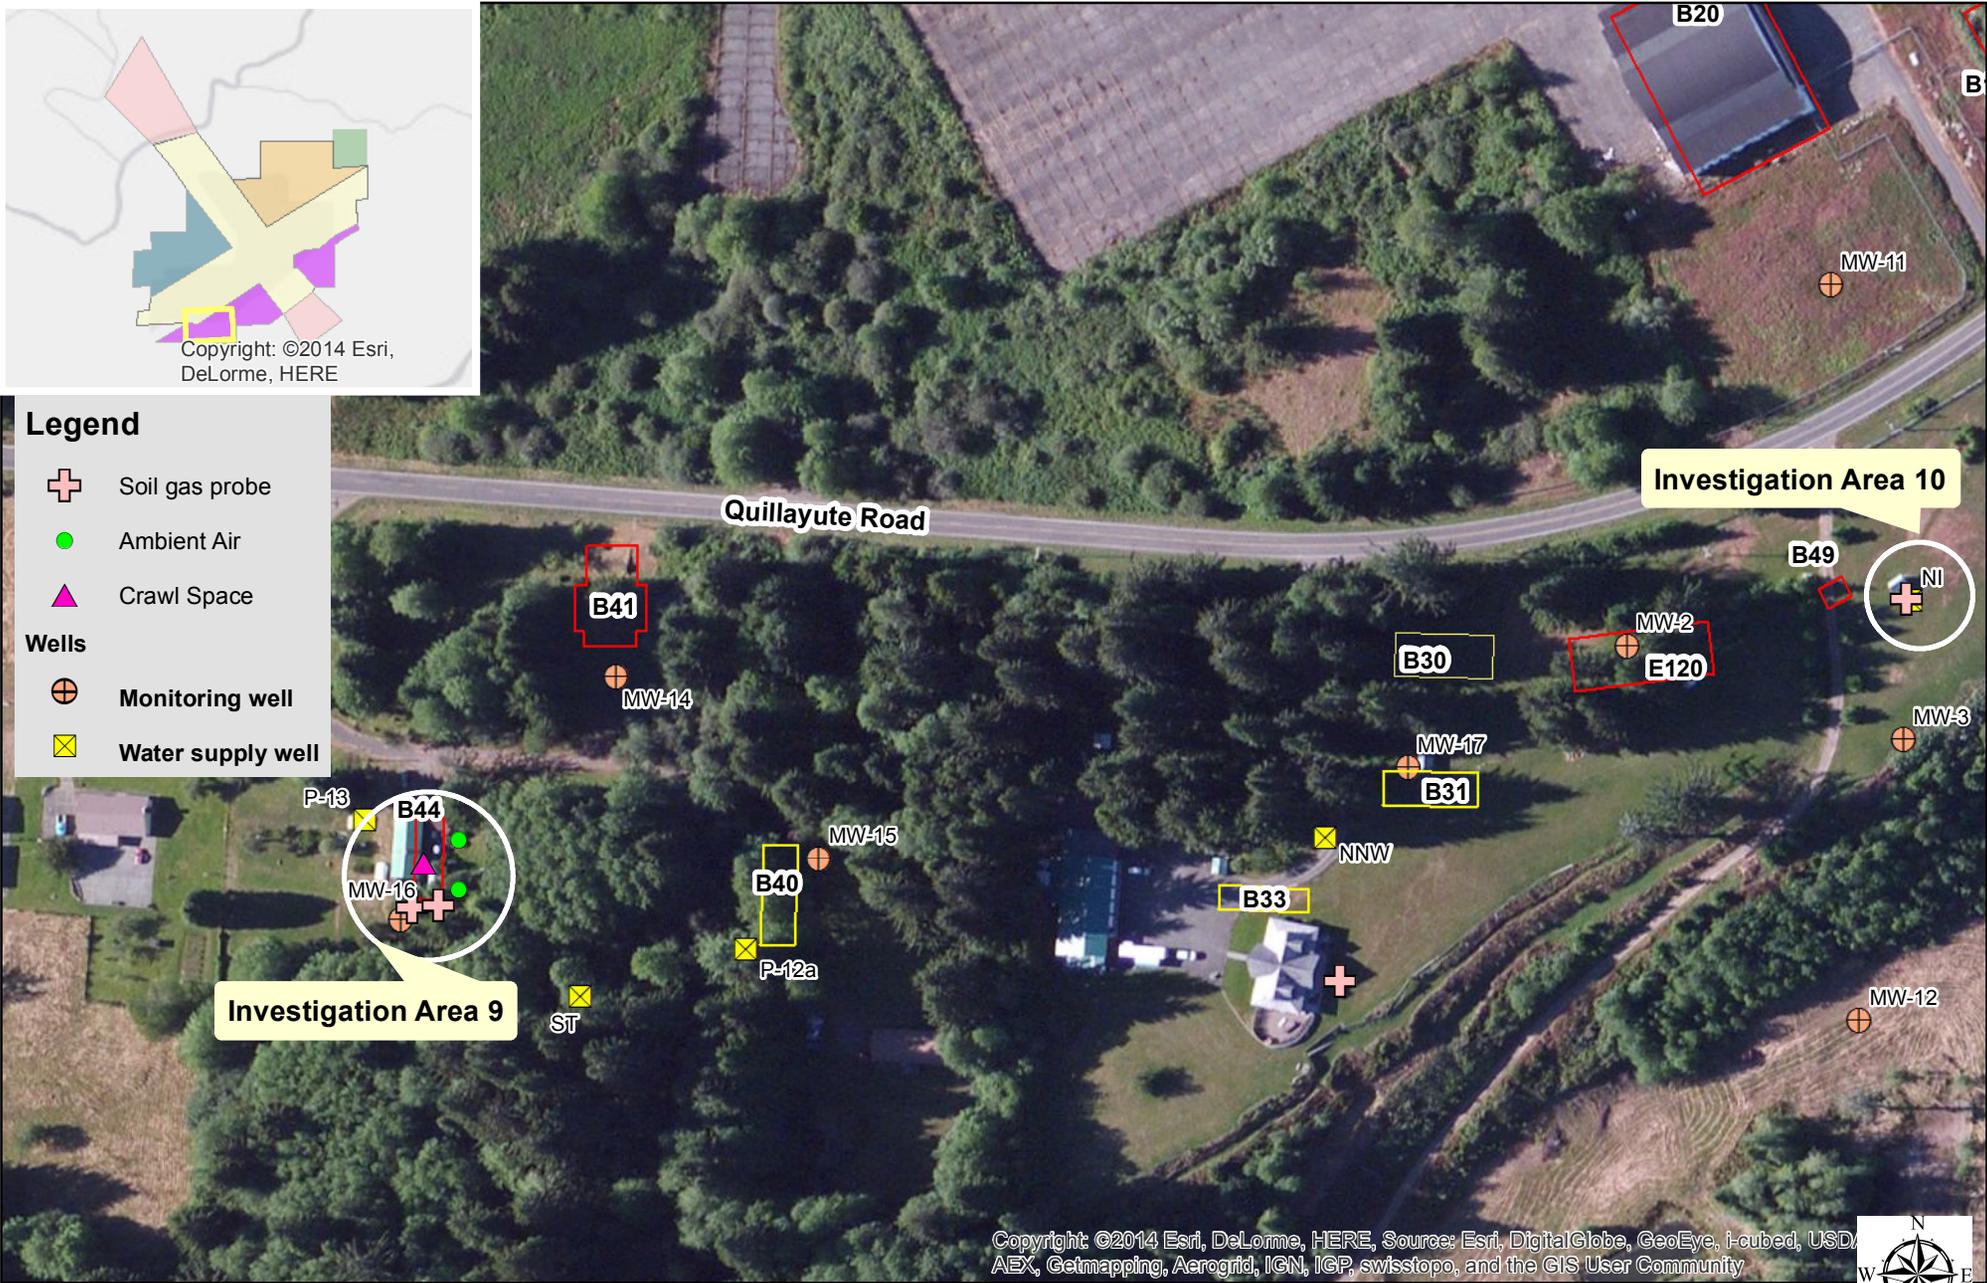
- Soil gas probe
- Ambient Air
- Crawl Space

- Monitoring well
- Water supply well

slab that was the foundation for B44, the Dry Cleaner building at former NAAS Quillayute. Vapor intrusion was evaluated in the vicinity of the NI well. These locations were investigated for vapor intrusion because volatile chemicals had been detected in groundwater samples from the NI well and from monitoring MW-16 located next to the B44 slab (Figure 7).
