# Site Specific Chemical Warfare Materiel Scoping and Security Study Report

Formerly Used Defense Sites  
Site Inspection Report

**Northwestern Division Properties**

**Fort Crowder  
FUDS No. B07MO013801**

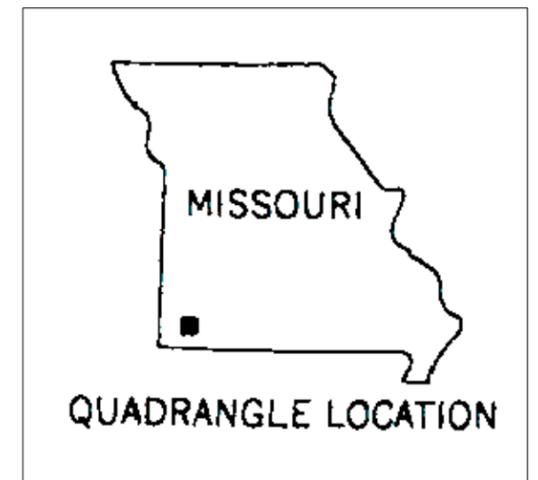
3.2.1.1. The ASR (TCT-St. Louis, 1992) identified the area around the Former Pistol Ranges and the No. 110 Gas Chambers Area as the Chemical Exercise Area but no boundaries were identified. The two areas are adjacent and separated by Mink Drive (formerly June Road). An interviewee identified an area about 350 feet east of the gas chambers as the location where training with chemical agents occurred (this corresponds to the area identified as the Chemical Exercise Area). The training consisted of exposing soldiers to chemical agents in a setting that simulated actual battlefield conditions. The interviewee stated that the agents used at this site included mustard (H, HS), Lewisite (M-1 or L), chloropicrin (PS), and phosgene (CG). Figure 3.1 presents the location of the No. 110 Gas Chambers Area.

- T1670  Approximate Location of Gas Chambers
- Area of Interest
- Missouri National Guard Fort Crowder Boundary

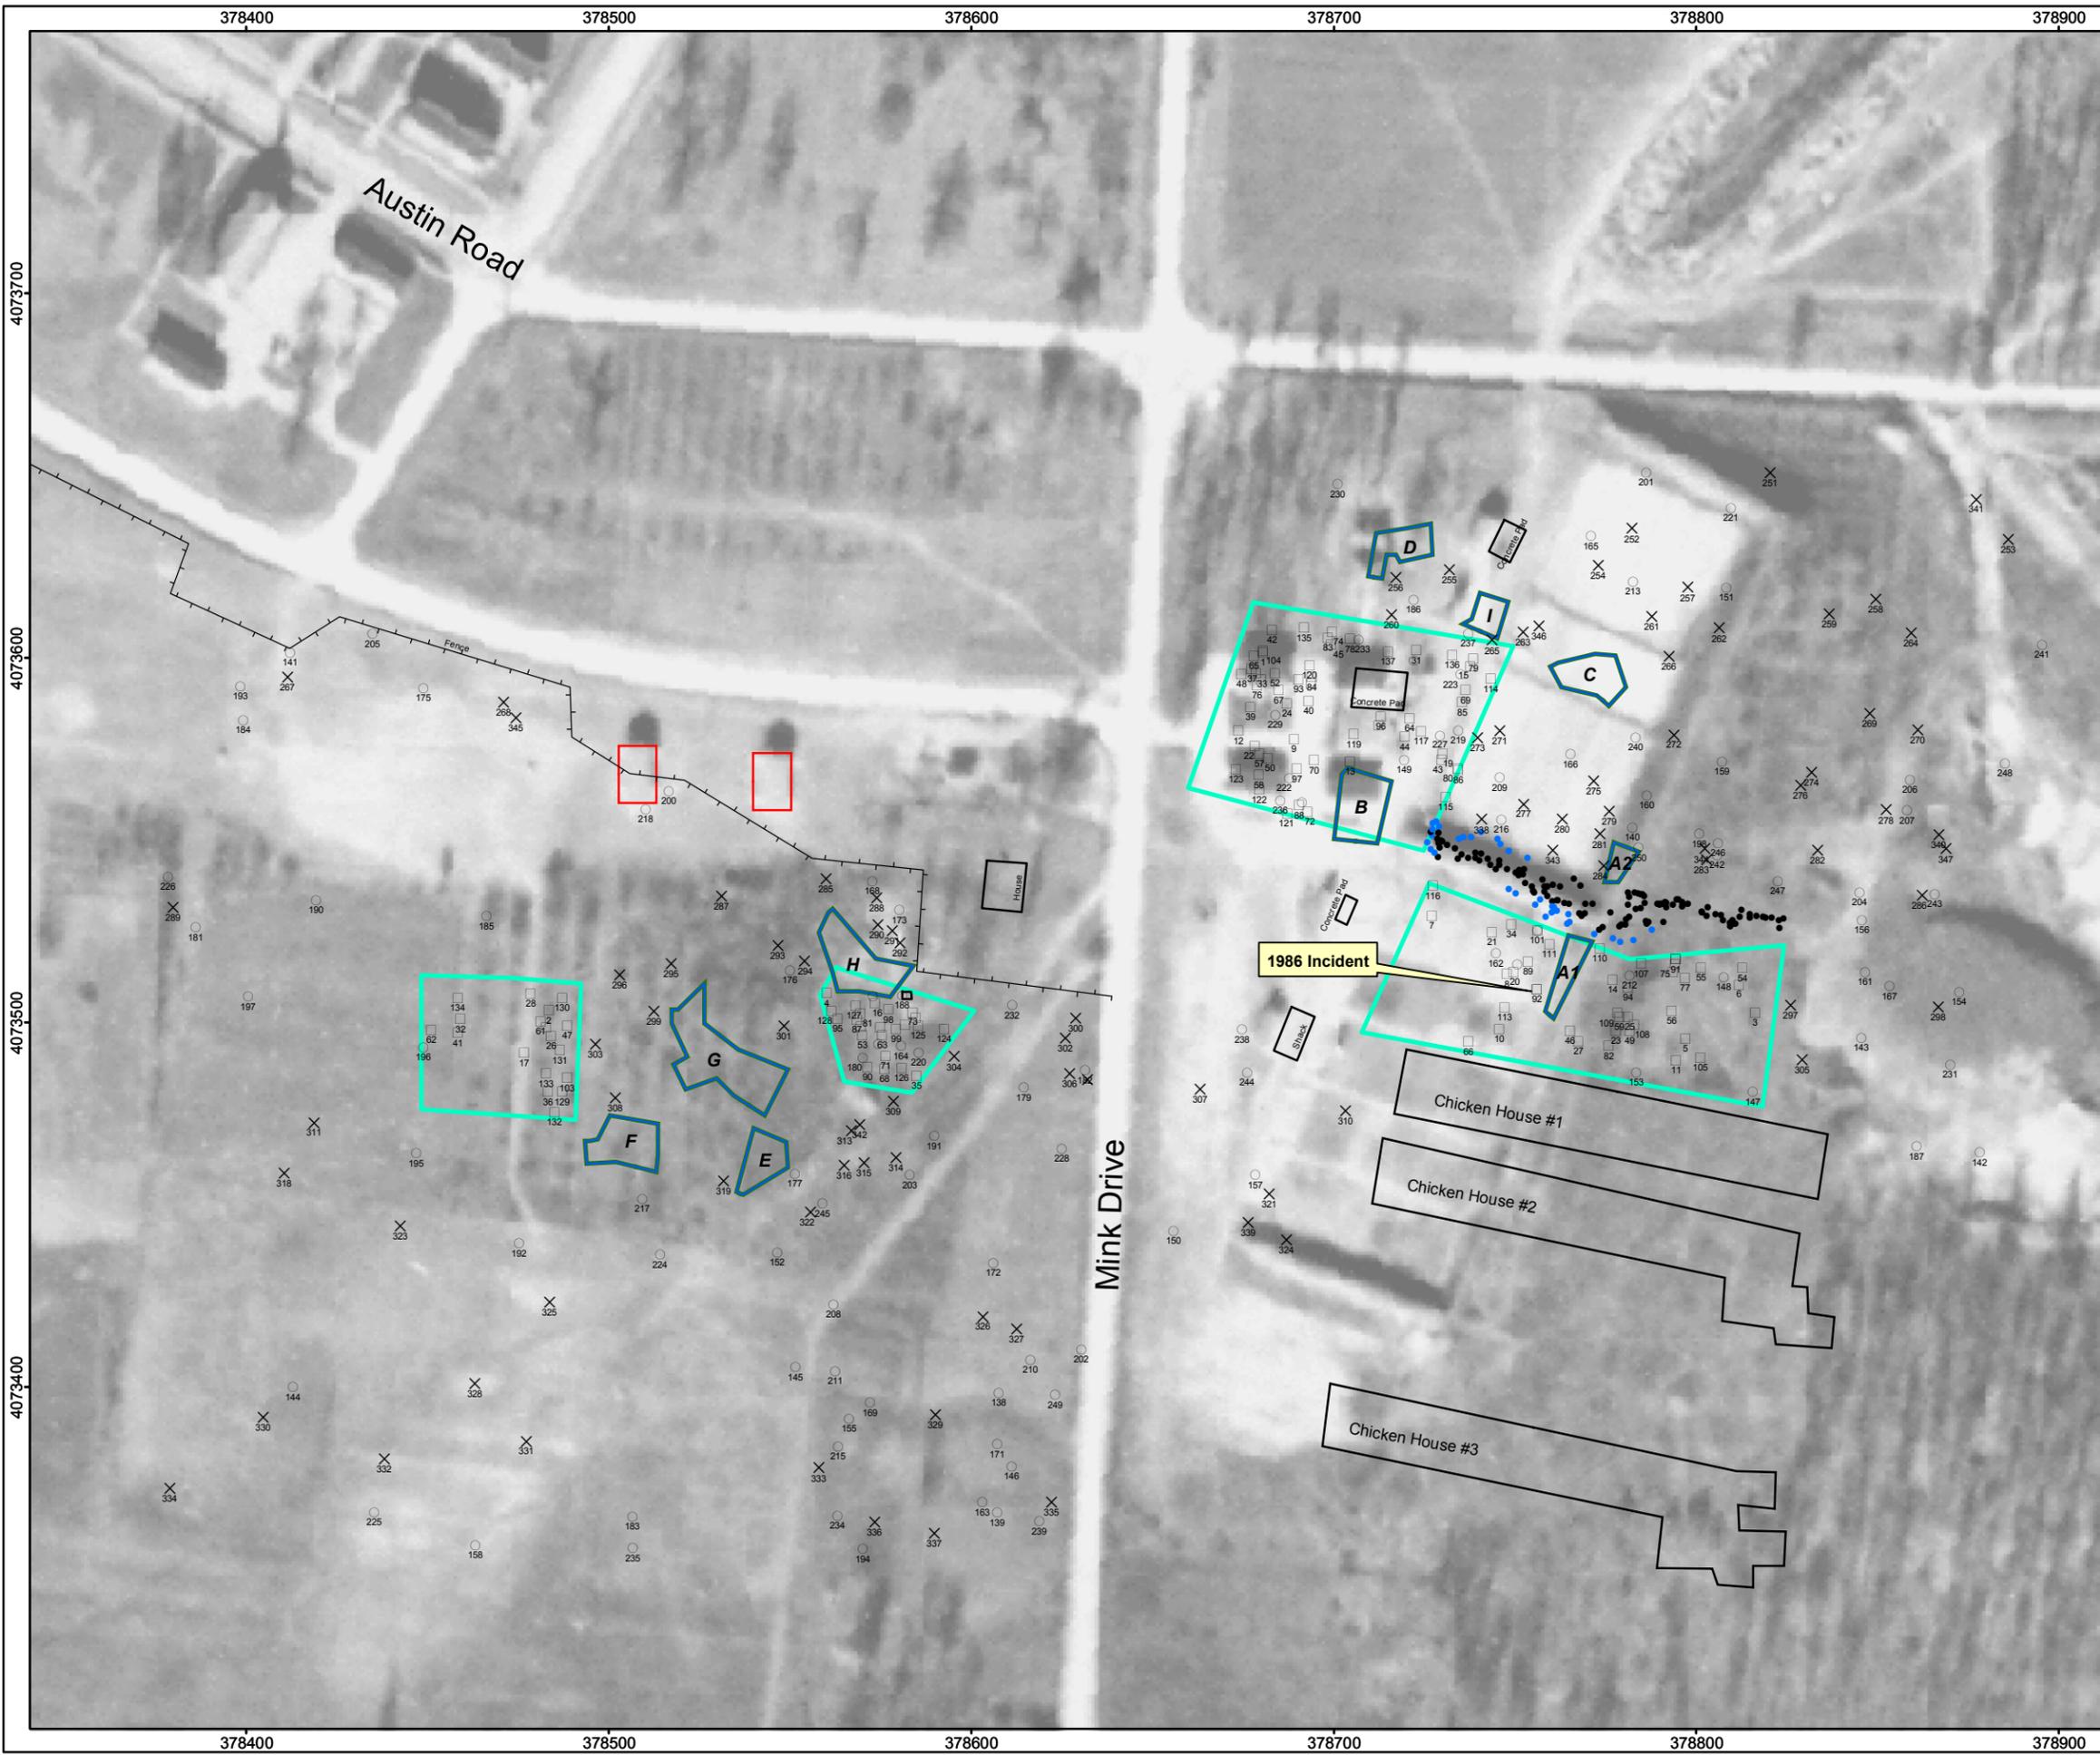
Figure 3.3  
 Geophysical Anomalies  
 Fort Crowder  
 Neosho, MO  
**For Official Use Only**

The anomalies and anomalous areas selected for investigation by the Project Geophysicist were uniquely numbered and depicted on Anomaly Dig Sheets for intrusive investigation. Coordinates for these anomalies were compiled into waypoint files and uploaded to the Trimble RTK GPS unit for reacquisition by the field team. The field team used the GPS to navigate to the anomaly location and confirm the presence of the anomaly using the EM61-MK2. Survey flags were labeled with the unique anomaly identification number and placed in the ground at the edge of the anomaly location. For area anomalies, the boundaries of the anomalous zones were marked with flags depicting the unique area identification. A total of 321 individual anomaly locations and 10 anomalous areas were reacquired and marked for investigation. The berm remaining on site was inspected and flagged using a Schonstedt magnetometer. An additional 144 anomalies were flagged for investigation on the berm. Figure 3.3 presents the location of the reacquired anomalies and scar areas for the former Fort Crowder.

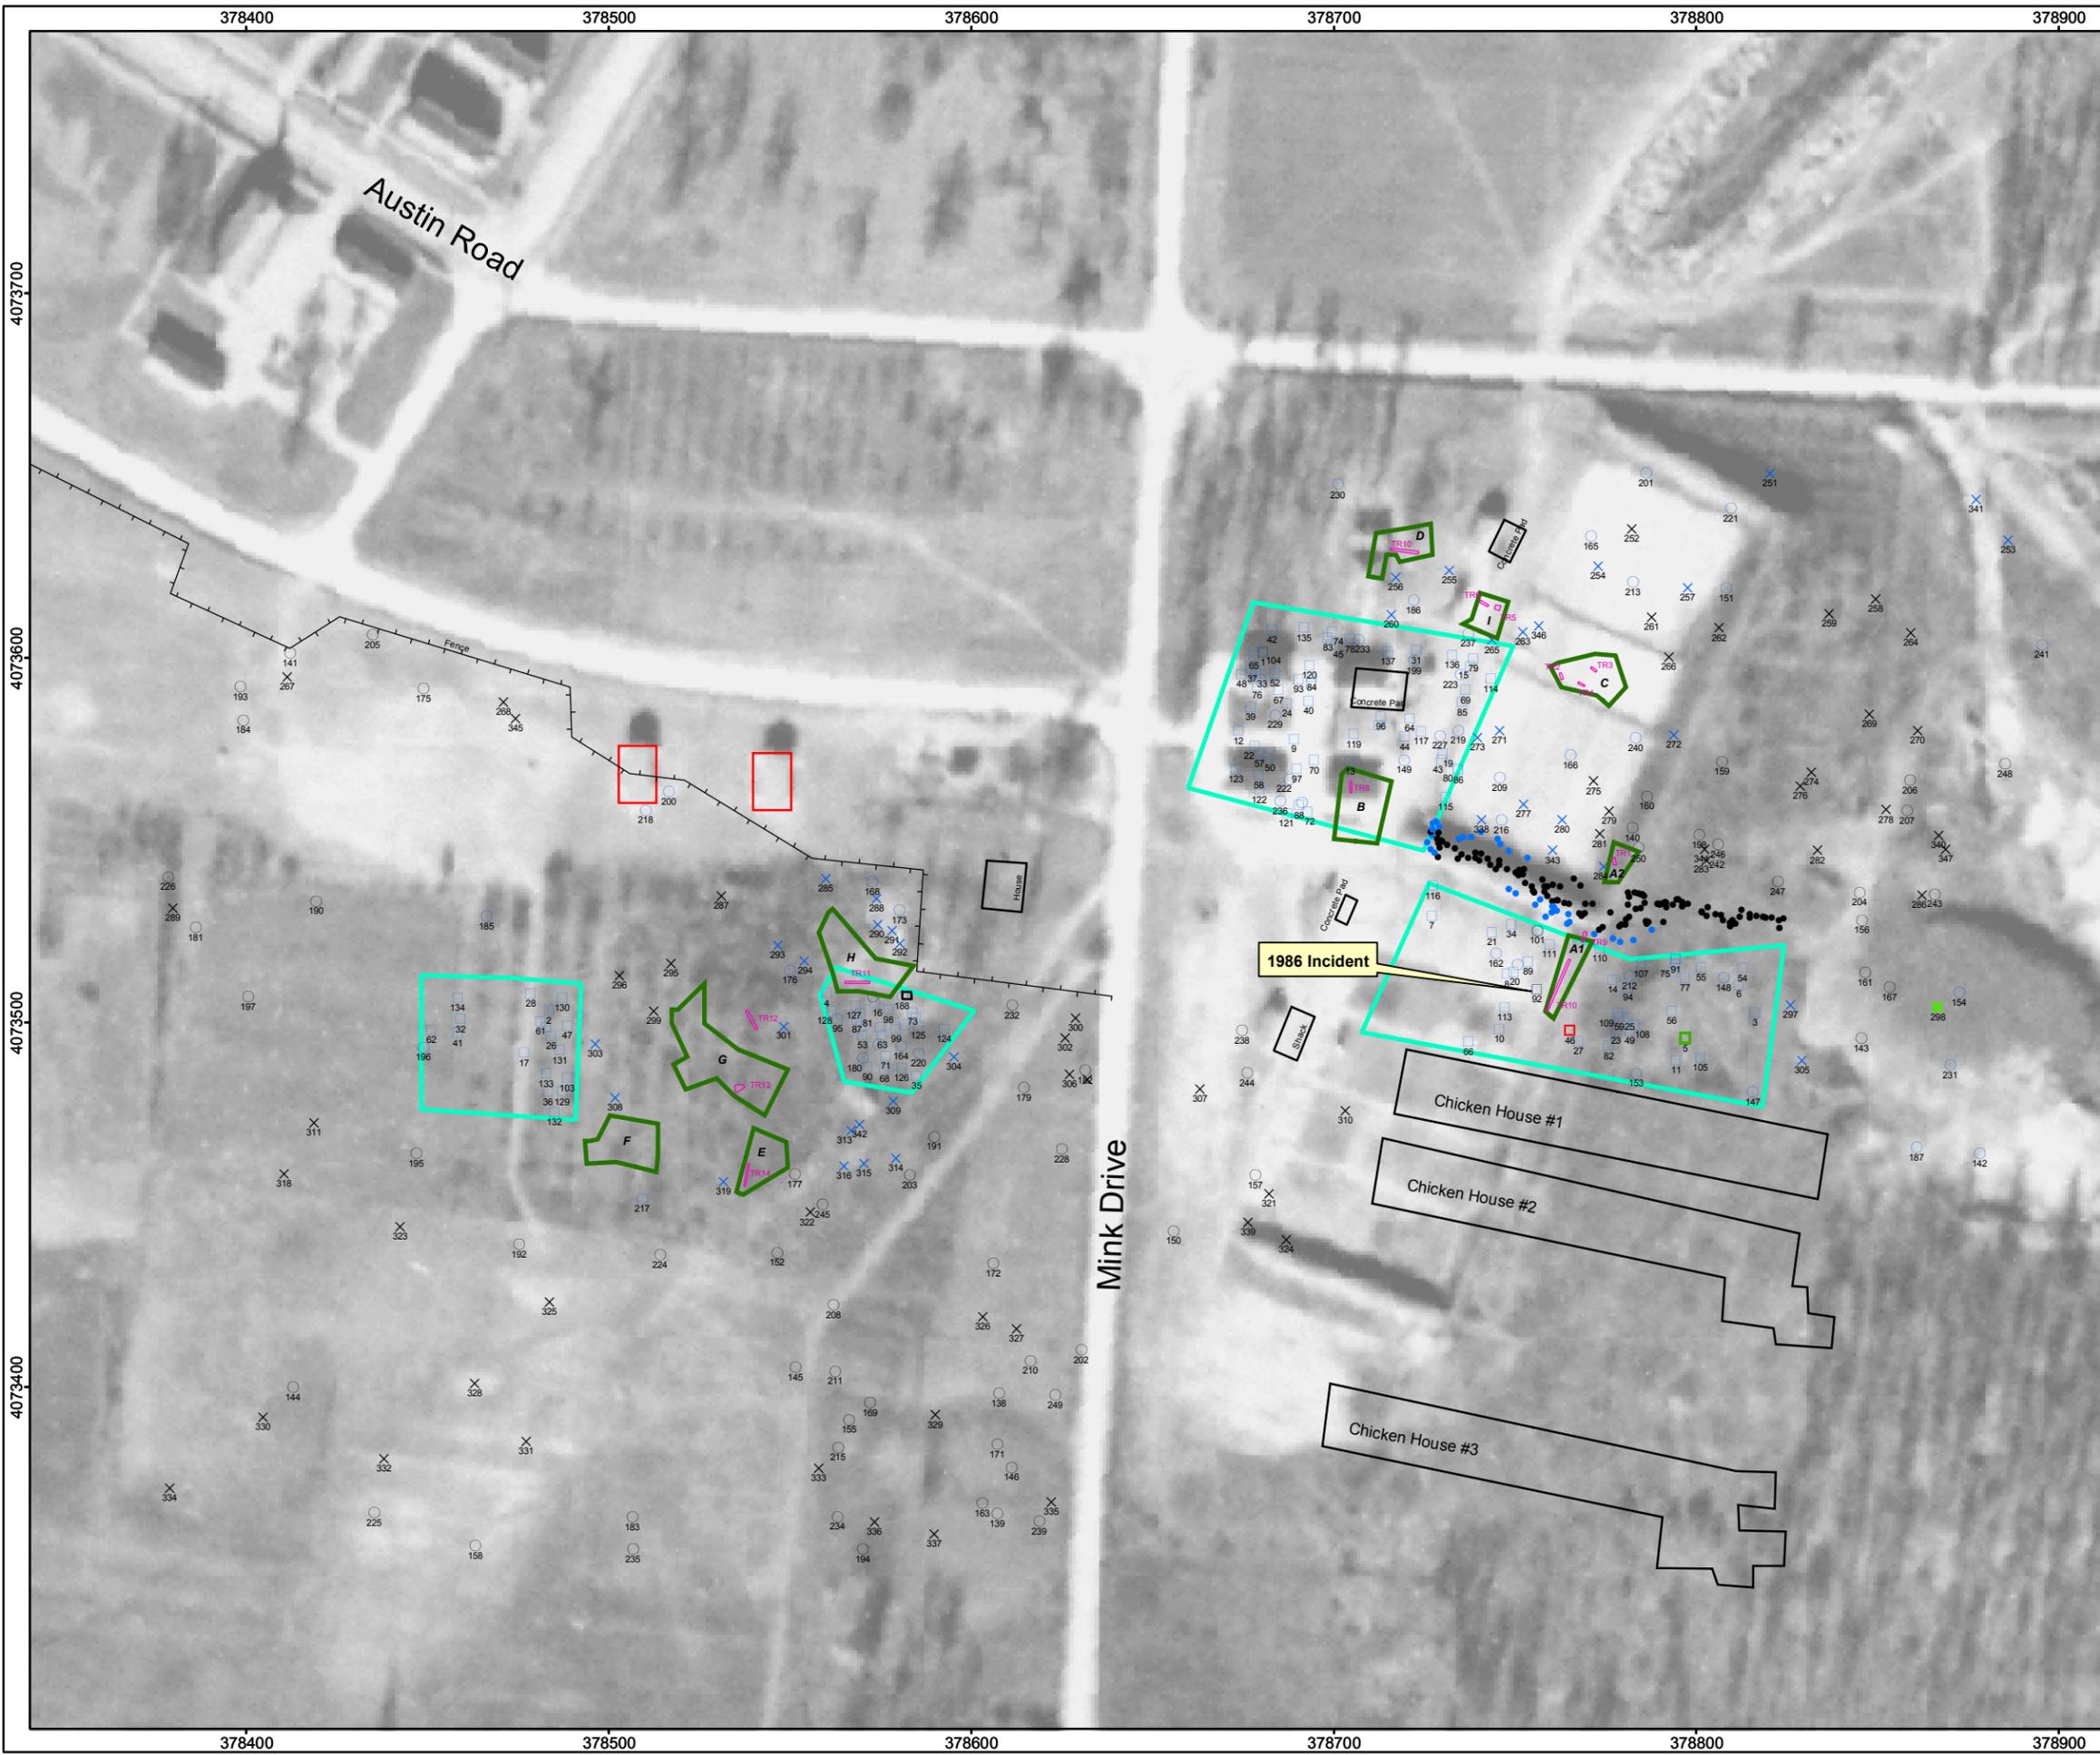
Figure 3.4  
Findings  
Fort Crowder  
Neosho, MO  
**For Official Use Only**

3.3.2.4.1. Intrusive investigation activities were conducted at the former No. 110 Gas Chambers Area and the former Pistol Range Area from November 3, 2003 through November 20, 2003. The anomalies investigated consisted of all 137 “high priority” anomalies, 49 of the 113 “piglike” anomalies, 39 of the 98 “high amplitude, non-piglike” anomalies, 34 of the 144 “mag and flag” anomalies from the berm, and the 10 anomalous areas identified during the geophysical survey. The results of the Fort Crowder intrusive investigation are summarized in Table 3.1. Figure 3.4 shows the locations of the anomalies that were intrusively investigated; the location of the mine fuze and ordnance related scrap; and the location of the trenches that were excavated during the operation.
