Final
Mitigation Banking Instrument

For the
Clear Fork
Wetland & Stream Mitigation Bank

July 2013

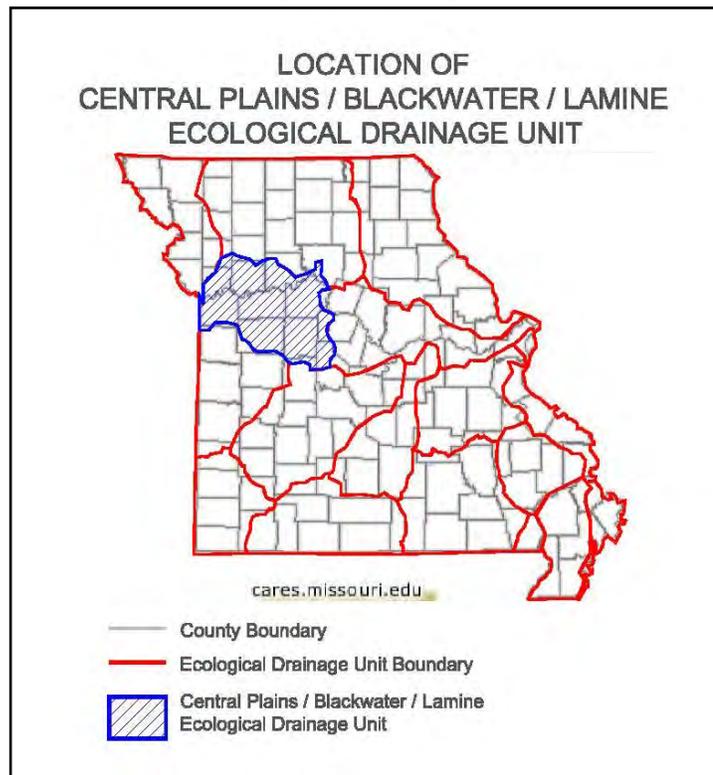
Image 2. Location of Central Plains / Blackwater / Lamine Ecological Drainage Unit

The service area of the Bank is the Central Plains / Blackwater / Lamine Ecological Drainage Unit (EDU) in Missouri. The location and boundaries of this EDU are shown in Image 2. On a case-by-case basis the Corps, in consultation with the IRT, may approve mitigation credits at the Bank to be sold to offset impacts from Department of the Army permit impacts that occur outside this Bank's service area. If determined appropriate, the Corps will determine the number of credits needed to be purchased at the Bank in order to adequately replace the aquatic resources lost at the Department of the Army permit site. The Sponsor has provided the Corps with a shapefile of this service area boundary.

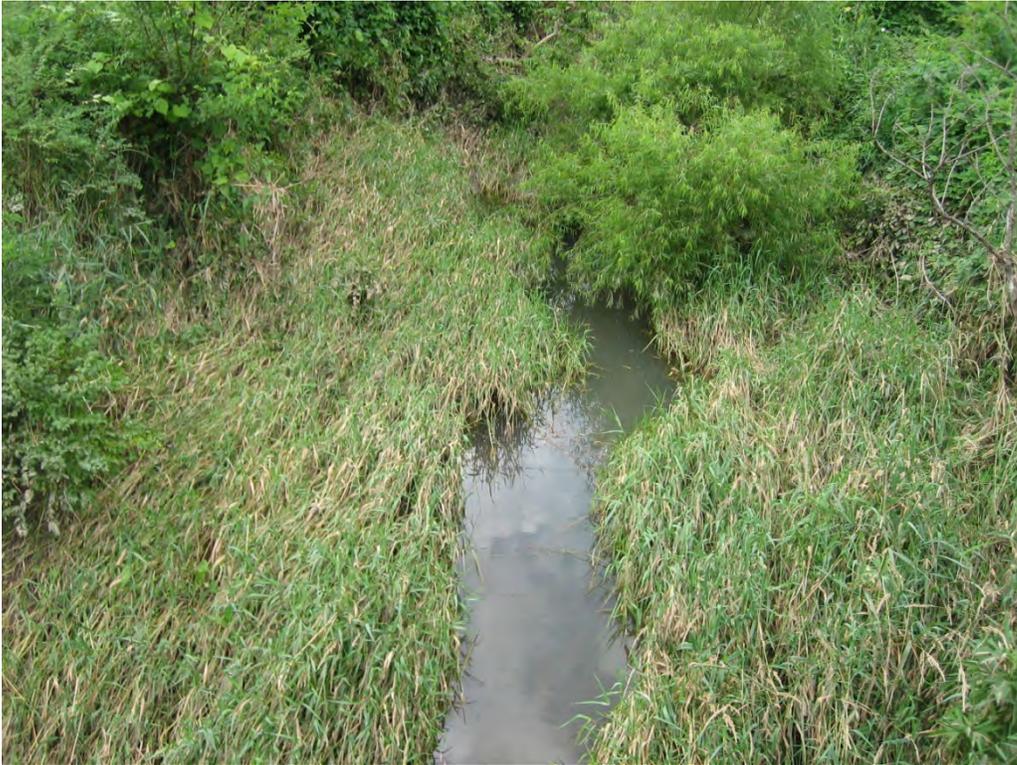
PHOTO #: 1

DATE: 06/25/2008	SITE NAME: Clear Fork Wetland & Stream Mitigation Bank
TAKEN BY: CG	
COMMENTS: Photo of Intermittent # 1 just off the property boundary. OHWM of I-1 averages 9 feet. View faces South.

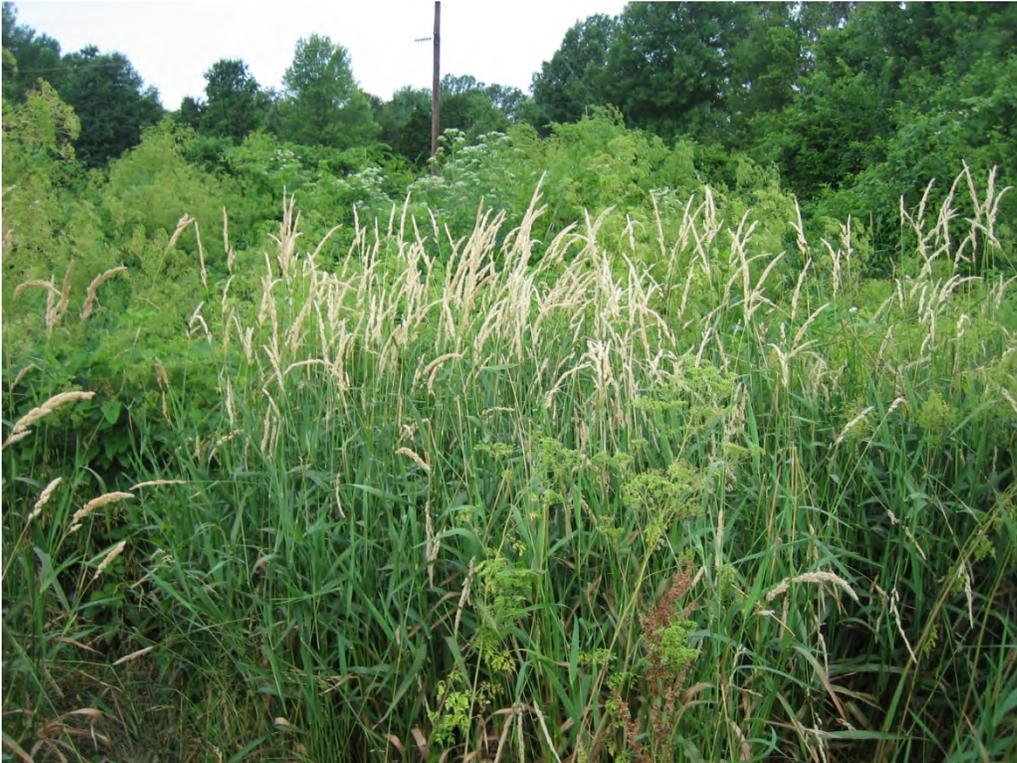
PHOTO #: 2

DATE: 06/25/2008	SITE NAME: Clear Fork Wetland & Stream Mitigation Bank
TAKEN BY: CG	
COMMENTS: Photo of Intermittent # 1 further upstream. View faces Northwest.

Intermittent #1 is identified as a blue-line stream on the USGS topographical map of the property included as Figure 5. It originates off the parcel and runs parallel to the westernmost boundary, conveying off-site drainage, while collecting local drainage from adjacent agricultural fields. It has a drainage area of approximately 650 acres and maintains baseflow through groundwater influence from the surrounding uplands. It has definitive bed and bank within the parcel with an average width at top of bank of approximately 16 feet and a bank height of approximately five feet. The substrate consists primarily of sediment and gravel and the average width at ordinary high water mark is approximately nine feet. Dominant vegetation surrounding this stream consists of *Celtis occidentalis* (hackberry), *Ampelopsis cordata* (raccoon grape), *Festuca arundinacea* (tall fescue), *Rudbeckia hirta* (black-eyed Susan), *Elymus virginicus* (Virginia wild rye), *Symphoricarpos orbiculatis* (coralberry), *Solidago graminifolia* (grass-leaved goldenrod), *Phalaris arundinacea* (reed canarygrass), *Rumex crispus* (curly dock), *Salix nigra* (black willow) and *Ambrosia trifida* (giant ragweed). The riparian buffer averages approximately 75 feet per side although the most downstream 100-feet or so of this stream on the property is denuded of trees and shrubs.

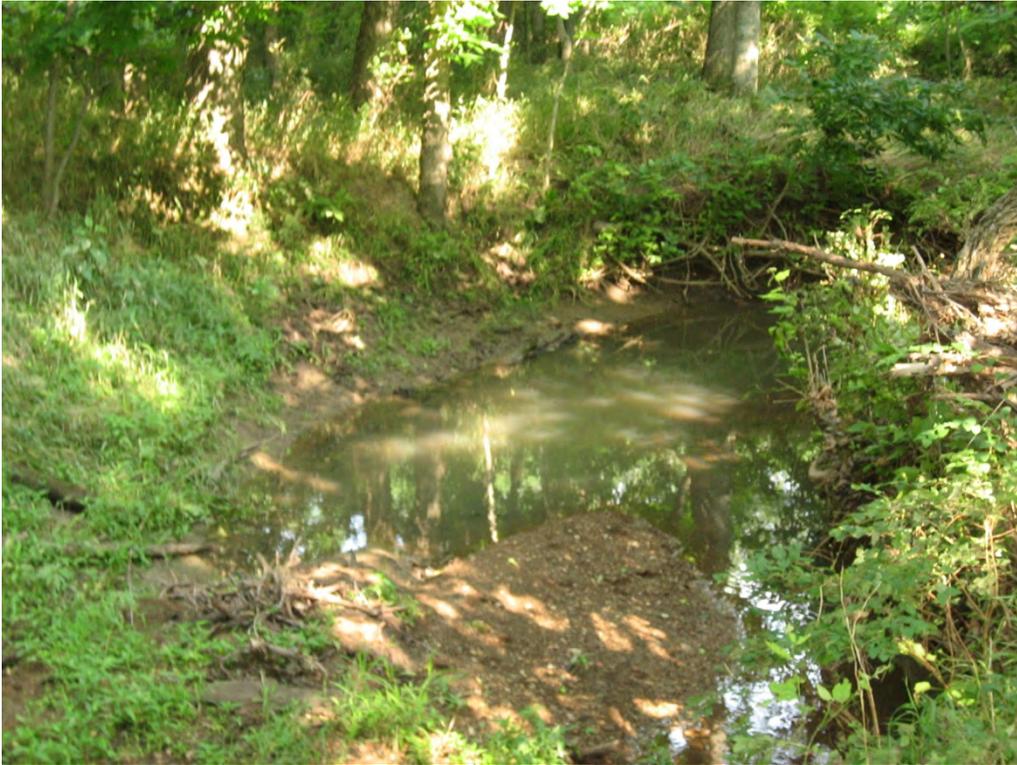
PHOTO #: 3

DATE: 06/25/2008	SITE NAME: Clear Fork Wetland & Stream Mitigation Bank
TAKEN BY: CG	
COMMENTS: Photo of farmed Wetland # 2. View faces South.

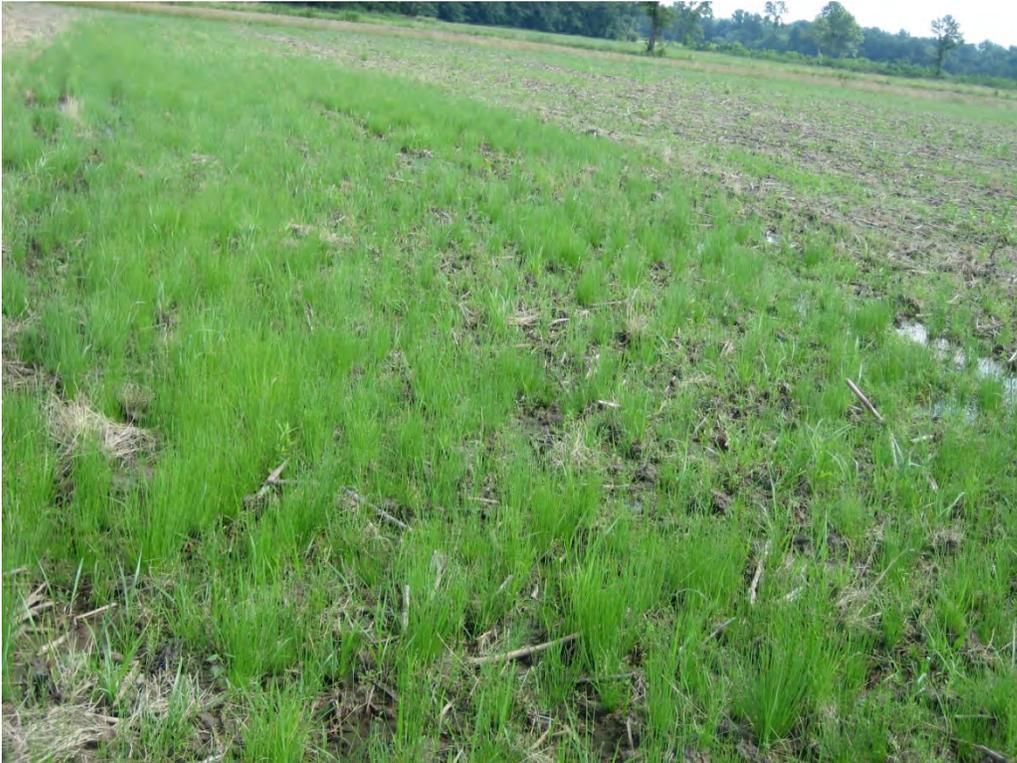
PHOTO #: 4

DATE: 06/25/2008	SITE NAME: Clear Fork Wetland & Stream Mitigation Bank
TAKEN BY: CG	
COMMENTS: Photo of farmed Wetland # 3. View faces Southwest.

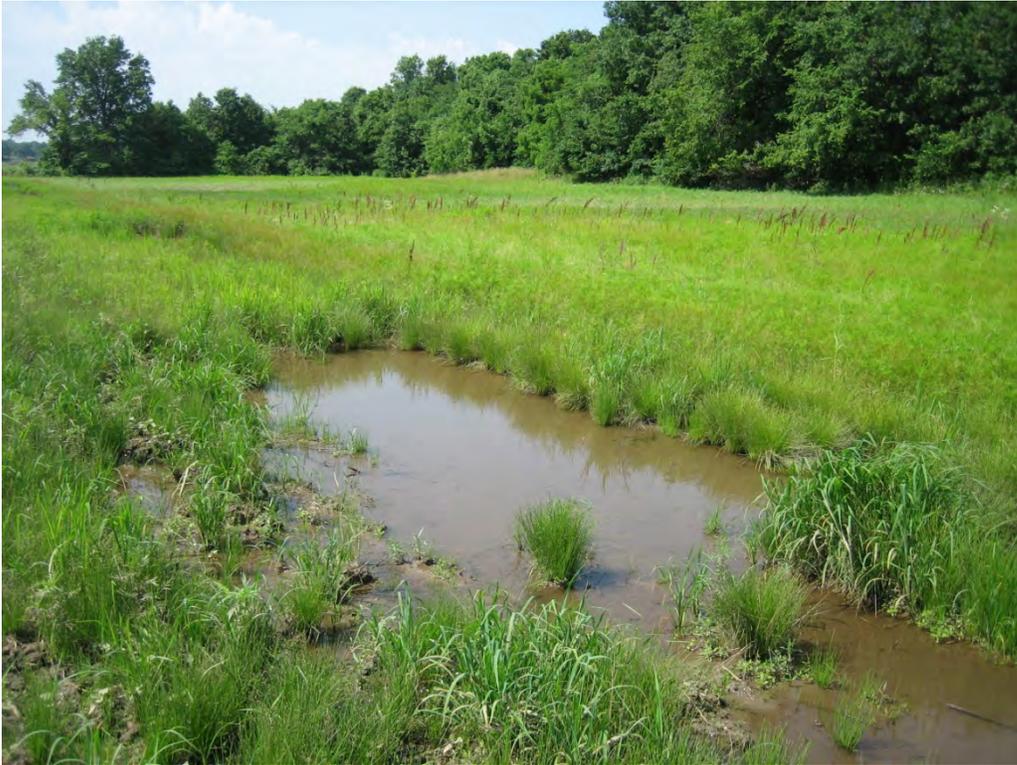
PHOTO #: 5

DATE: 06/25/2008	SITE NAME: Clear Fork Wetland & Stream Mitigation Bank
TAKEN BY: CG	
COMMENTS: Photo of farmed Wetland # 4. View faces Southeast.

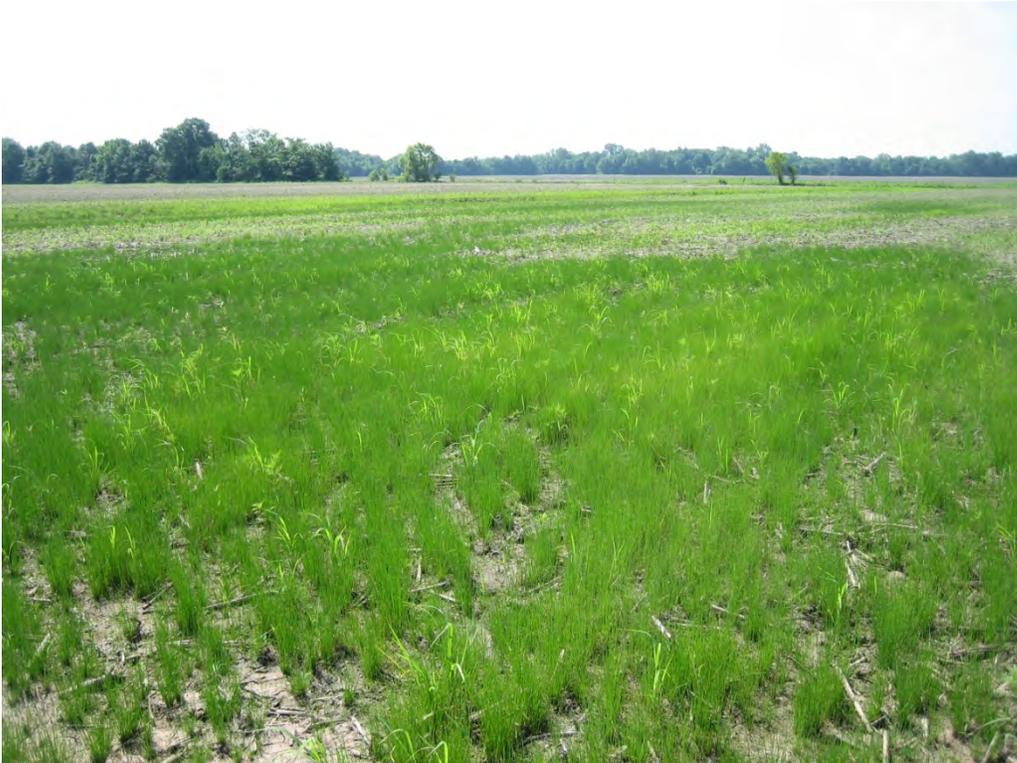
PHOTO #: 6

DATE: 06/25/2008	SITE NAME: Clear Fork Wetland & Stream Mitigation Bank
TAKEN BY: CG	
COMMENTS: Photo of farmed Wetland # 5. View faces East.

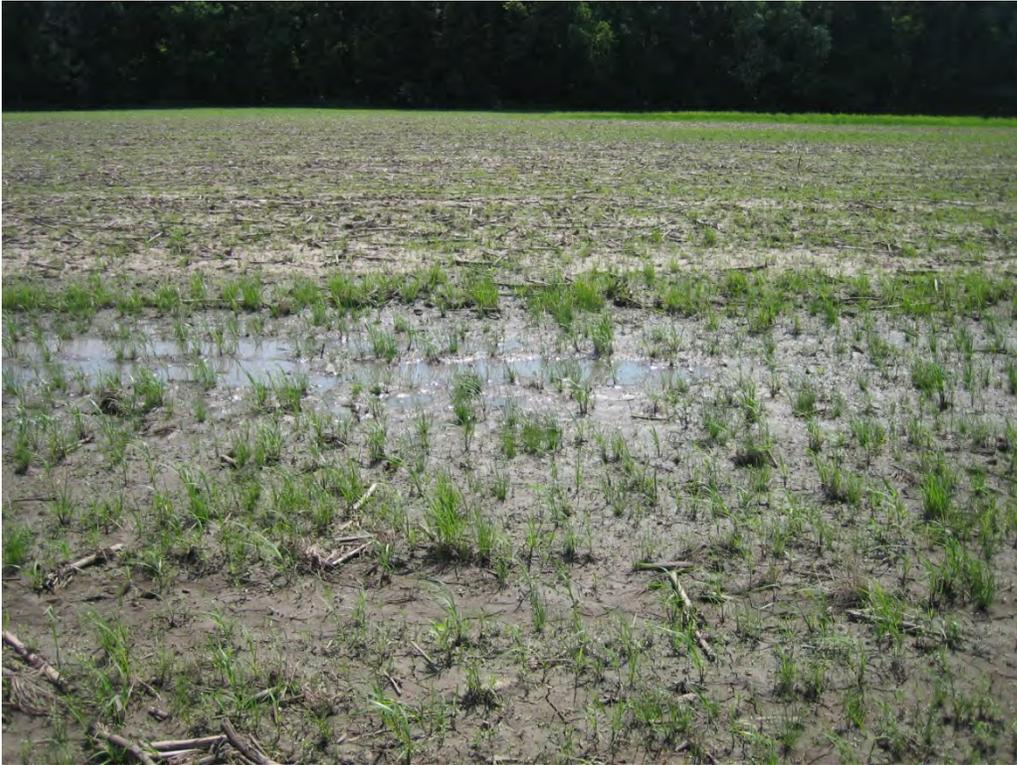
PHOTO #: 7

DATE: 06/25/2008	SITE NAME: Clear Fork Wetland & Stream Mitigation Bank
TAKEN BY: CG	
COMMENTS: Photo of farmed Wetland # 6. View faces South.

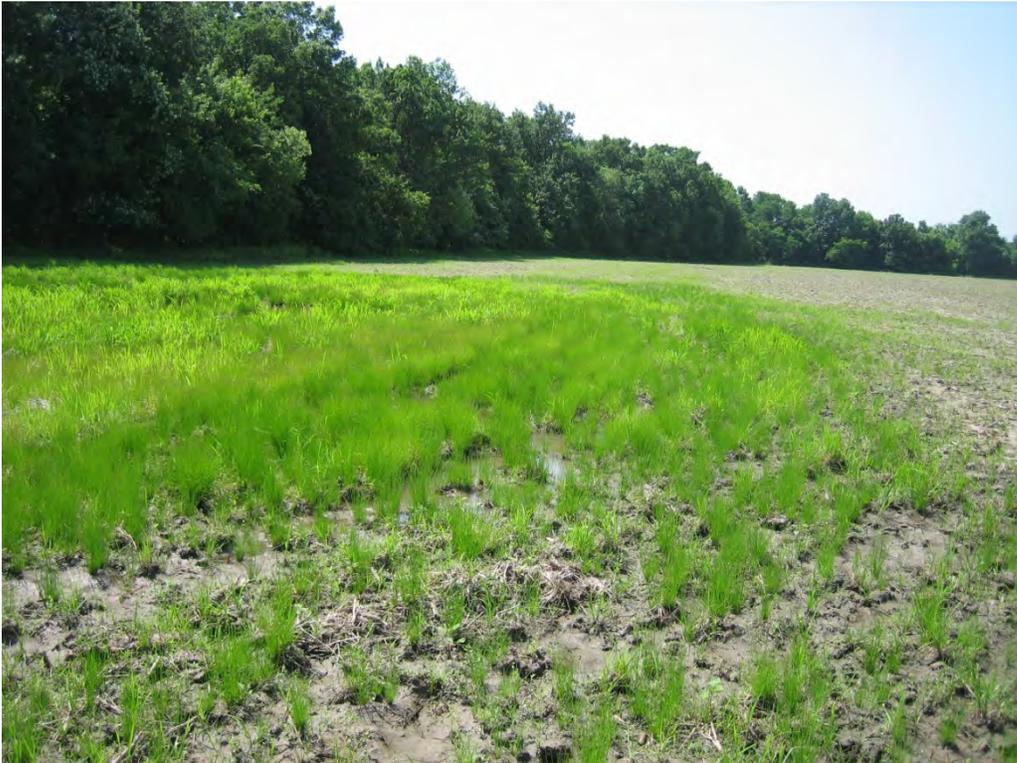
PHOTO #: 8

DATE: 06/25/2008	SITE NAME: Clear Fork Wetland & Stream Mitigation Bank
TAKEN BY: CG	
COMMENTS: Photo of farmed Wetland # 7. View faces Northeast.

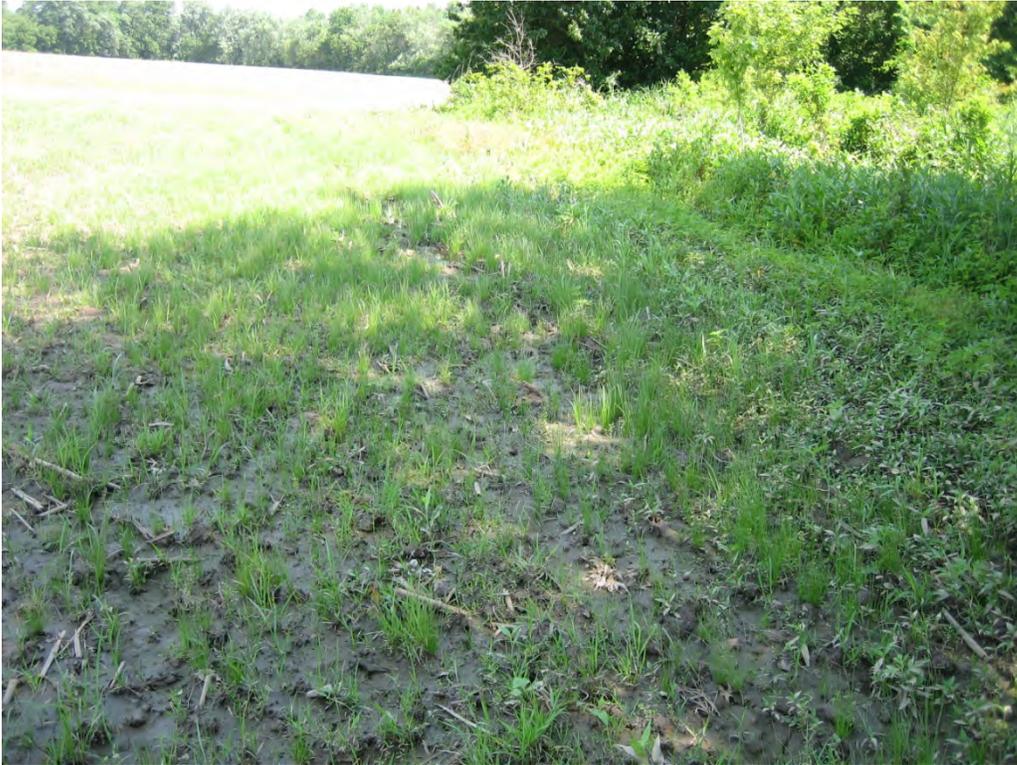
PHOTO #: 9

DATE: 06/25/2008	SITE NAME: Clear Fork Wetland & Stream Mitigation Bank
TAKEN BY: CG	
COMMENTS: Photo of confluence of Intermittent # 2 with Clear Fork. OHWM of I-2 averages 4 feet. View faces Southeast.

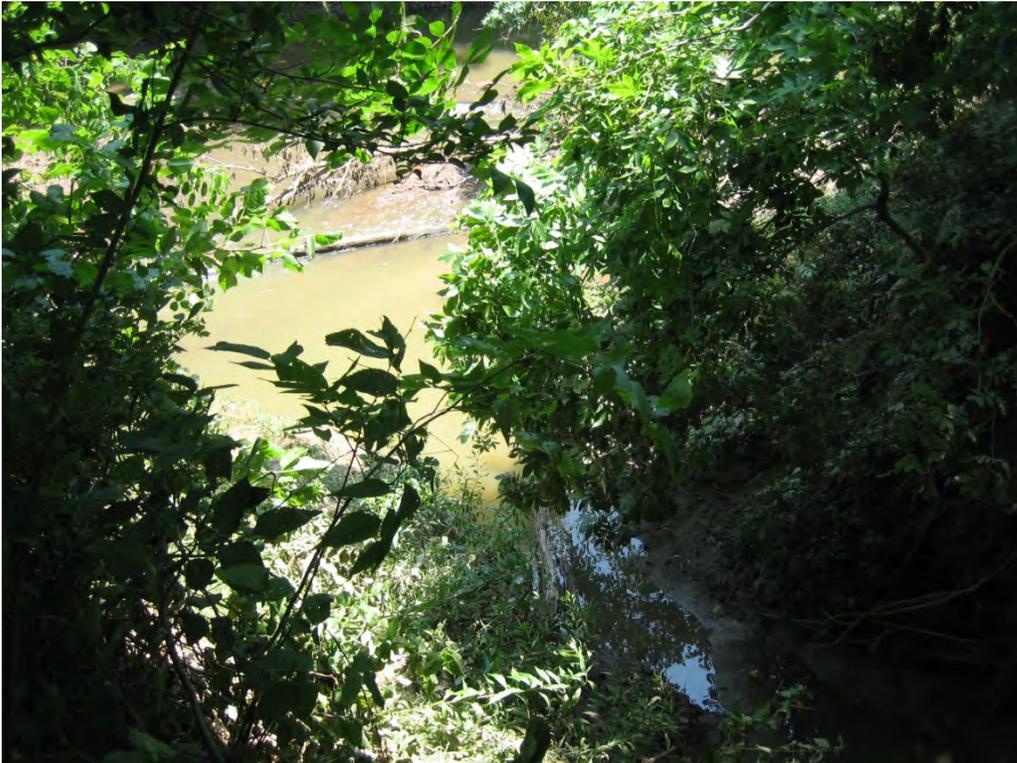
PHOTO #: 10

DATE: 06/25/2008	SITE NAME: Clear Fork Wetland & Stream Mitigation Bank
TAKEN BY: CG	
COMMENTS: Photo of Intermittent # 2 further upstream. View faces Southwest.

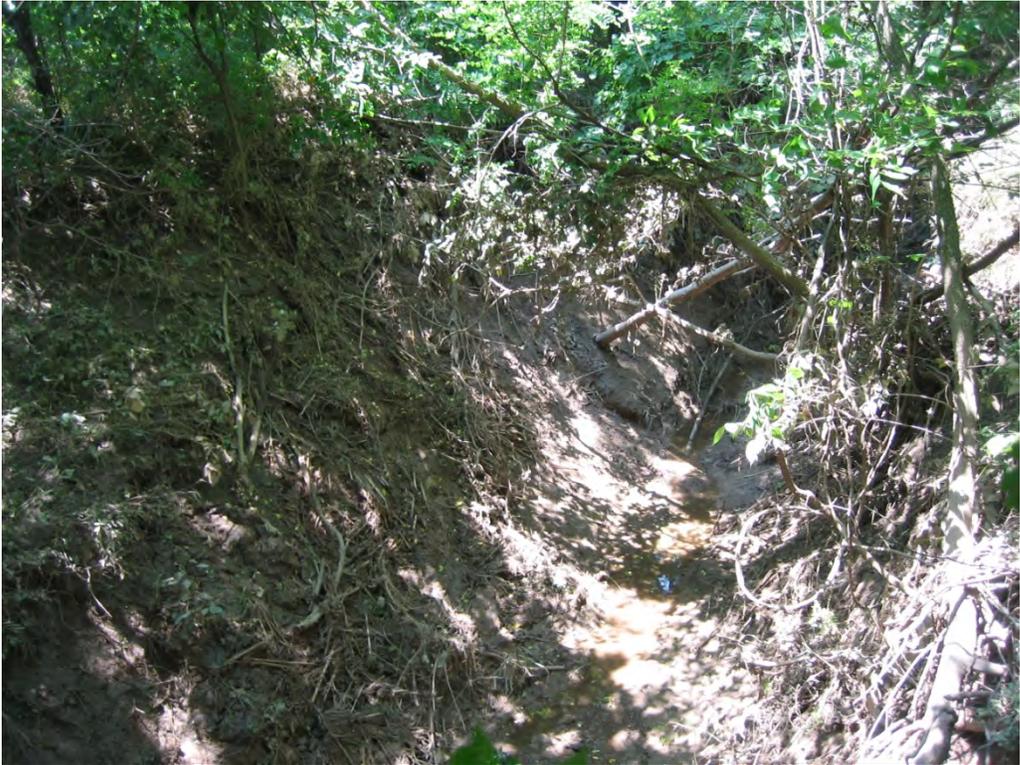
PHOTO #: 11

DATE: 06/25/2008	SITE NAME: Clear Fork Wetland & Stream Mitigation Bank
TAKEN BY: CG	
COMMENTS: Photo of emergent Wetland # 8 within the margin of Intermittent # 2. View faces Northwest.

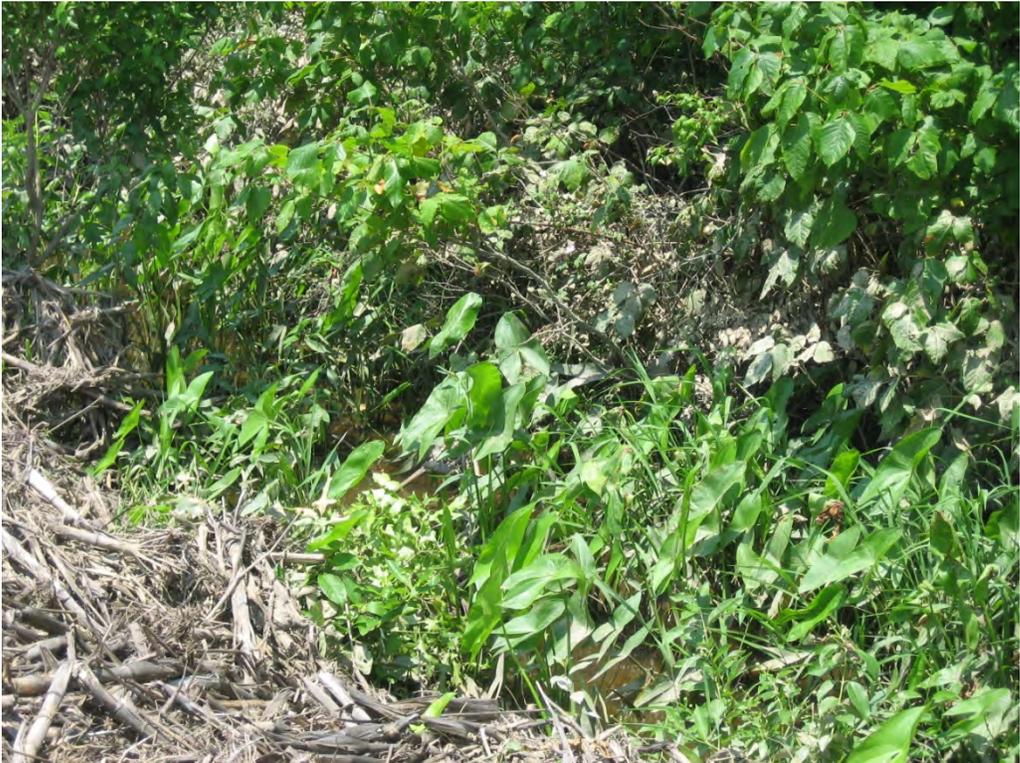
PHOTO #: 12

DATE: 06/25/2008	SITE NAME: Clear Fork Wetland & Stream Mitigation Bank
TAKEN BY: CG	
COMMENTS: Photo of Intermittent # 2 entering the parcel in the far southwest corner. View faces Southwest.

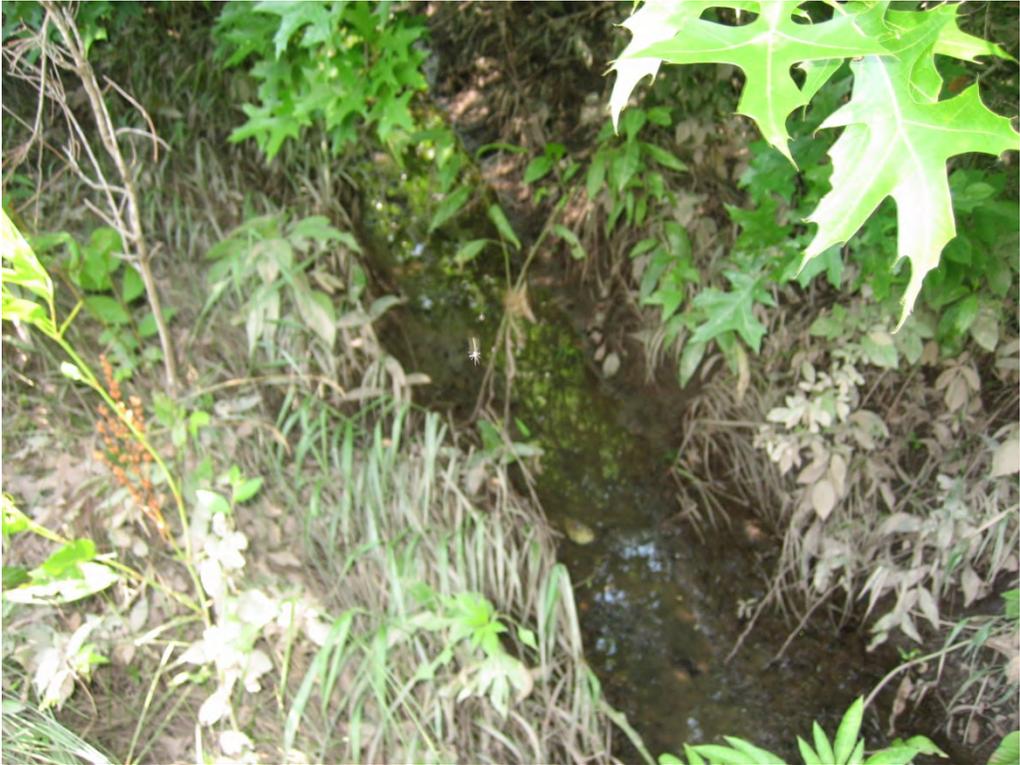
PHOTO #: 13

DATE: 06/25/2008	SITE NAME: Clear Fork Wetland & Stream Mitigation Bank
TAKEN BY: CG	
COMMENTS: Photo of Clear Fork further downstream. View faces East.

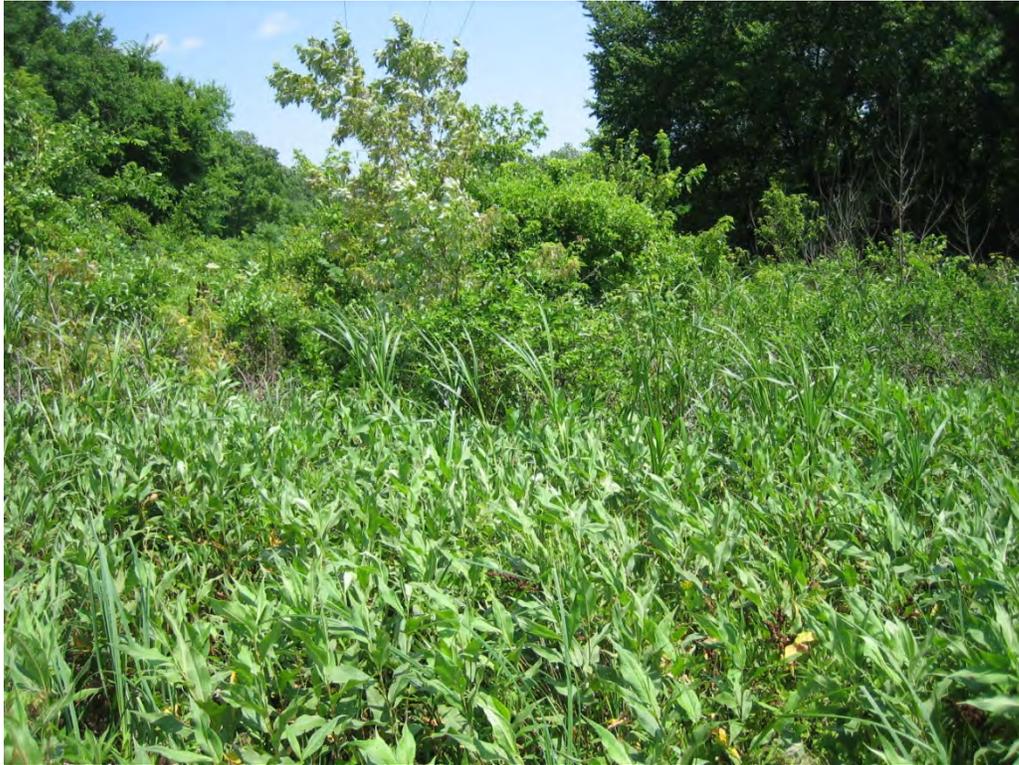
PHOTO #: 15

DATE: 06/25/2008	SITE NAME: Clear Fork Wetland & Stream Mitigation Bank
TAKEN BY: CG	
COMMENTS: Photo of NWI mapped forested Wetland # 10. View faces North.

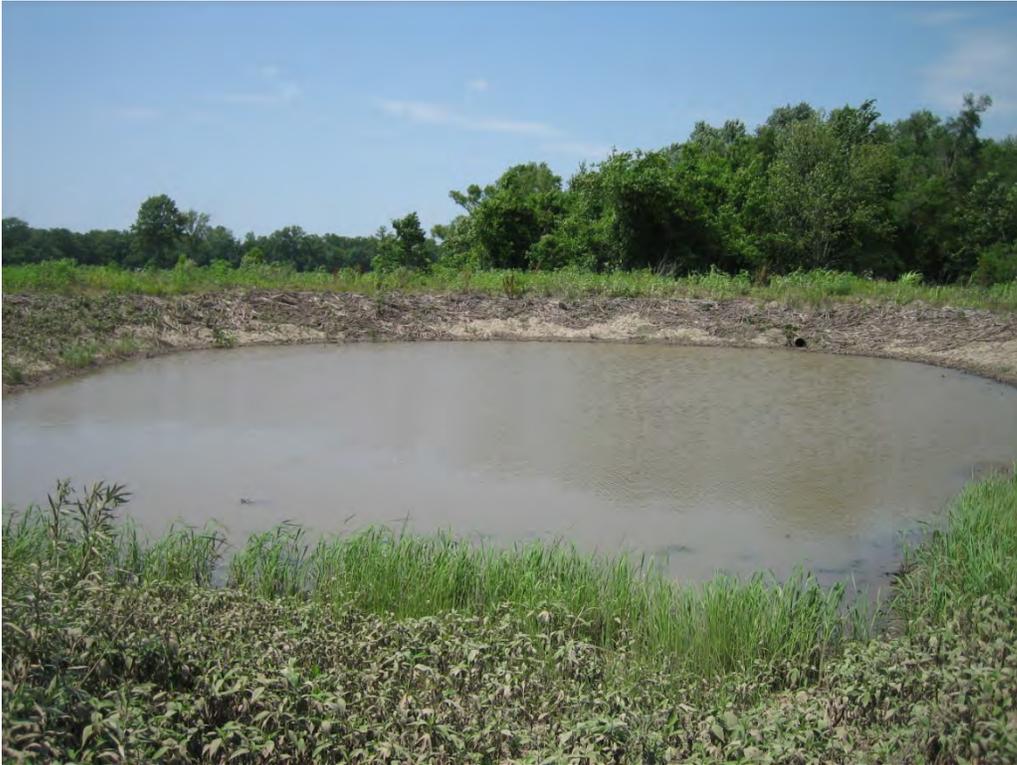
PHOTO #: 17

DATE: 06/25/2008	SITE NAME: Clear Fork Wetland & Stream Mitigation Bank
TAKEN BY: CG	
COMMENTS: Photo of Pond # 1 spillway. View faces North.

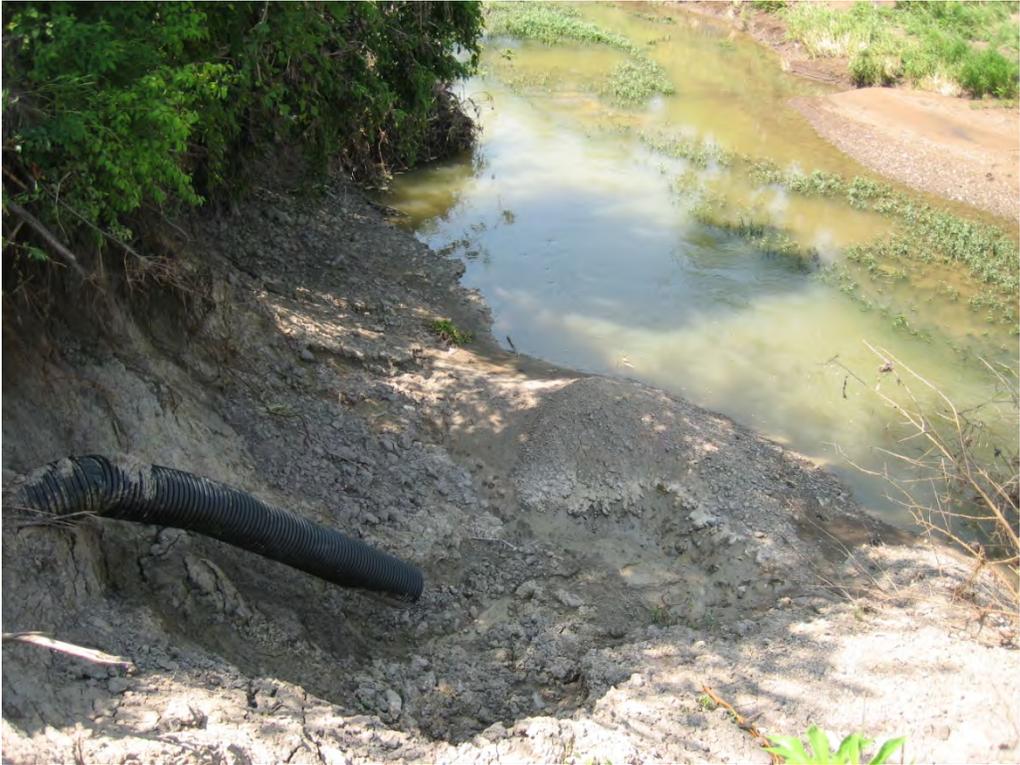
PHOTO #: 19

DATE: 06/25/2008	SITE NAME: Clear Fork Wetland & Stream Mitigation Bank
TAKEN BY: CG	
COMMENTS: Photo of spillway from Pond # 1 emptying into Clear Fork. View faces Northwest.

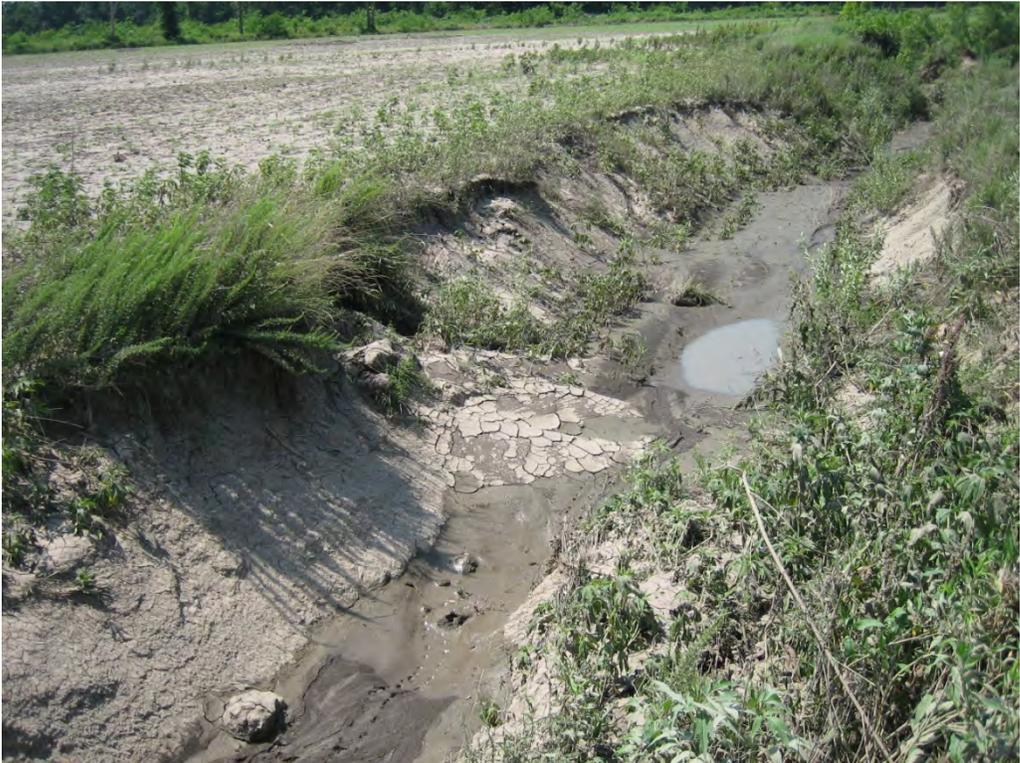
PHOTO #: 20

DATE: 06/25/2008	SITE NAME: Clear Fork Wetland & Stream Mitigation Bank
TAKEN BY: CG	
COMMENTS: Photo of erosional feature with no OHWM along Clear Fork. View faces Northwest.

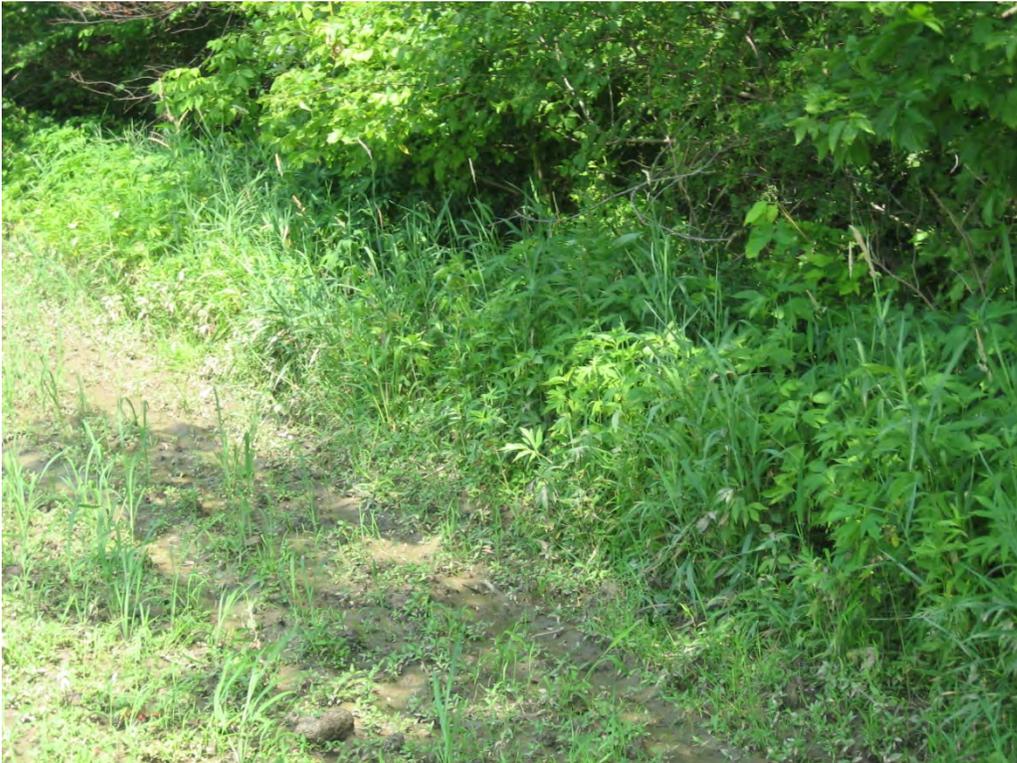
PHOTO #: 22

DATE: 06/25/2008	SITE NAME: Clear Fork Wetland & Stream Mitigation Bank
TAKEN BY: CG	
COMMENTS: Photo of farmed Wetland # 13. View faces Northeast.

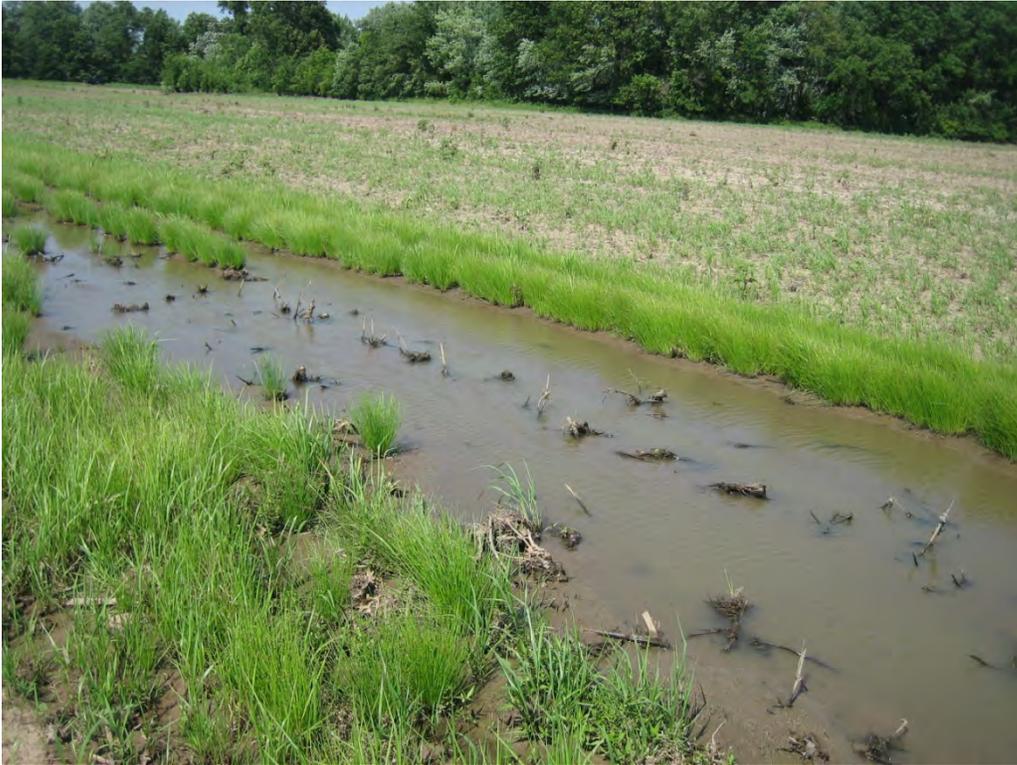
PHOTO #: 25

DATE: 06/25/2008	SITE NAME: Clear Fork Wetland & Stream Mitigation Bank
TAKEN BY: CG	
COMMENTS: Photo of farmed Wetland # 15. View faces South.

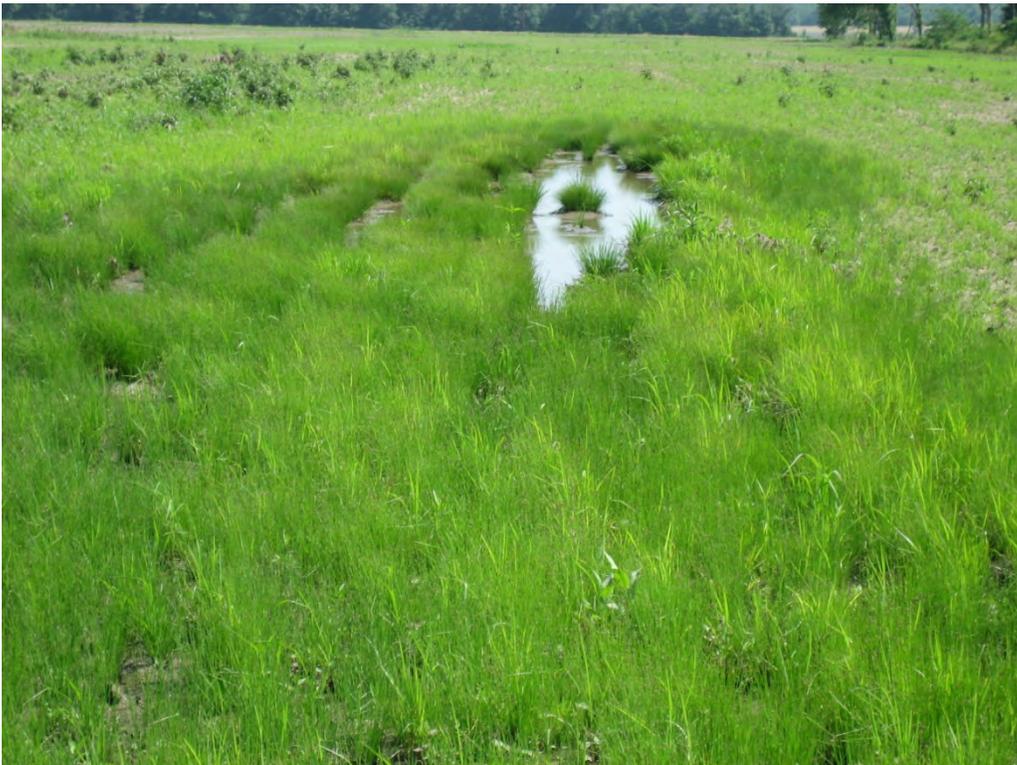
PHOTO #: 26

DATE: 06/25/2008	SITE NAME: Clear Fork Wetland & Stream Mitigation Bank
TAKEN BY: CG	
COMMENTS: Photo of farmed Wetland # 16. View faces South.

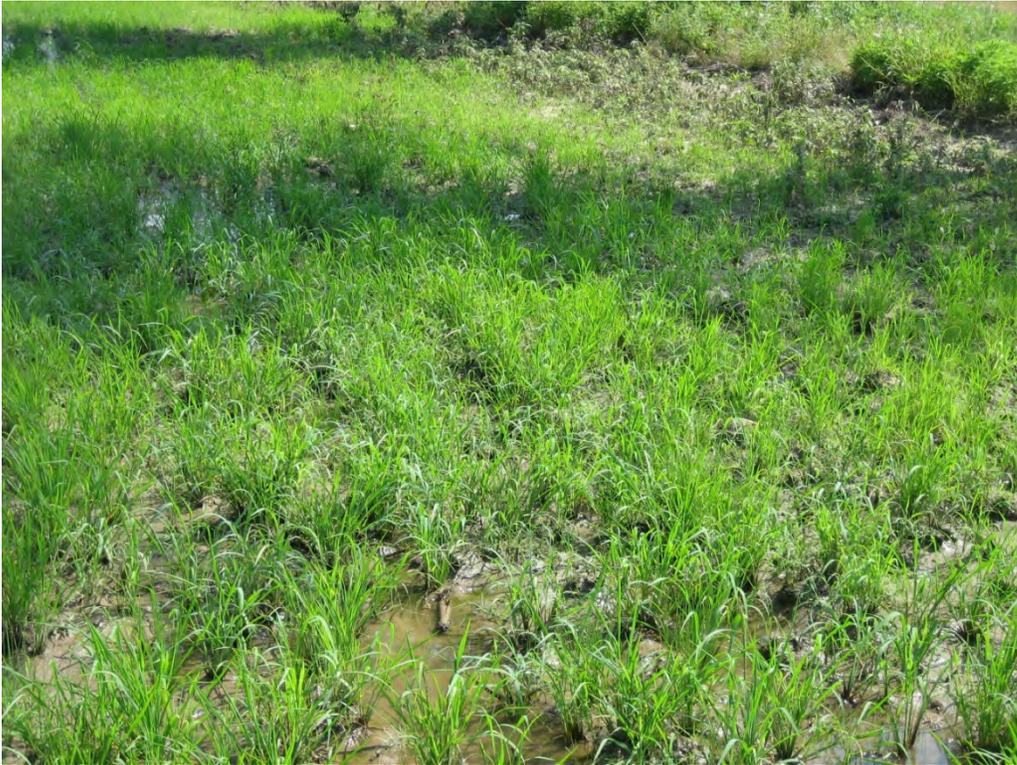
PHOTO #: 27

DATE: 06/25/2008	SITE NAME: Clear Fork Wetland & Stream Mitigation Bank
TAKEN BY: CG	
COMMENTS: Photo of farmed Wetland # 17. View faces West.

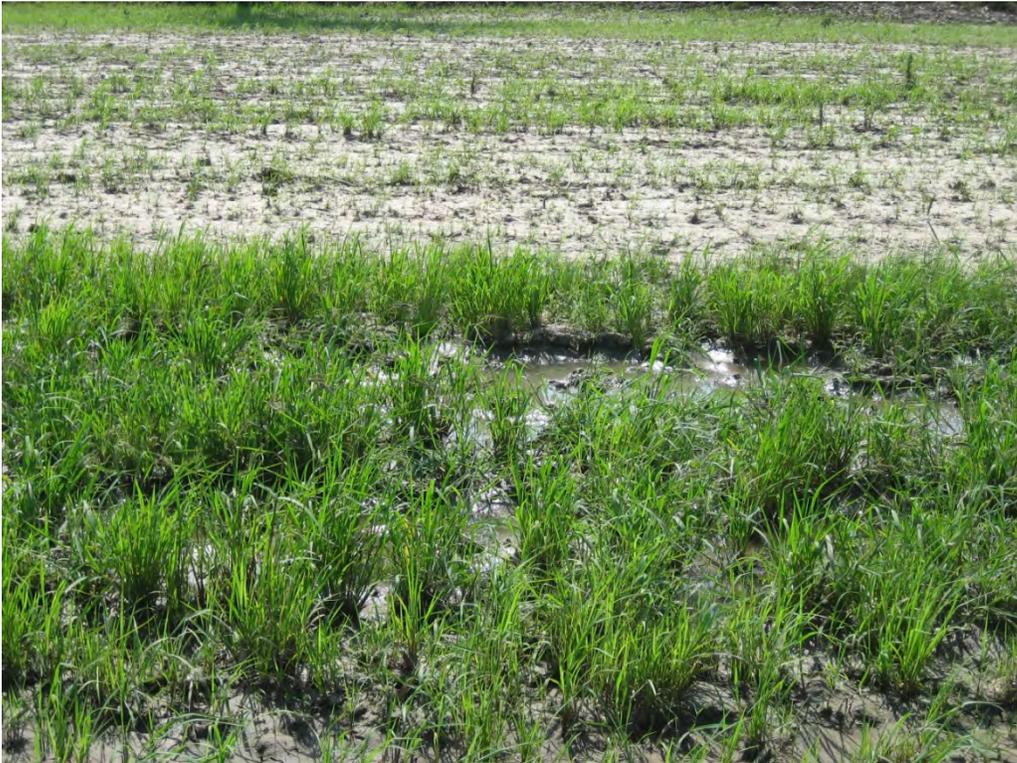
PHOTO #: 28

DATE: 06/25/2008	SITE NAME: Clear Fork Wetland & Stream Mitigation Bank
TAKEN BY: CG	
COMMENTS: Photo of field drainage ditch. View faces South.

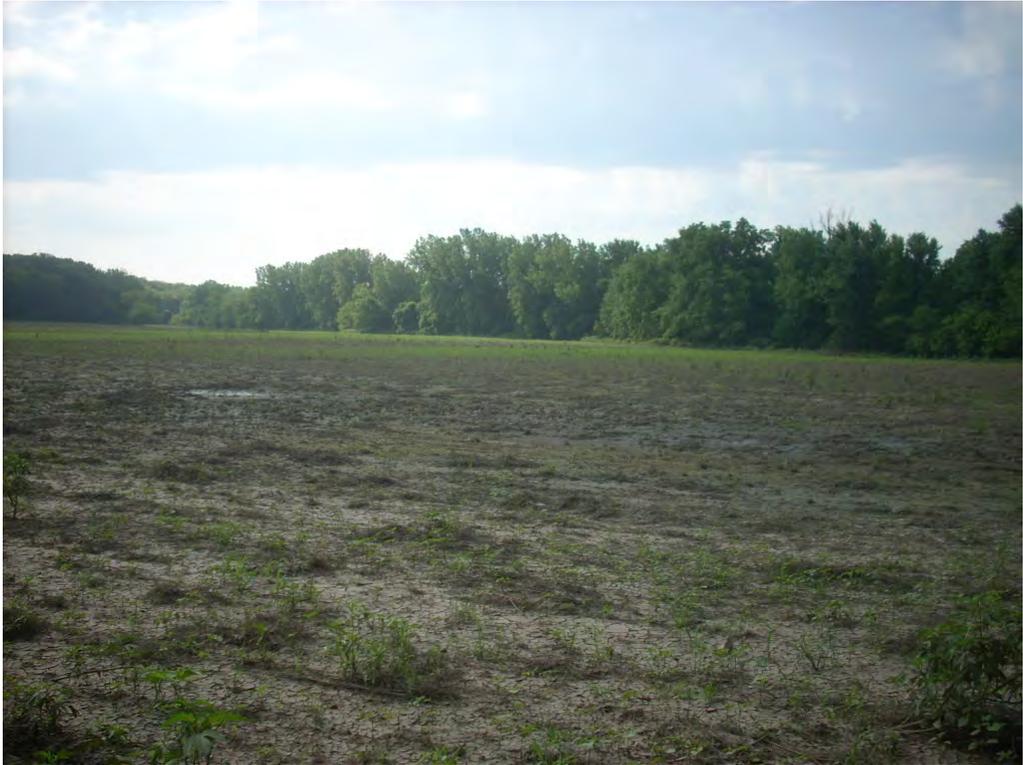
PHOTO #: 30

DATE: 06/25/2008	SITE NAME: Clear Fork Wetland & Stream Mitigation Bank
TAKEN BY: GW	
COMMENTS: Photo of condition of agricultural field east of Clear Fork. View faces Southeast.

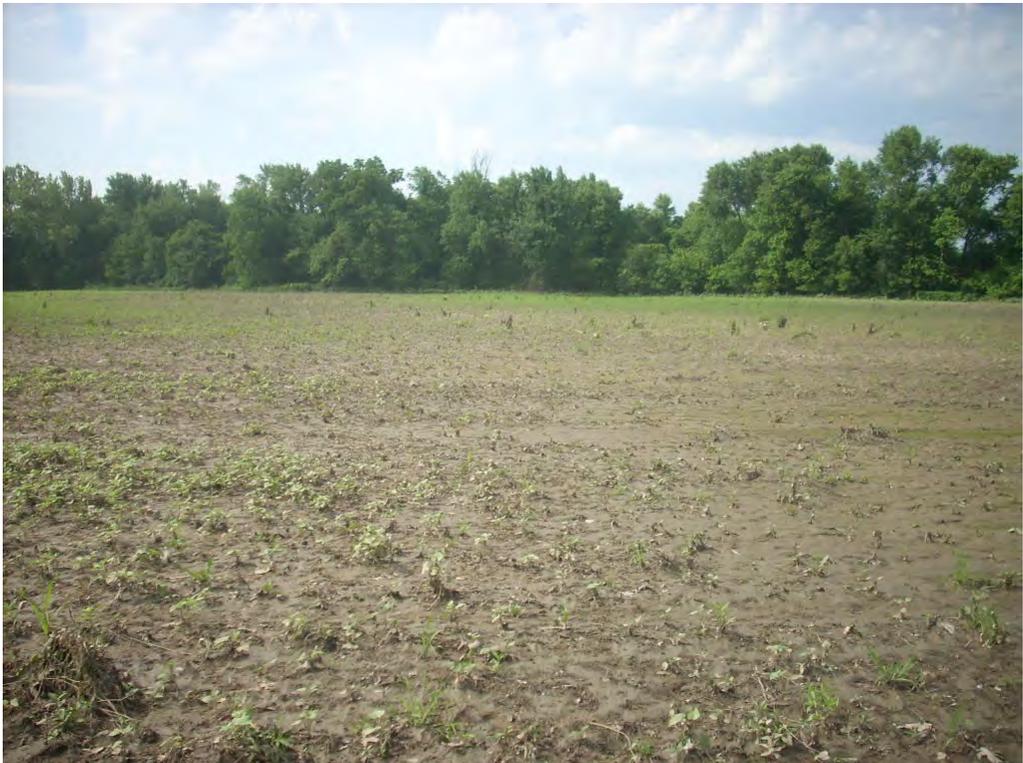
PHOTO #: 31

DATE: 06/25/2008	SITE NAME: Clear Fork Wetland & Stream Mitigation Bank
TAKEN BY: GW	
COMMENTS: Photo of farmed Wetland # 19. The wetland is indicated on the NWI map. View faces South.

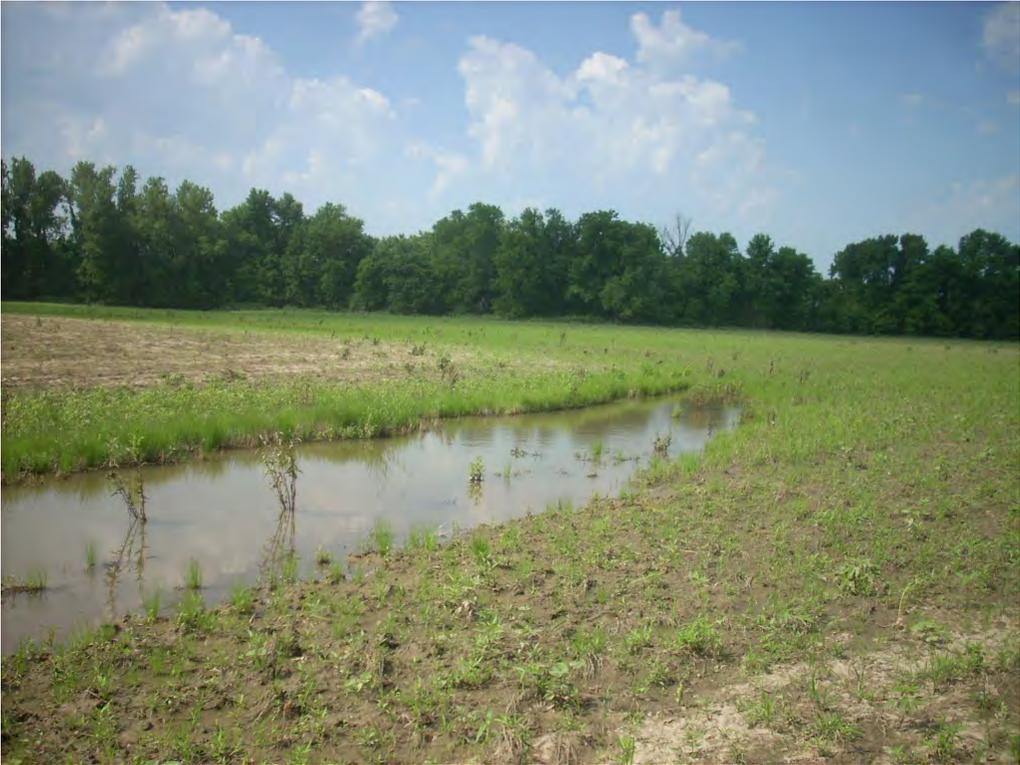
PHOTO #:32

DATE: 06/25/2008	SITE NAME: Clear Fork Wetland & Stream Mitigation Bank
TAKEN BY: GW	
COMMENTS: Photo of farmed Wetland # 20. View faces West.

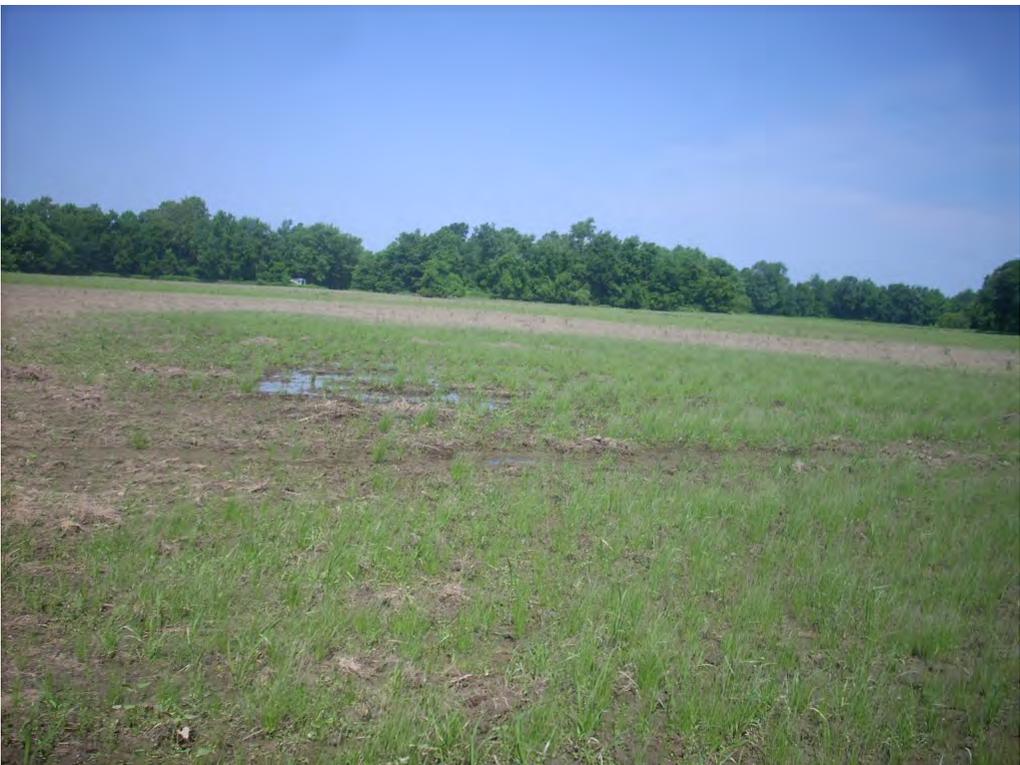
PHOTO #: 33

DATE: 06/25/2008	SITE NAME: Clear Fork Wetland & Stream Mitigation Bank
TAKEN BY: GW	
COMMENTS: Photo of farmed Wetland # 21. View faces West.
