Final
Mitigation Banking Instrument

For the
Clear Fork
Wetland & Stream Mitigation Bank

July 2013

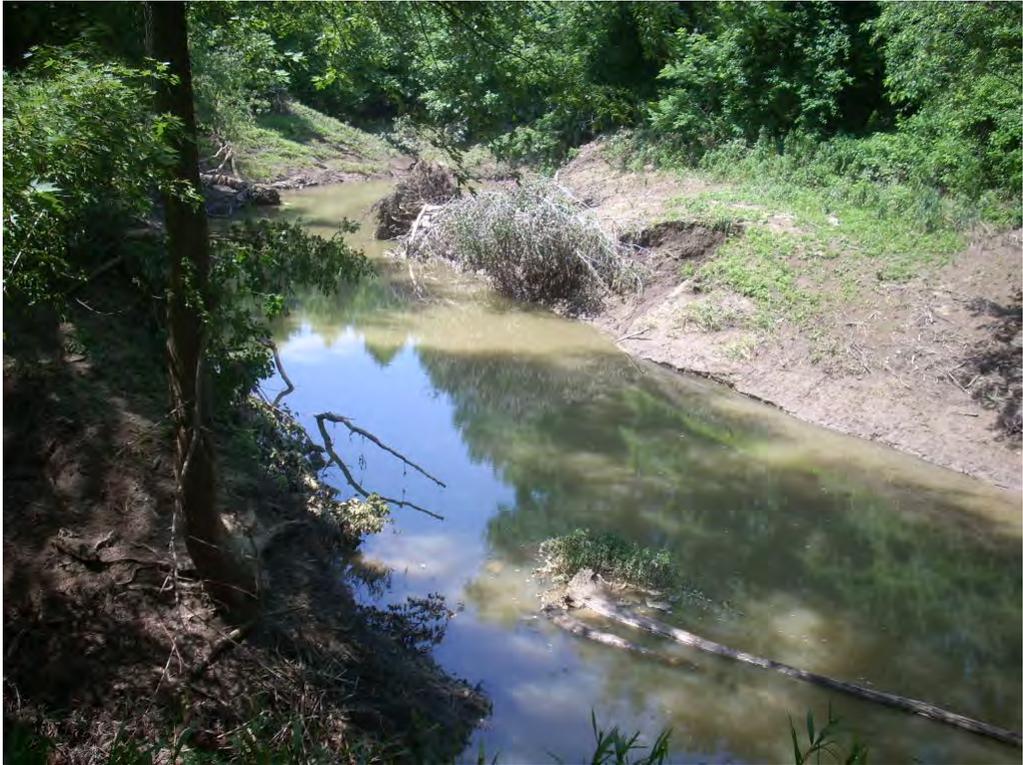
PHOTO #: 35

DATE: 06/25/2008	SITE NAME: Clear Fork Wetland & Stream Mitigation Bank
TAKEN BY: GW	
COMMENTS: Photo of the confluence of Intermittent # 3 with Clear Fork. OHWM of I-3 averages 5 feet. View faces South.

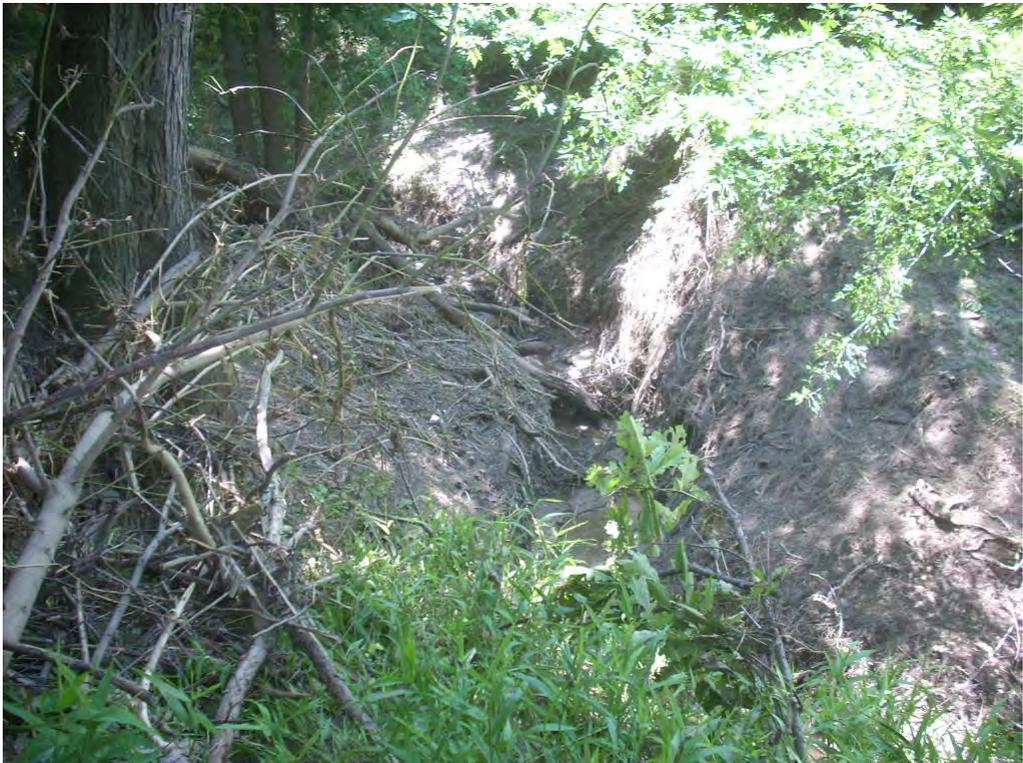
DATE: 06/25/2008	SITE NAME: Clear Fork Wetland & Stream Mitigation Bank
TAKEN BY: GW	
COMMENTS: Photo of Intermittent # 1 upstream of previous photo. View faces Southeast.

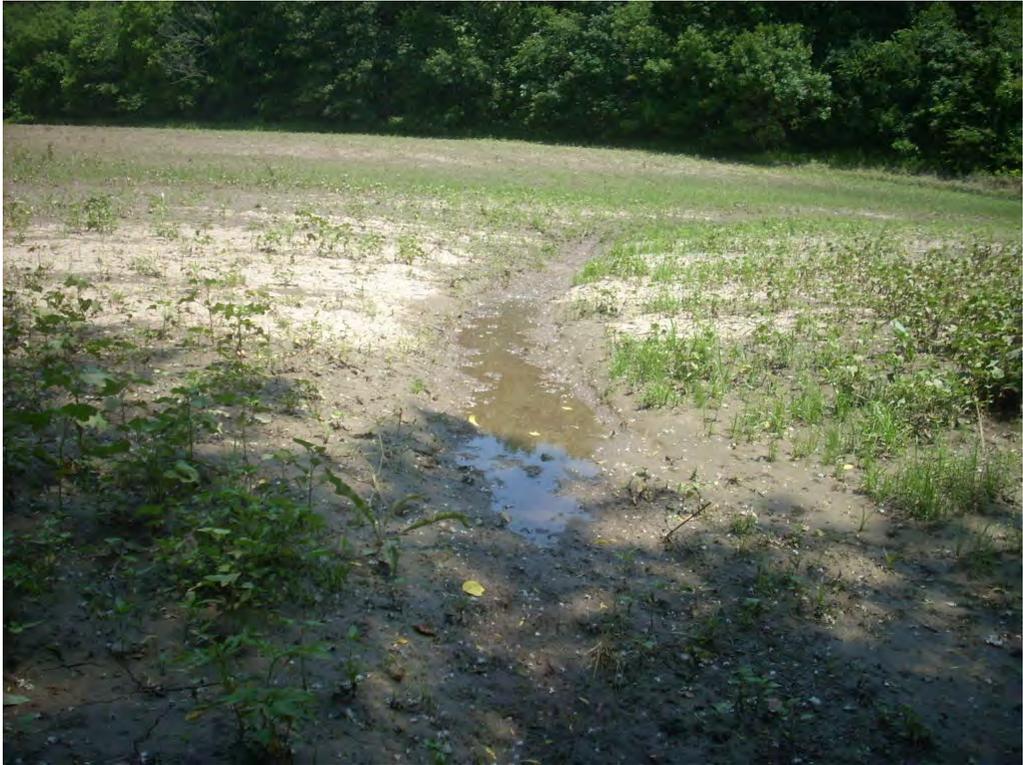
PHOTO #: 37

DATE: 06/25/2008	SITE NAME: Clear Fork Wetland & Stream Mitigation Bank
TAKEN BY: GW	
COMMENTS: Photo of erosional swale connecting to Intermittent # 3. View faces Northeast.

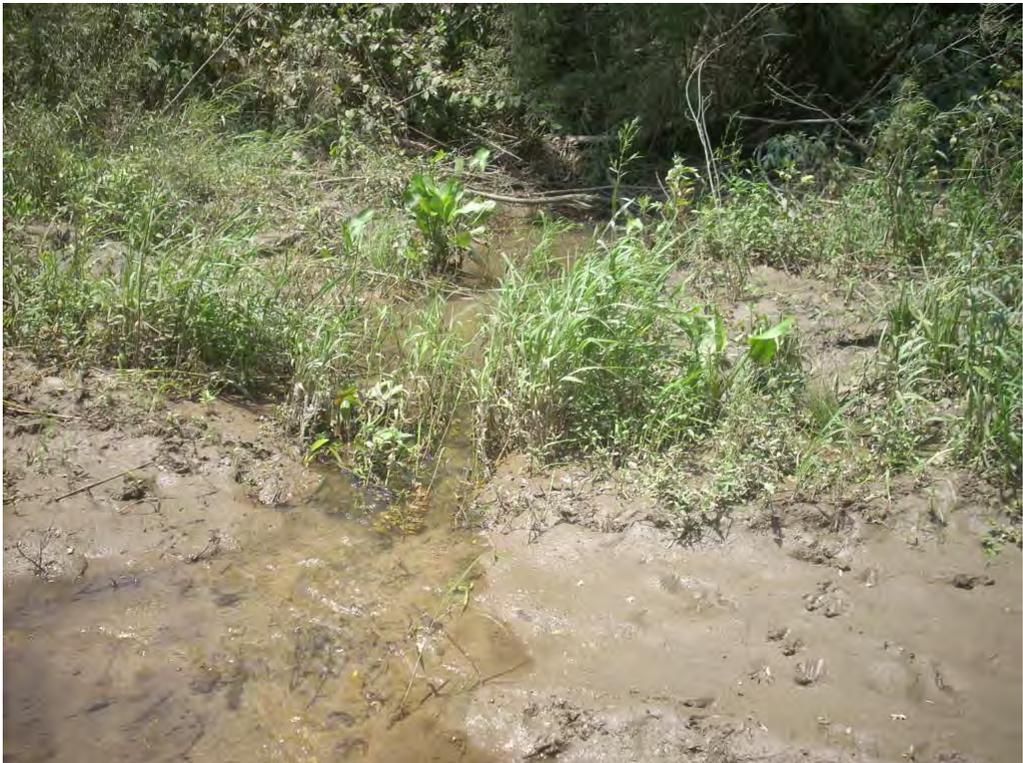
PHOTO #: 39

DATE: 06/25/2008	SITE NAME: Clear Fork Wetland & Stream Mitigation Bank
TAKEN BY: GW	
COMMENTS: Photo of field crossing along Intermittent # 3. View faces West.

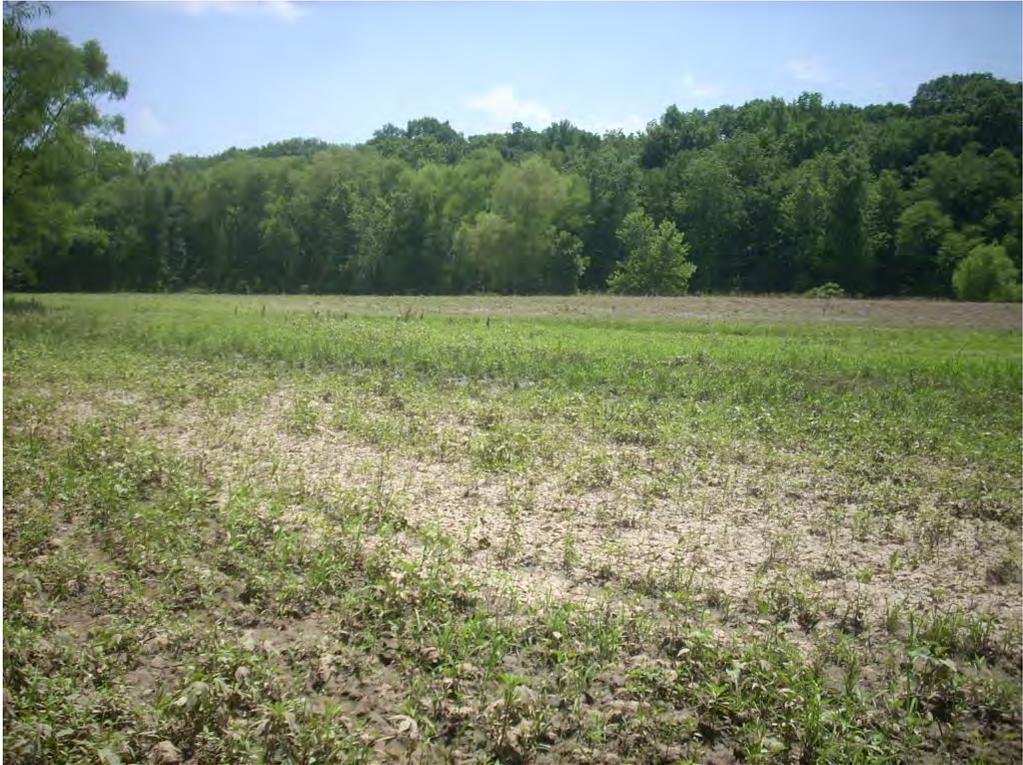
PHOTO #: 40

DATE: 06/25/2008	SITE NAME: Clear Fork Wetland & Stream Mitigation Bank
TAKEN BY: GW	
COMMENTS: Photo of farmed Wetland # 24. View faces Southeast.

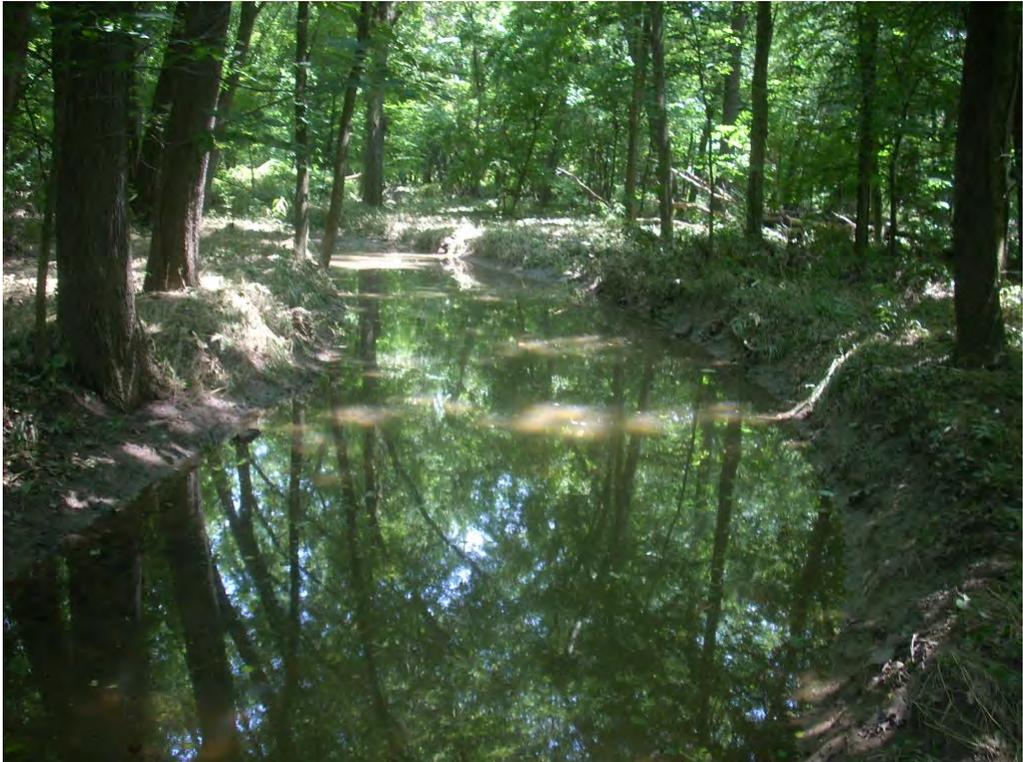
PHOTO #: 41

DATE: 06/25/2008	SITE NAME: Clear Fork Wetland & Stream Mitigation Bank
TAKEN BY: GW	
COMMENTS: Photo of Intermittent # 3 entering the property. View faces East.

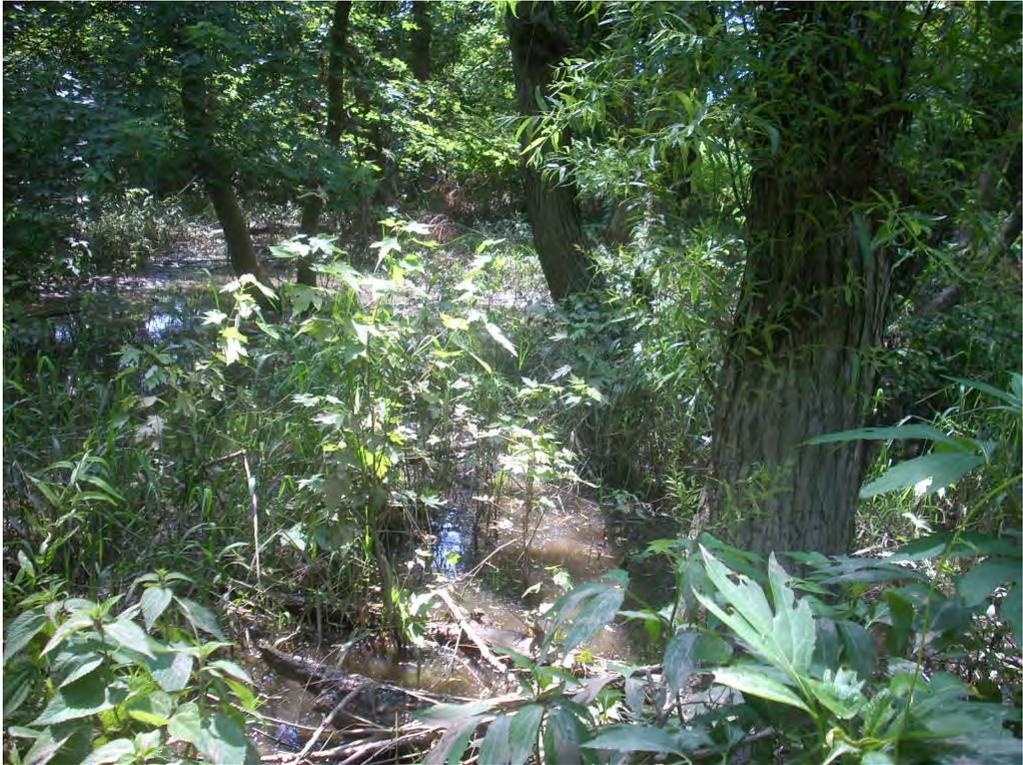
PHOTO #: 42

DATE: 06/25/2008	SITE NAME: Clear Fork Wetland & Stream Mitigation Bank
TAKEN BY: GW	
COMMENTS: Photo of forested Wetland # 25 along slough south of Intermittent # 3. View faces Southwest.

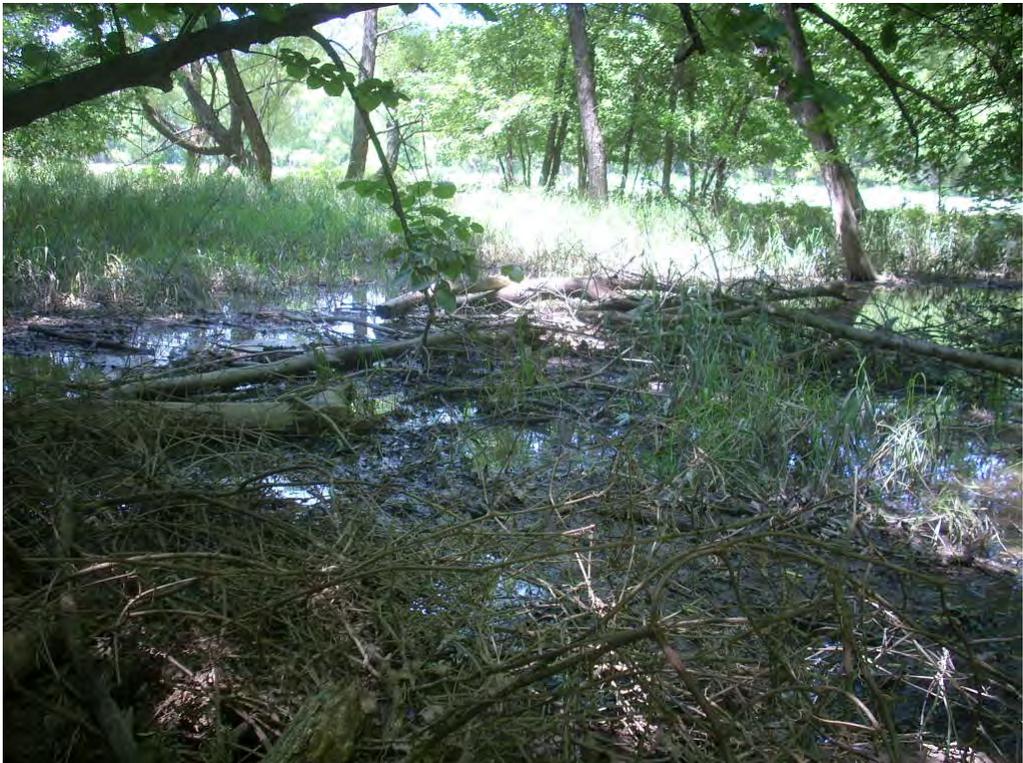
PHOTO #: 44

DATE: 06/25/2008	SITE NAME: Clear Fork Wetland & Stream Mitigation Bank
TAKEN BY: GW	
COMMENTS: Photo of Intermittent # 5 emptying into forested Wetland # 25. OHWM of E-5 averages 2 feet. View faces West.

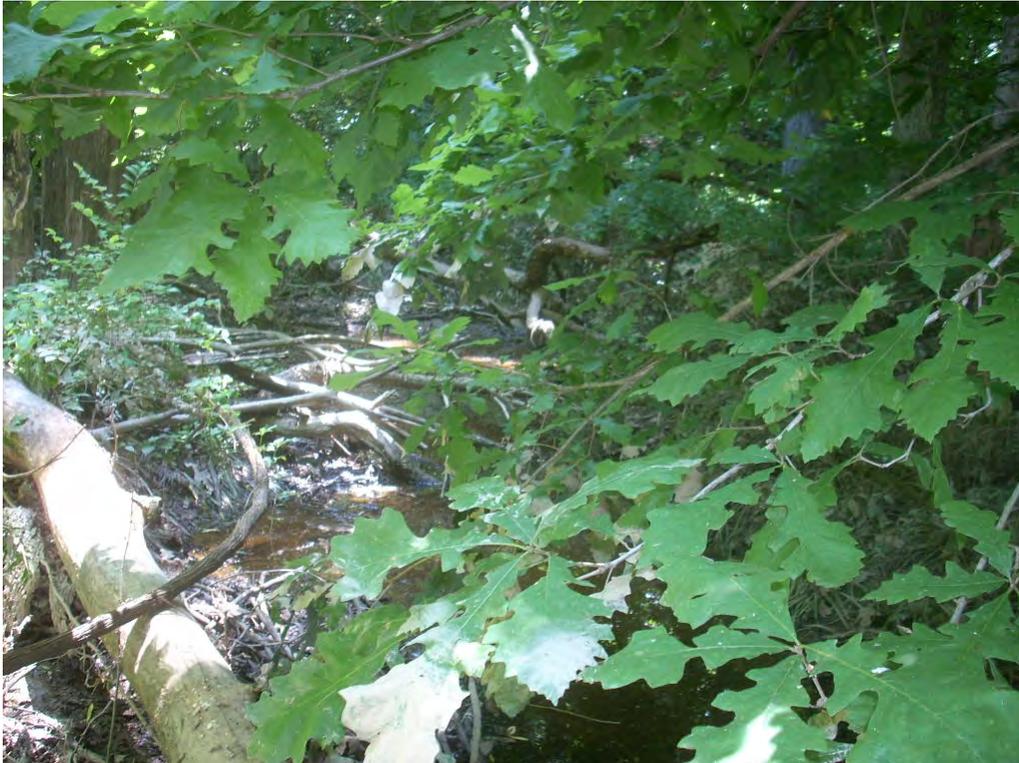
DATE: 06/25/2008	SITE NAME: Clear Fork Wetland & Stream Mitigation Bank
TAKEN BY: GW	
COMMENTS: Photo of Intermittent # 5 upstream of the previous photo. View faces East.

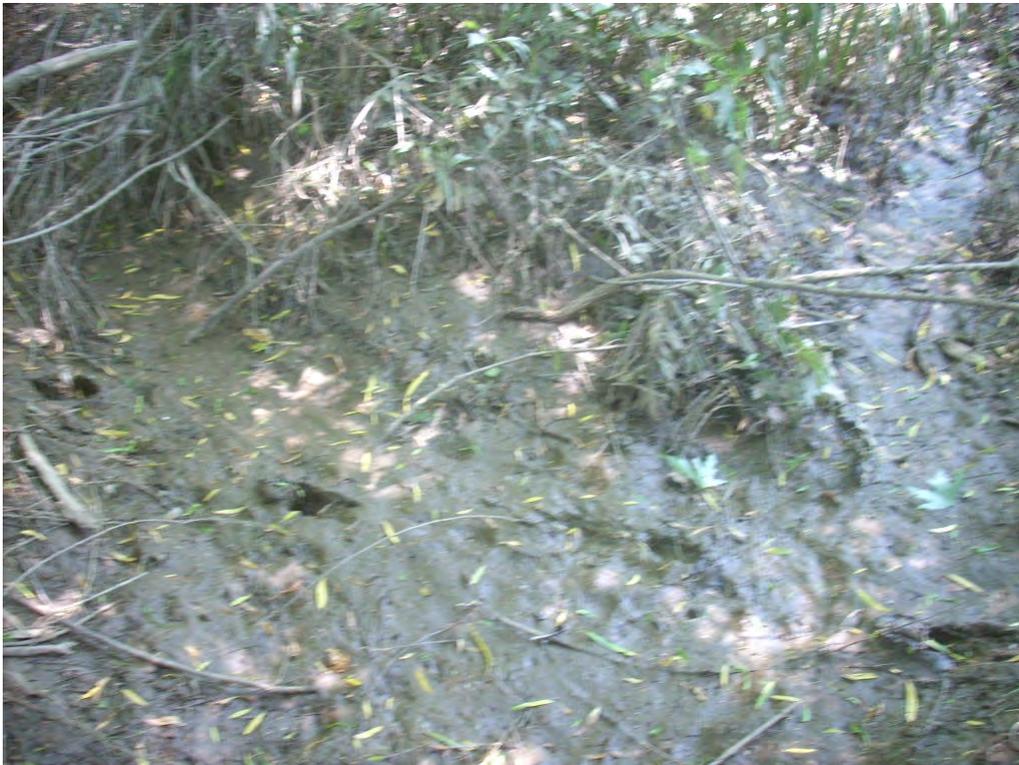
PHOTO #: 45

DATE: 06/25/2008	SITE NAME: Clear Fork Wetland & Stream Mitigation Bank
TAKEN BY: GW	
COMMENTS: Photo of Intermittent # 5. View faces Southeast.

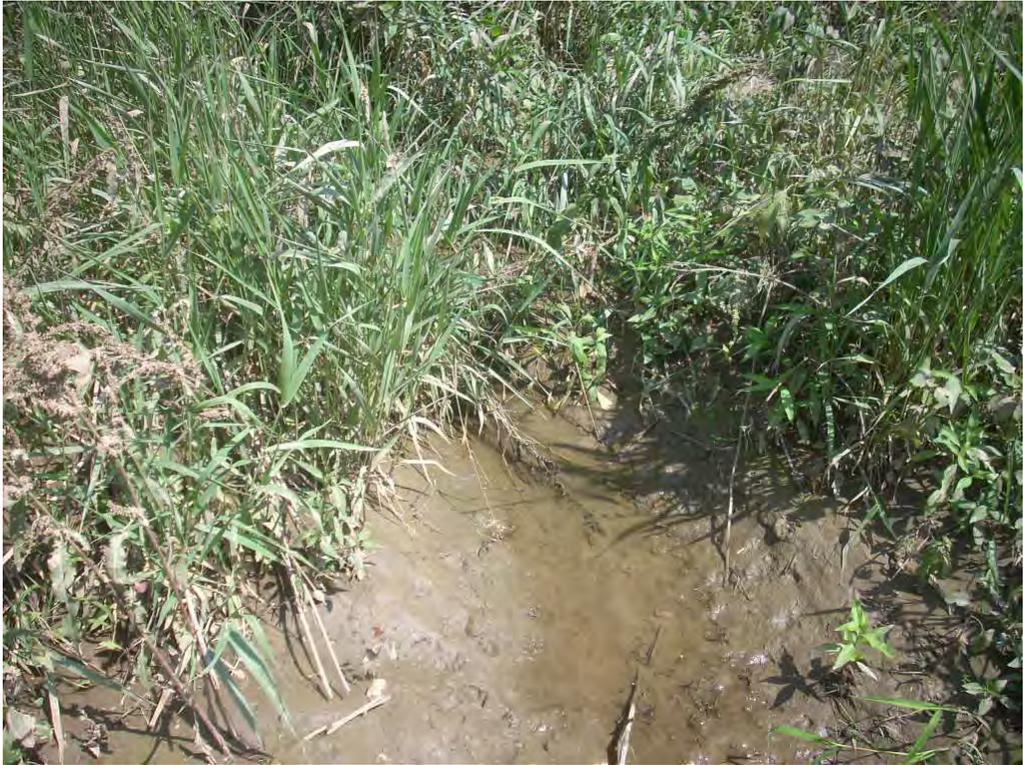
PHOTO #: 46

DATE: 06/25/2008	SITE NAME: Clear Fork Wetland & Stream Mitigation Bank
TAKEN BY: GW	
COMMENTS: Photo of farm crossing along Intermittent # 5. View faces East.

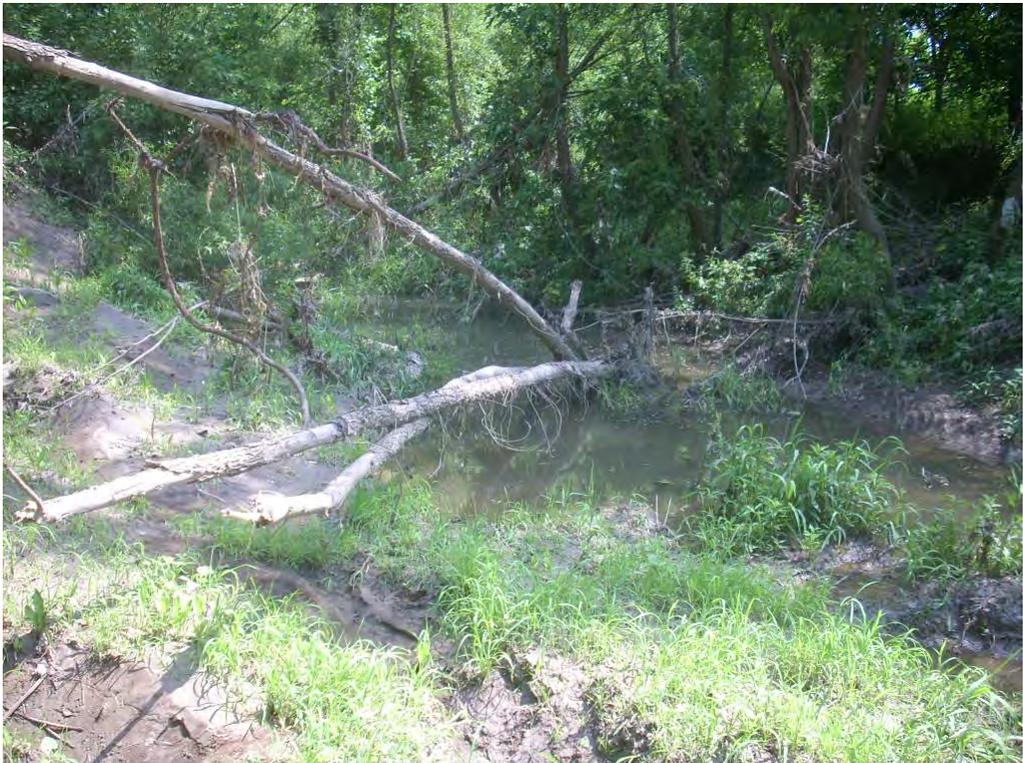
PHOTO #: 48

DATE: 06/25/2008	SITE NAME: Clear Fork Wetland & Stream Mitigation Bank
TAKEN BY: GW	
COMMENTS: Photo of agricultural drainage ditch created by previous landowner. View faces South.

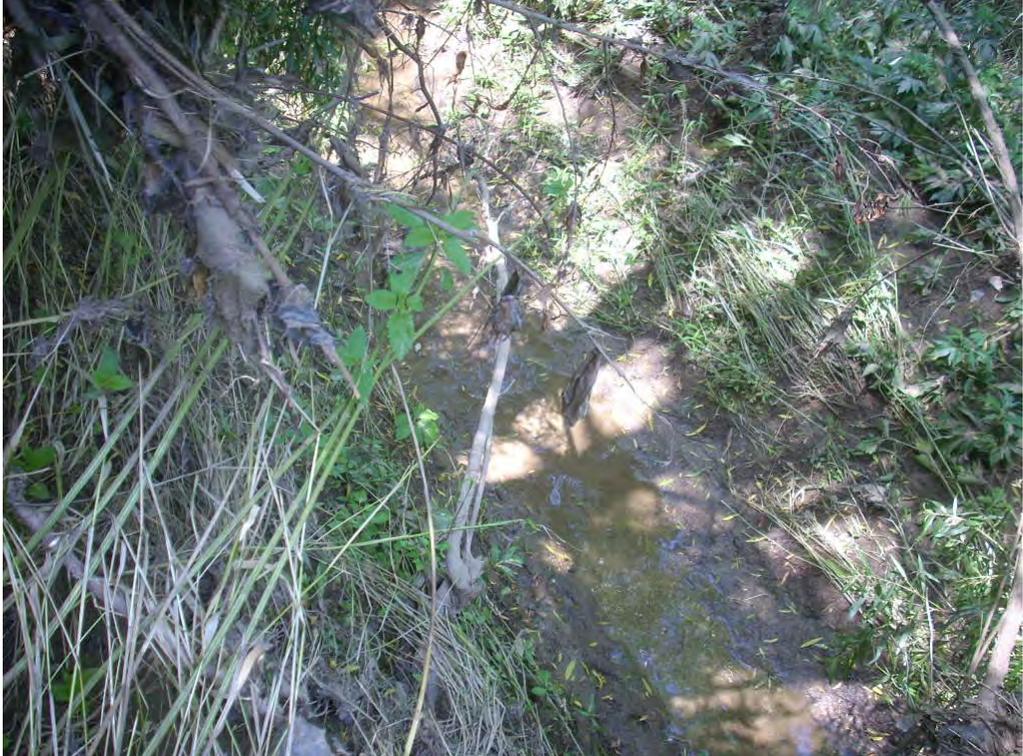
DATE: 06/25/2008	SITE NAME: Clear Fork Wetland & Stream Mitigation Bank
TAKEN BY: GW	
COMMENTS: Photo of cut-off ditch emptying into Intermittent # 5. View faces West.

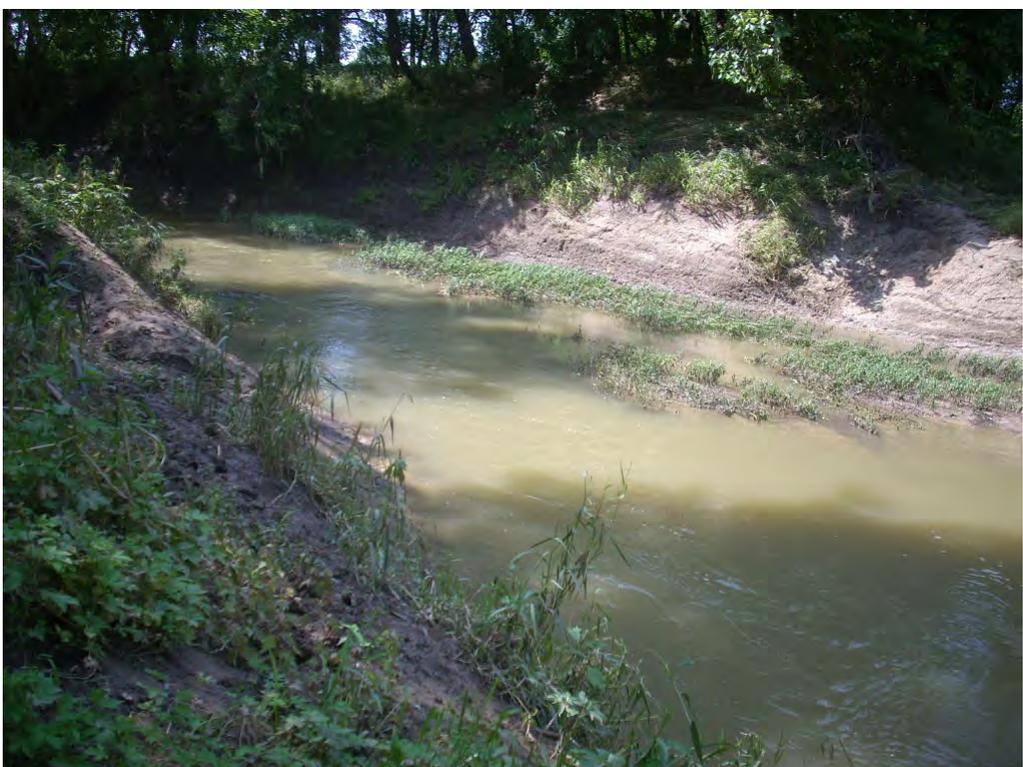
PHOTO #: 49

DATE: 06/25/2008	SITE NAME: Clear Fork Wetland & Stream Mitigation Bank
TAKEN BY: GW	
COMMENTS: Photo of the confluence of Intermittent # 5 with Clear Fork. View faces Southwest.

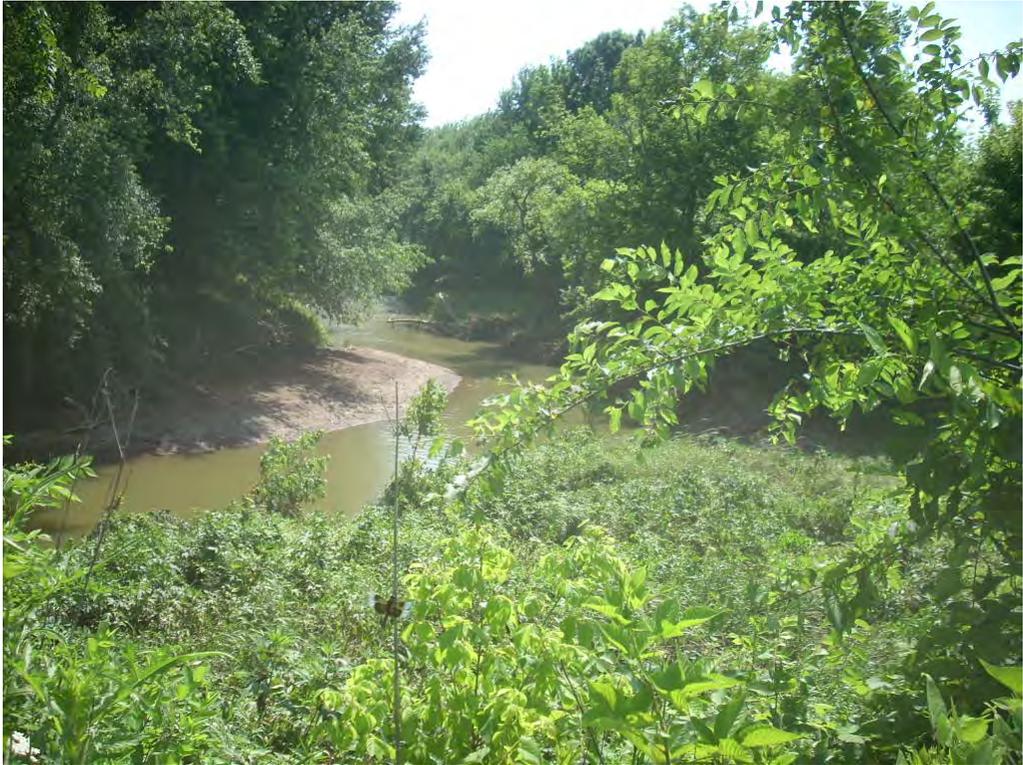
PHOTO #: 50

DATE: 06/25/2008	SITE NAME: Clear Fork Wetland & Stream Mitigation Bank
TAKEN BY: GW	
COMMENTS: Photo of confluence of drainage ditch with Clear Fork. View faces Southwest.

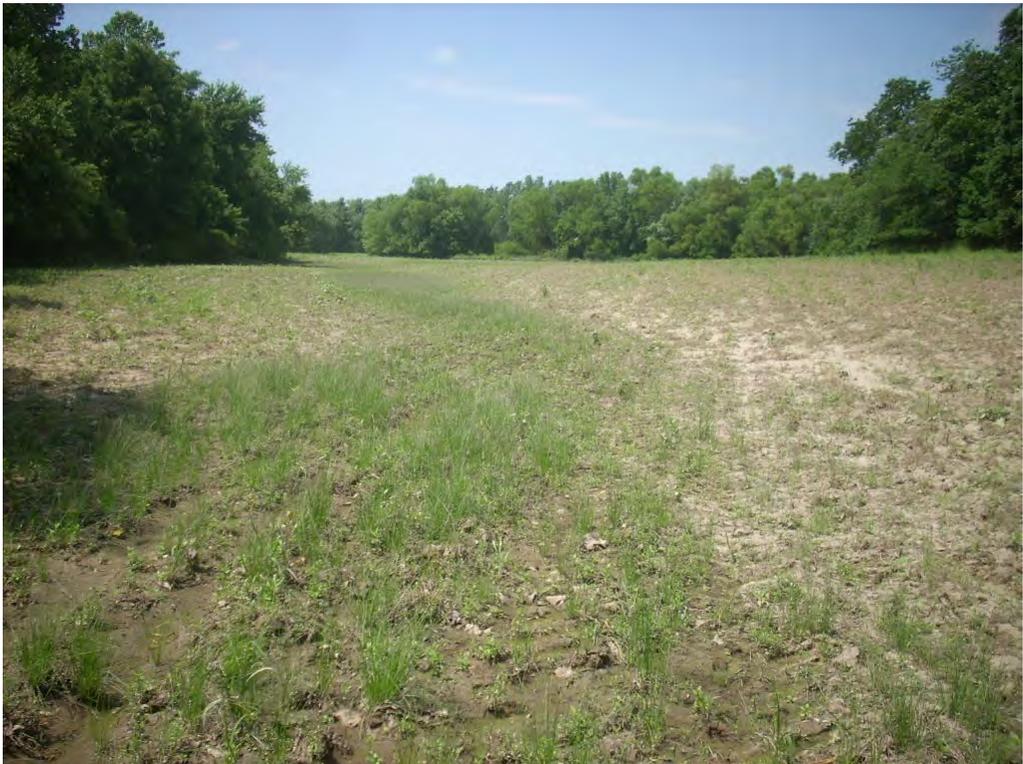
PHOTO #: 51

DATE: 06/25/2008	SITE NAME: Clear Fork Wetland & Stream Mitigation Bank
TAKEN BY: GW	
COMMENTS: Photo of farmed Wetland # 26. View faces Southwest.

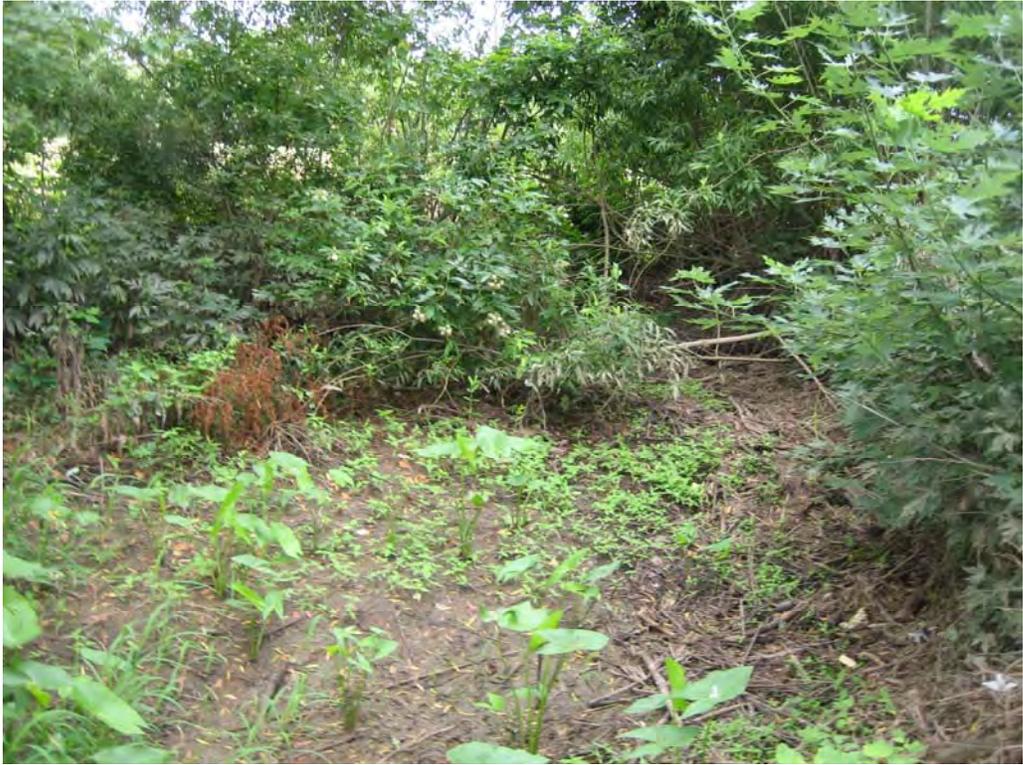
PHOTO #: 52

DATE: 06/25/2008	SITE NAME: Clear Fork Wetland & Stream Mitigation Bank
TAKEN BY: GW	
COMMENTS: Photo of forested Wetland # 27. View faces Southwest.

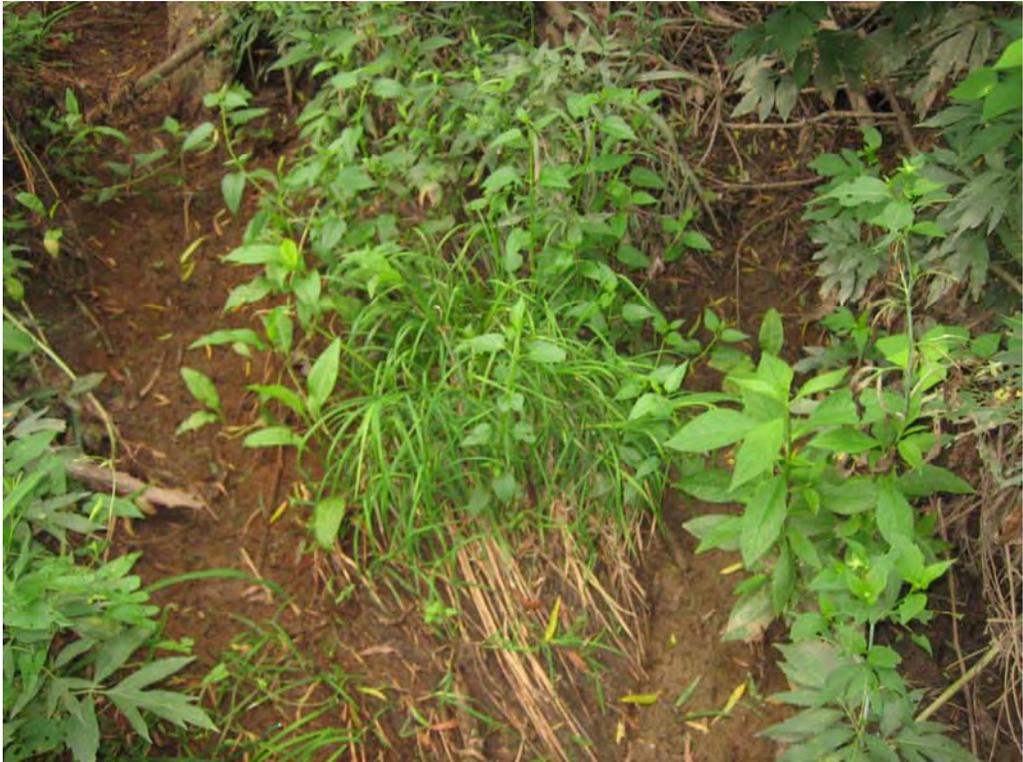
PHOTO #: 54

DATE: 06/25/2008	SITE NAME: Clear Fork Wetland & Stream Mitigation Bank
TAKEN BY: GW	
COMMENTS: Photo of confluence of Intermittent # 3 and 4. OHWM of I-4 averages 3 feet. View faces Southeast.

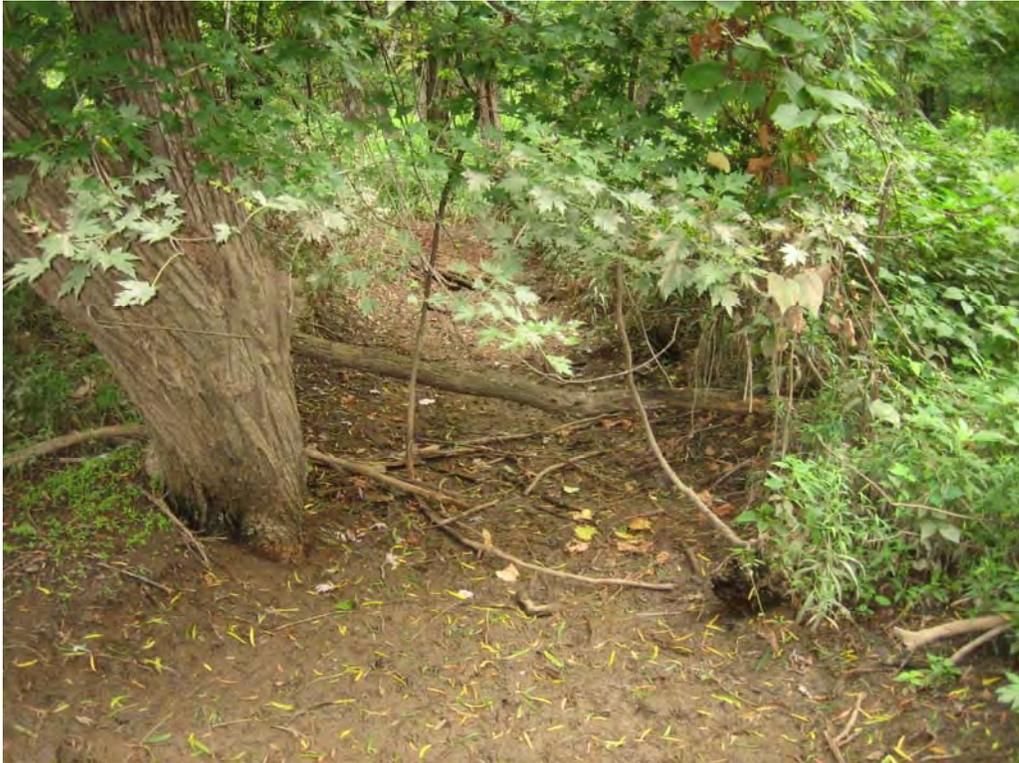
DATE: 06/25/2008	SITE NAME: Clear Fork Wetland & Stream Mitigation Bank
TAKEN BY: GW	
COMMENTS: Photo of Intermittent # 4 further upstream, near parcel boundary. View faces Northeast.

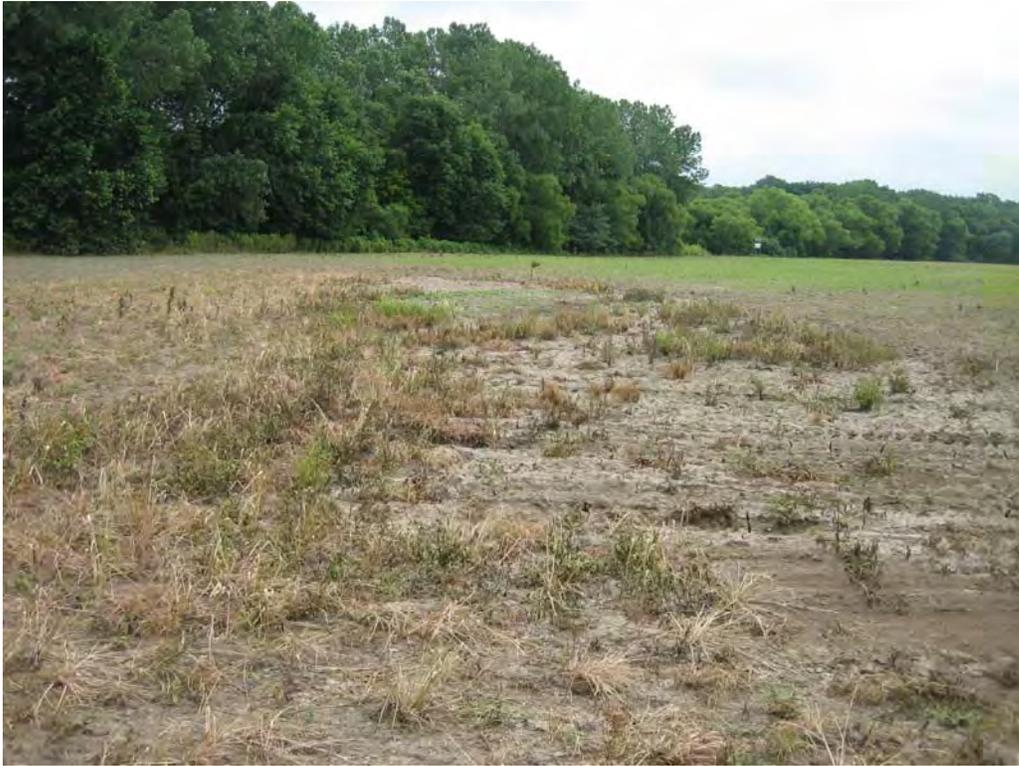
PHOTO #: 55

DATE: 06/25/2008	SITE NAME: Clear Fork Wetland & Stream Mitigation Bank
TAKEN BY: GW	
COMMENTS: Photo of farmed Wetland # 28. View faces North.

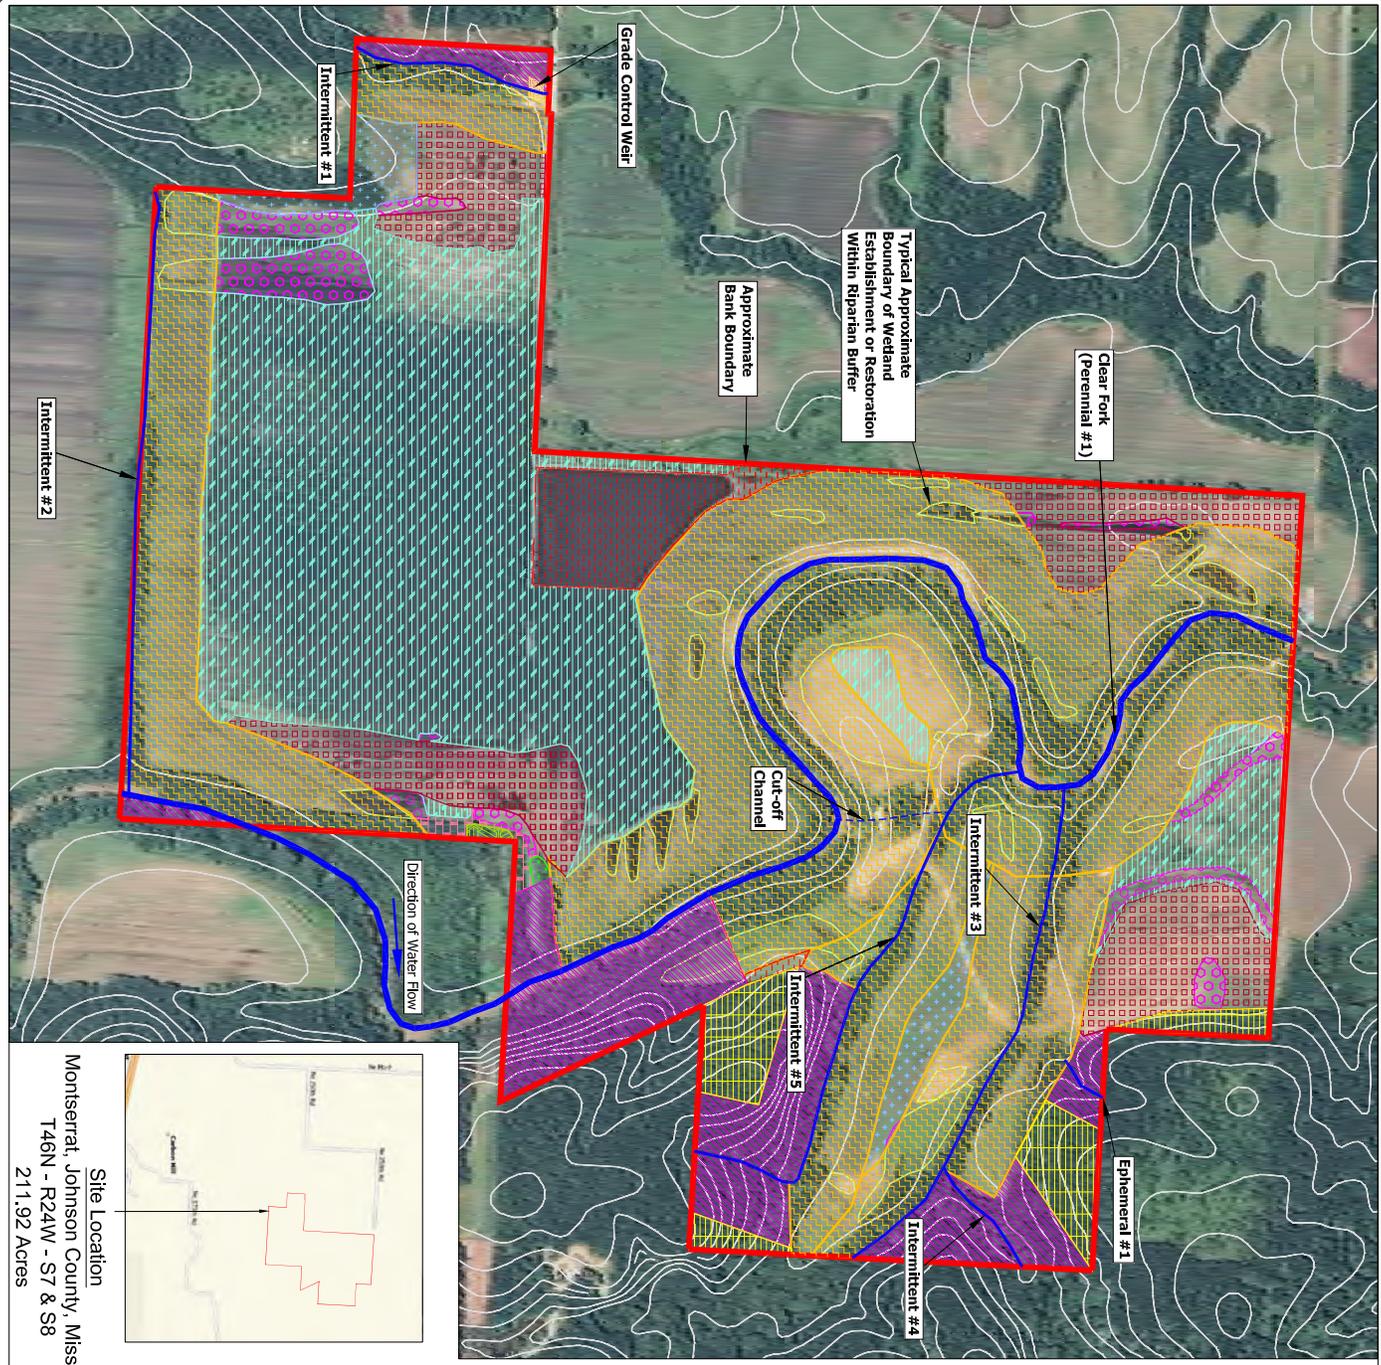
APPENDIX D
BANK DEVELOPMENT PLAN

Note: Wetlands Within a Riparian Buffer Are Counted Within The Acreage Total For Riparian Buffer Restoration or Riparian Buffer Enhancement And Are Not Proposed For Wetland Credit.
