**MARIES RIVER REGION
MODOT STREAM MITIGATION BANK
DRAFT PROSPECTUS**

Environmental Unit
Design Division

December 2009

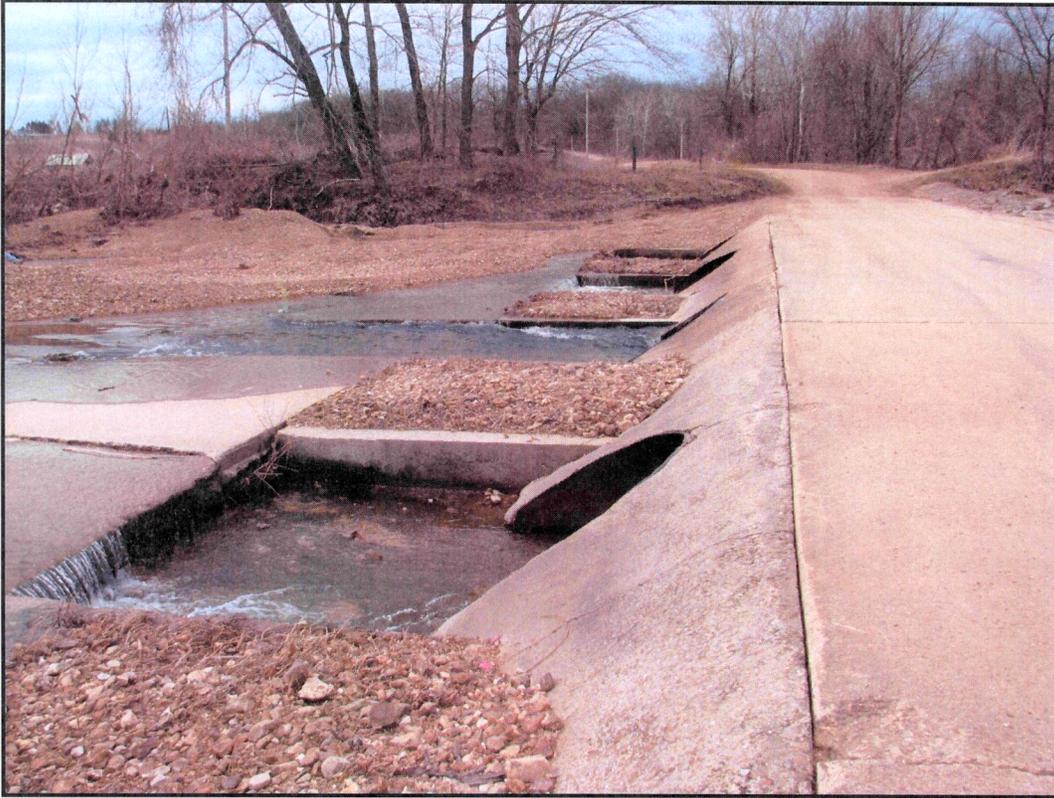
Photograph 1: Taken 2/9/09. Looking west at upstream side of Sestak's Slab.

Sestak Slab is a low water crossing with an older second crossing parallel to the newer crossing. This particular structure is a good candidate because there are strong numbers of Niangua darters downstream of the crossing. In order to restore stream function and habitat, MoDOT will be surveying the streambed upstream of the crossing and valley sections upstream and downstream of the crossing. These surveys will show changes in the streambed elevation and cross section. A uniform cross section does not have a lot of habitat diversity, whereas a varied cross section with a low flow channel has more diverse habitat. The Missouri Department of Conservation regularly monitors darter populations in the Maries River. This data can also be used to demonstrate habitat restoration.

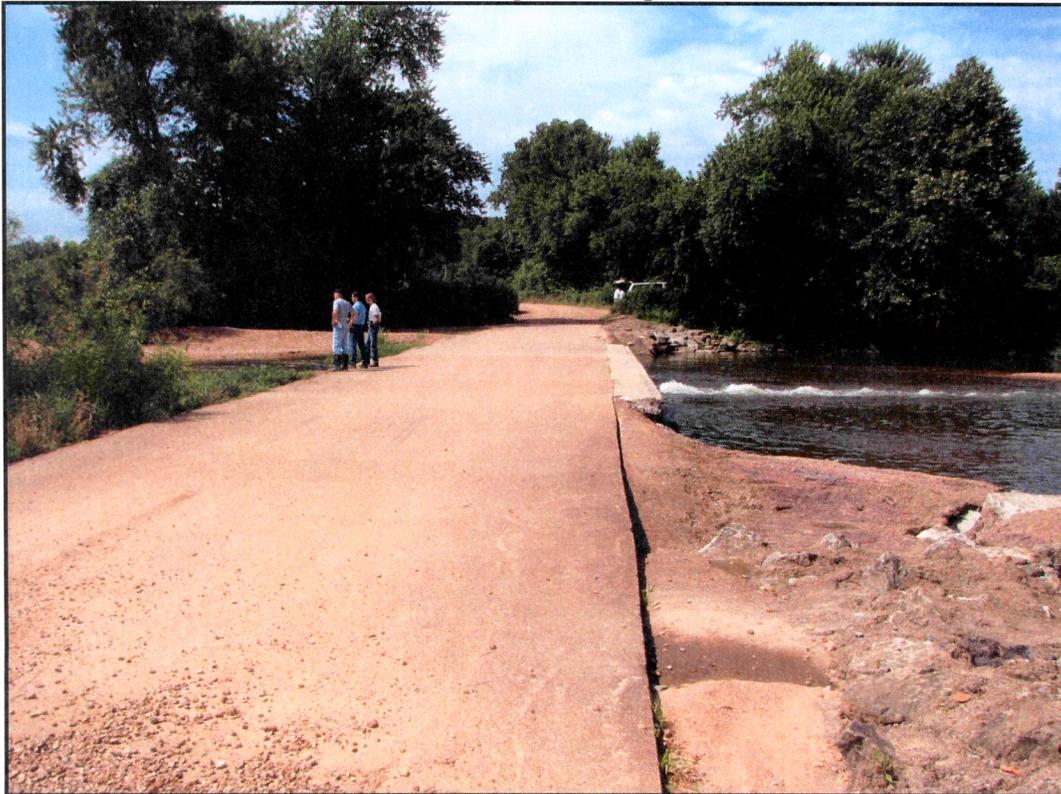
Photograph 2: Taken 7/16/09. Looking west at downstream side of Sestak's Slab.
