# Lower Missouri River Flood Risk and Resiliency System Plan

## Appendix A.1: Missouri River Past Performance Assessment

**December 2025**

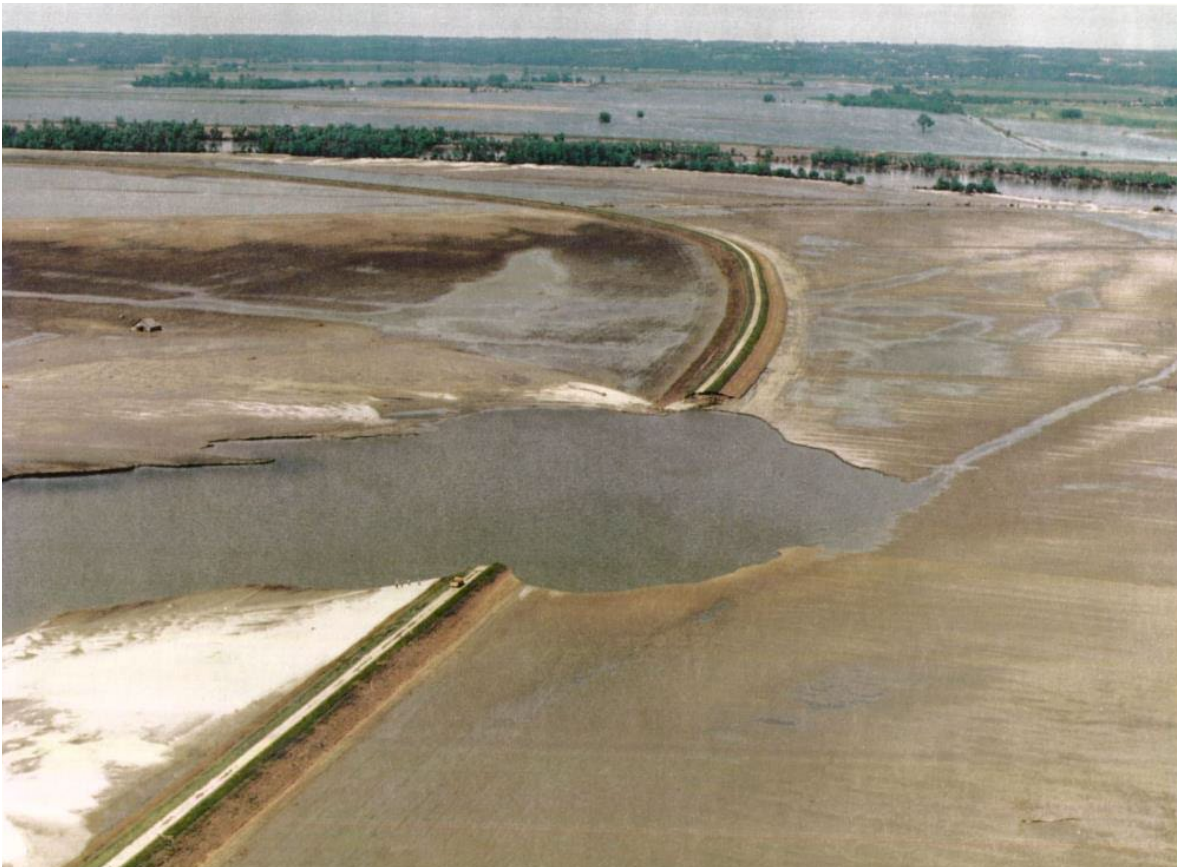
**Figure 3: Levee Breach at MRLS 471-460-R, Elwood, KS, 6 August 1993**

The 1993 post flood report (USACE, 1994) showed that the levees and reservoir system prevented an estimated \$4.57 billion in damages at the 1993-1994 price level. In Fiscal Year 2023 dollars, that figure would be \$12.37 billion. While flooding would have been much worse without the flood risk management projects in place, flood damages were still extensive. Flooding from this event caused major highways, bridges, and rail lines to be closed for long periods. All non-federal levee systems along the Missouri River were overtopped and breached, along with nine federal levee systems in the Kansas City District alone, resulting in the most extensive levee rehabilitation effort at that time. Until then, no other natural disaster in U.S. history affected or touched so many lives for so long a duration as did the Midwest Flood of 1993 (USACE, 1994). Figure 3 shows the overtopping breach on federal levee MRLS 471-460-R near Elwood, KS.

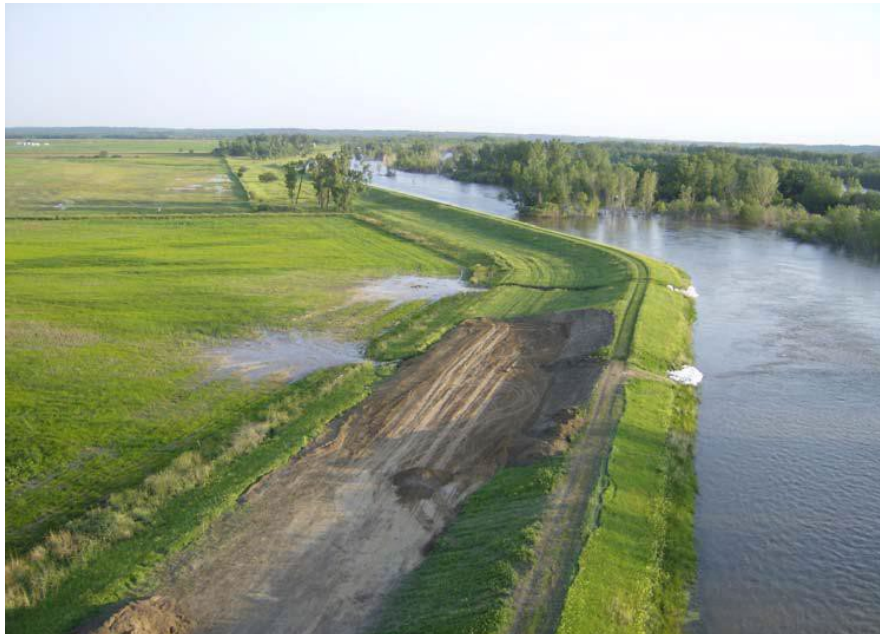
**Figure 4: Damaged Levee along the Missouri River L-575 Levee System near Hamburg, IA  
(Photo taken June 2011, USACE Omaha District)**

The long duration of the 2011 flood subjected both federal and non-federal levees along the Missouri River to months of hydraulic loading, resulting in seepage and erosions issues and breaches even when the levees did not overtop. All told, the event caused moderate to extensive damage to roughly 75 federal levees (and many more non-federal levees) within the basin due to overtopping, erosion, and under seepage. In addition to damages to the levees, the long duration of high flows caused significant damage to river channel training structures, such as dikes and revetments constructed to maintain the navigation channel. These high flows caused both erosion and sediment deposition at different locations along the Lower Missouri, most notably seen in the floodplains that experienced levee breaches (Figure 4 and Figure 5). New channels were scoured, and several feet of sand deposited in the same general area. Recreation areas, boat ramps and marinas, fish and wildlife habitats, and historic Tribal sites along the river channel were also impacted in many locations by the 2011 flood.

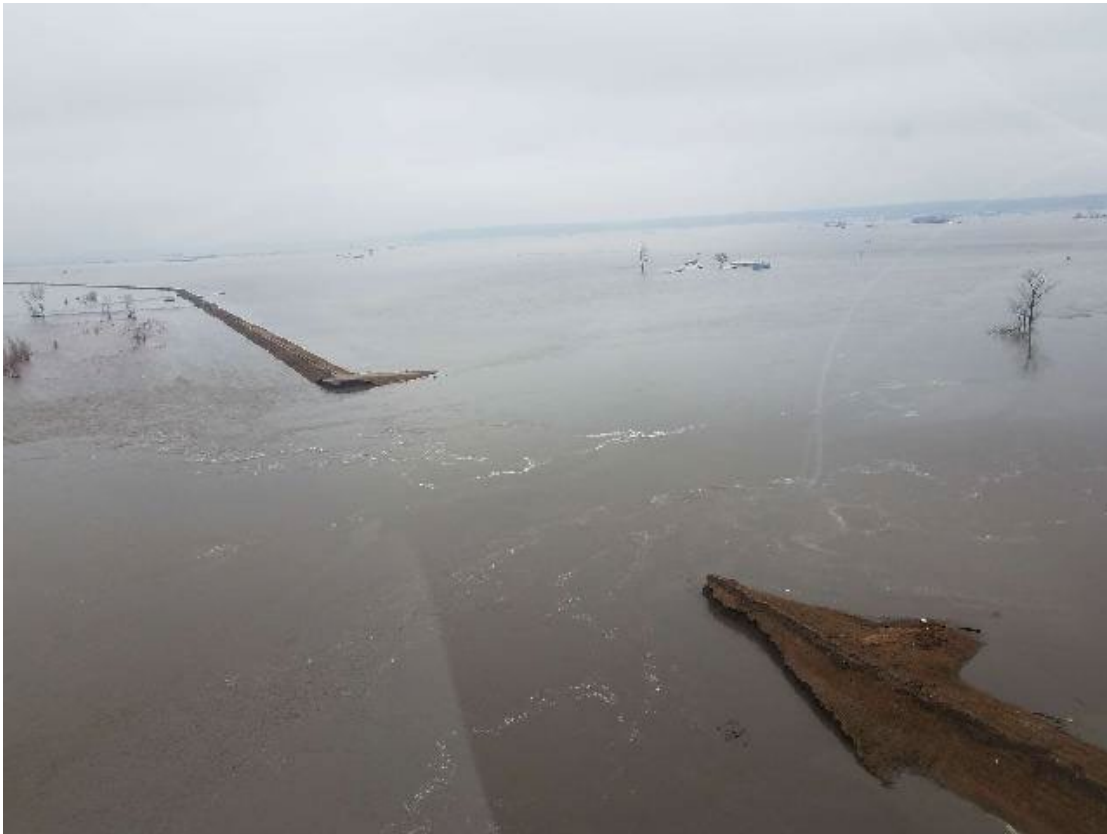
**Figure 6: Levee Breach along the Missouri River L-575 Levee System near Hamburg, IA  
(Photo taken March 2019, USACE Omaha District).**

As a result of the flooding, 36 federal and active non-federal levee systems were damaged or breached during the March Bomb Cyclone event in the Omaha District area of operations. Of those, 31 were active in the Rehabilitation Program and were eligible for repair assistance. In the Kansas City District, 14 active non-federal levee systems, all upstream of Kansas City, were overtopped and breached in March. All were eligible for repair assistance through the Rehabilitation Program.

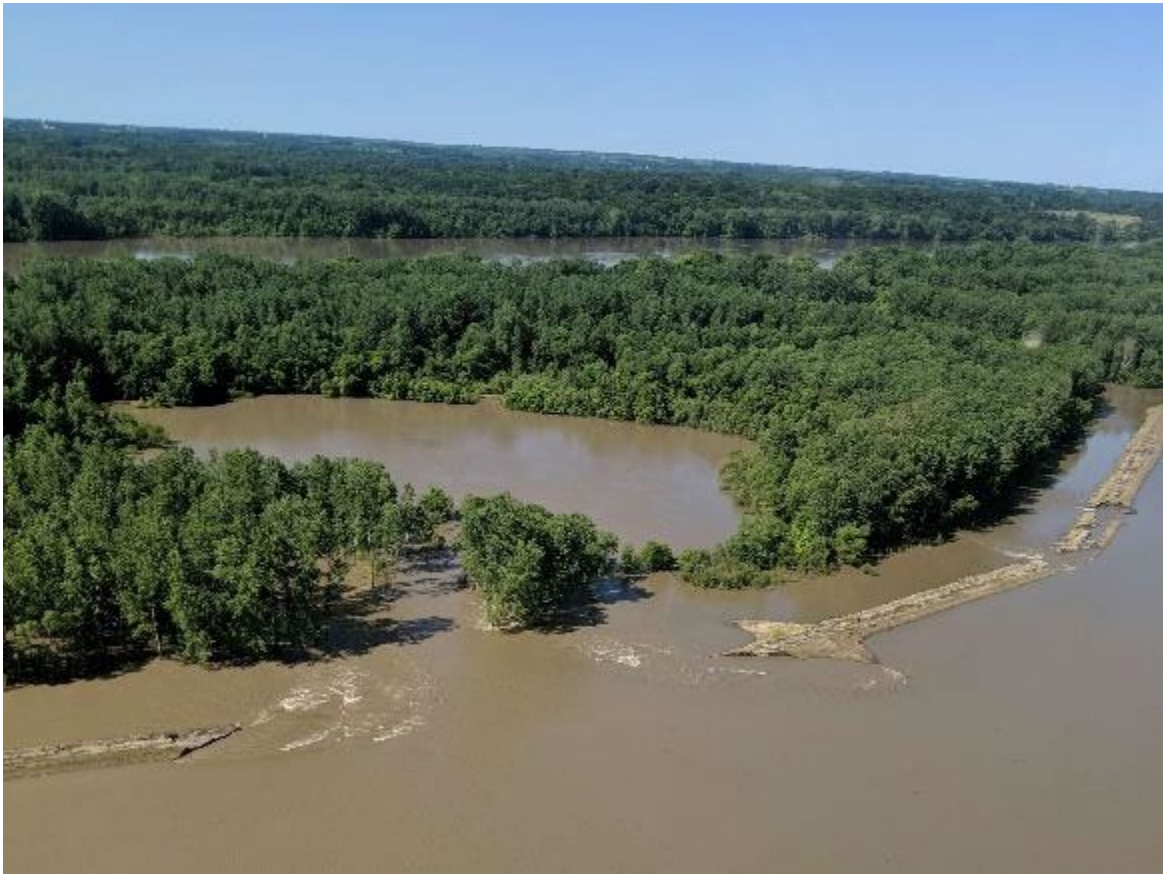
**Figure 7: MRLS 246-L Levee System in Chariton County, MO was Breached at Five Locations 2019. (Photo taken June 2019, USACE Kansas City District).**

In the Kansas City District, extended high upper basin runoff combined with record setting local rainfall resulted in a second peak event. The month of May included record amounts of rainfall across the Kansas River Basin where 10 to 15 inches of widespread rainfall occurred within the Kansas City District's area of responsibility (AOR). According to the Kansas State University May 2019 Kansas Climate Summary, May was recorded as the wettest May in Kansas since 1895 with a state-wide average precipitation of 10.26 inches. Fifteen to 20 inches of precipitation was also documented within the Grand River Basin in Missouri for the month of May. Beginning May 22 and extending into June, 51 levee systems were overtopped or overtopped and subsequently breached along the Grand River and Missouri River between Kansas City and Herman, MO. Fifty of those were active non-federal levees and one was federal levee MRLS 246-L shown in Figure 7. In total, 65 levees overtopped and 45 levees breached within the Kansas City District area of operations during the 2019 flood event.

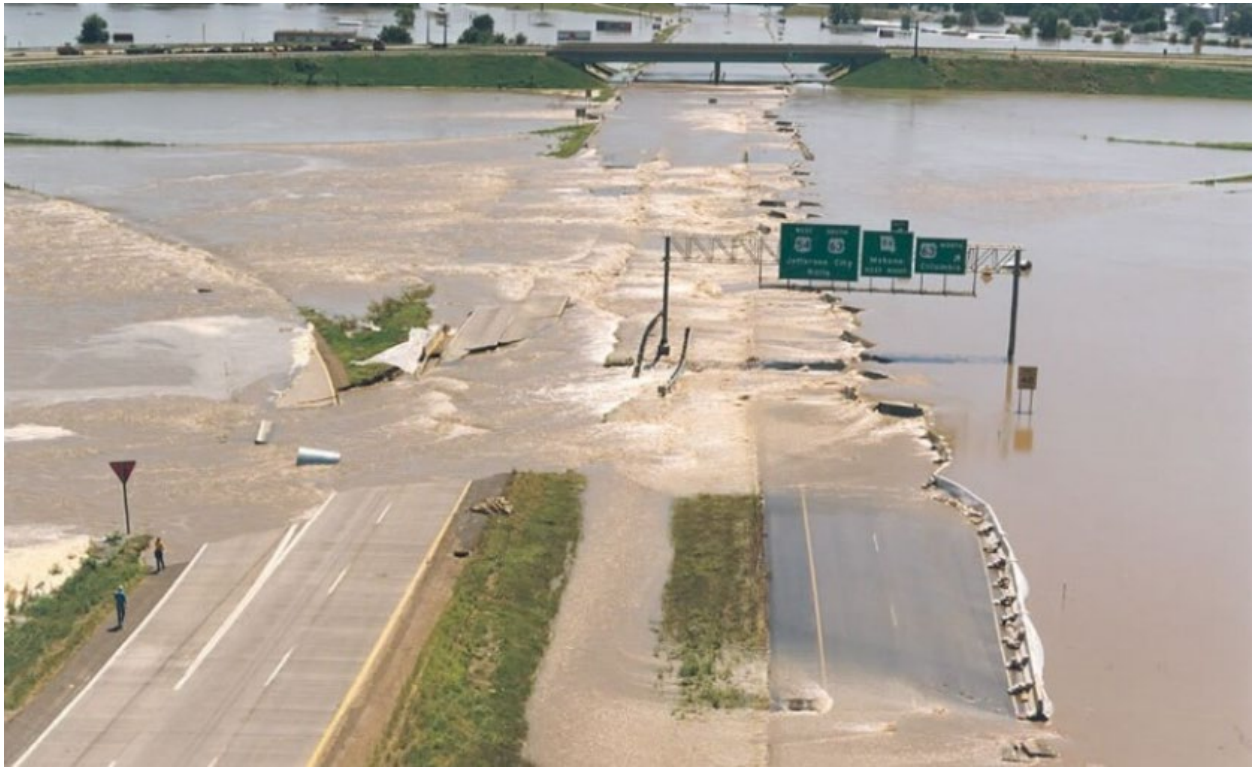
**Figure 19: Route 54 Overtopping in 1993**

In this reach, the Capital View Drainage District leveed area has the most development. While most of Jefferson City's population is on the right bank of the river on the bluff, there is housing, development, and the Jefferson City Municipal Airport on the left bank within the Capital View leveed area. The Capital View leveed area fills up like a bathtub when the levee overtops. Capital View levee overtopped and breached in 1993, 1995, and 2019. US Route 54 is a major route that crosses the Missouri River at Jefferson City connecting North Jefferson City, as well as Columbia, to Jefferson City and to the Lake of the Ozarks. The Lake of the Ozarks is the largest man-made non-flood control lake in the United States and draws in millions of visitors each summer. The 1993 flood overtopped US Hwy 54 causing significant damage and traffic impacts as seen in Figure 19. The lanes were raised after the 1993 flood and in 2019 water was within a few feet of requiring closure of the road.
