Chapter A-8

GEOTECHNICAL ANALYSIS FAIRFAX-JERSEY CREEK (JERSEY CREEK SHEET PILE WALL)

A-8.1 INTRODUCTION

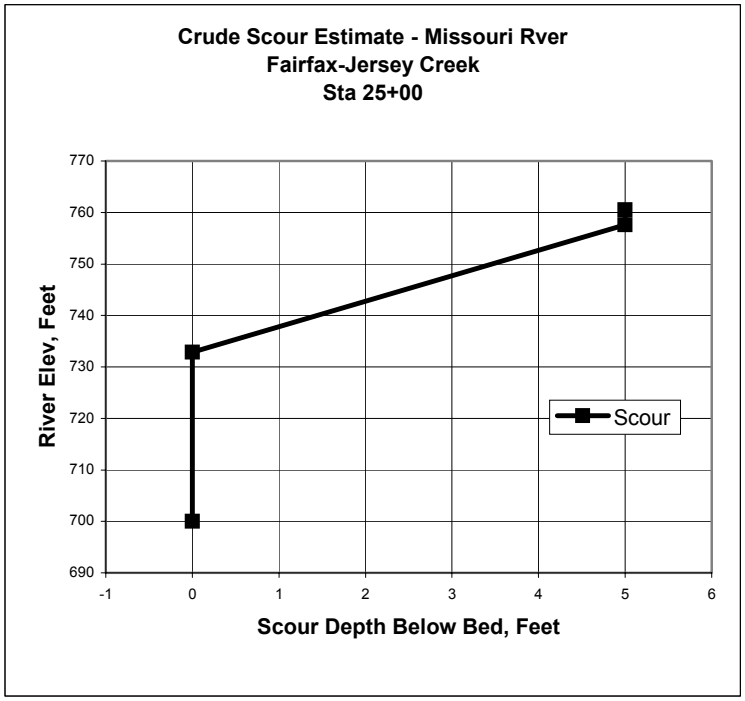
EXHIBIT A-8.1
River Scour Relationship

The scour relationship developed for this study used no scour for the 2-year river stage. A value of 5 feet was used for river stage representing a major flood event. For this reach of the river, the relationship is shown on Exhibits A-8.1 and A-8.19.

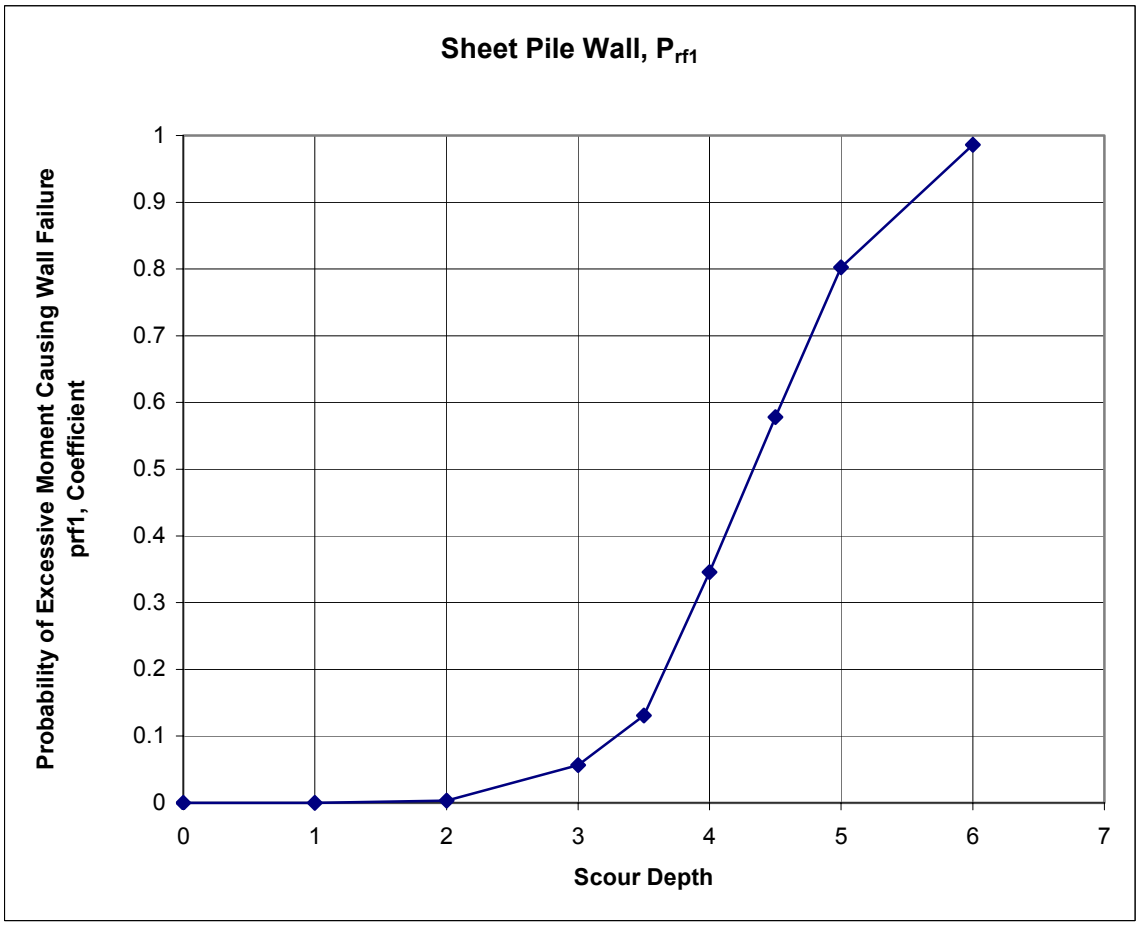
EXHIBIT A-8.2
Probability of Wall Failure, P_{rf1}
Versus River Bed Scour

The sheet pile wall was reported to have lost tieback support. This condition creates a cantilever wall condition. A cantilever wall remains stable only as long as passive resistance exceeds the driving forces on the wall. The horizontal force and moment equilibrium was considered to determine the stability of the wall for the existing conditions. The analysis was also done for incremental increases in the scour riverside of the retaining wall. An excel spreadsheet was designed to model the wall stability analysis. The spreadsheet was developed using a simple cantilever support analysis.

The soils and geometry of the slopes and water level in the bank landward of the retaining wall were used to develop the expected active earth forces on the retaining wall. The water level, soil materials and riverbed location riverward of the sheet pile retaining wall were used to determine the passive resistance below the embedment of the sheet pile retaining wall. The horizontal forces were determined and compared to model the reliability of the riverside soil to resist the horizontal movement of the wall. The driving and resisting horizontal force locations were used to determine the moment about the bottom of the wall to model the reliability of the overturning resistance. Net pressures were calculated along the wall and used in the model. A model using Taylor's series was added to develop the reliability of the wall using mean values of the soil strength parameter and unit weight parameters. The resulting reliability of the wall system was developed for scour values ranging from 0 feet at the 2-year river level stage to a scour of 5 feet representing the rare flood occurrence. The results of these spreadsheet analyses are presented in Exhibits A-8.20 through A-8.22, A-8.29 through A-8.30, and A-8.37 through A-8.38 of the Supplemental Exhibits section. The reliability of the wall appears to be questionable above the 100-year river level. The probability of a sheet pile wall failure was determined for this condition and defined as p_{rf1}.

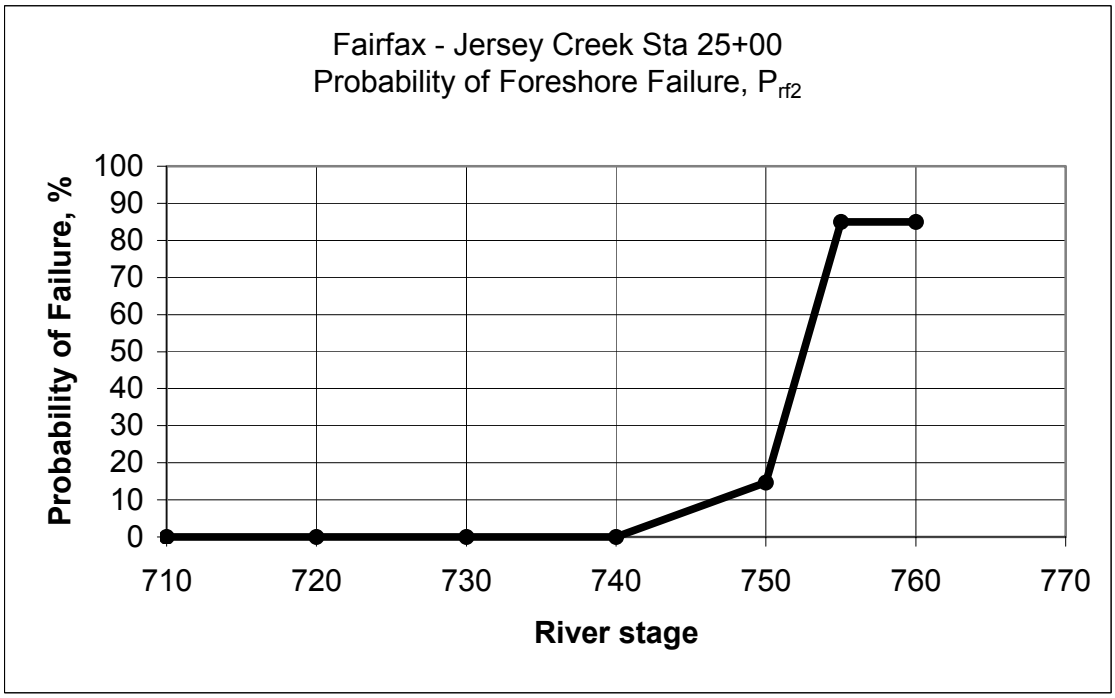
EXHIBIT A-8.3
Probability of Foreshore Failure, P_{rf2}
Versus River Elevation

Global slope stability calculations were performed and a summary of the results is provided in Exhibits A-8.23 through A-8.25, A-8.31 through A-8.33 in the Supplemental Exhibits section. The analysis provides a probability of failure of the first loss of foreshore bank after failure of the sheet pile retaining wall. The probability of the foreshore failure was determined for this condition and defined as p_{rf2}. The following graph displays the results of the probability of failure of the foreshore once the sheet pile wall fails for rising river levels.

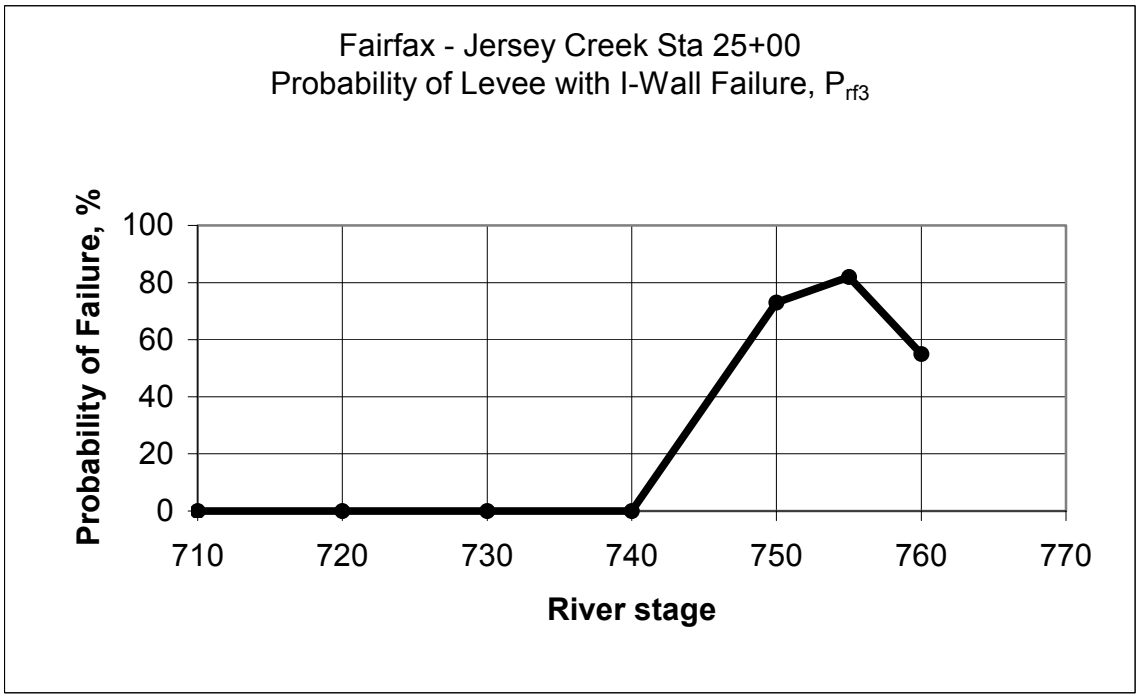
EXHIBIT A-8.4
Probability of Levee with I-Wall Failure
P_{rf3} Versus River Elevation

If the foreshore bank is lost during a flood event, the remaining bank with levee and I-wall is weakened and exposed to additional velocity scour. A revision in the geometry of the foreshore was modeled to reflect only the loss of the foreshore. Additional scour of the foundation was not modeled although it is felt additional scour will occur. The previous foreshore slide was removed from the input file for UTEXAS4. The river elevation and foundation pressures were revised to model the loss of the foreshore. A new search was made for the most critical reasonable slide that would cause loss of the levee with I-wall section. The critical section was modeled for reliability using Taylor's series with mean values and standard deviations as shown in Table A-8.5. The results of the reliability of this section and summary of these results are presented in Exhibits A-8.26 through A-8.28 and A-8.34 through A-8.36 in the Supplemental Exhibits section. The probability of the levee with I-wall bank failure was determined for this condition and defined as p_{rf3}. The following graph displays the results of the probability of failure of the foreshore once the sheet pile wall fails for rising river levels.

The drop in the probability of failure beyond river elevation can be attributed to the increase in river level providing a lateral surcharge on the section and that no additional scour of the section has been modeled for the elevations above 755 feet.

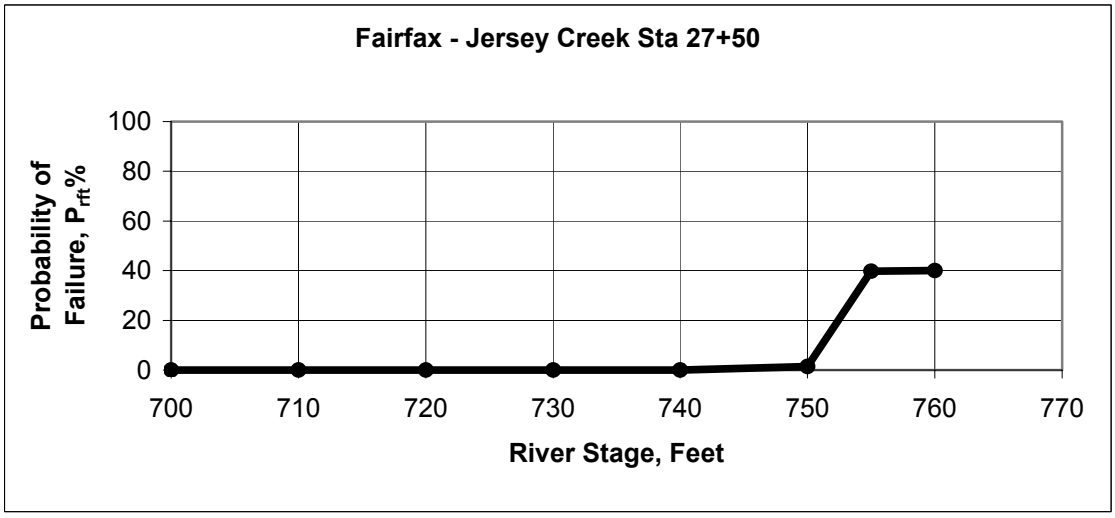
EXHIBIT A-8.5
Probability of Failure for Levee
Section 27+50 P_{rft} Versus River Elevation

The relationship of the reliability was developed for incremental increases in the river level. This information was provided to the economist on the project team for use in the HEC-FDA model. A schematic summary is provided in Exhibit A-8.18 in the Supplemental Exhibits section. The following graph displays the results of the probability of failure of the section 27+50 for rising river levels. The analysis indicates

a geotechnical reliability of only 60% once the river stage reached the top of the flood protection.

It should be noted that if the foundation soils riverside of the sheet pile foundations that support the flood wall on top of the levee are removed by scour, the individual probability of failure of the floodwall is increased. This has not been considered in the analysis.

There exists a sufficient risk of levee and I-wall failure to consider design solutions for the existing condition that would strengthen this portion of the Fairfax-Jersey Creek levee unit. The solutions considered include flood fighting, closed cell sheet piling protection, tied back auger cast pile retaining wall and an open cell cofferdam sheet pile system.

The recommended solution for strengthening this reach of the Fairfax-Jersey Creek flood protection unit is the use of a driven sheet pile system without reliance on tieback anchors. The open cell appears as the most economical solution. The solution is based on an estimate that includes a proprietary design cost. The project design team considered the best solution as some type of driven sheet pile wall system with adequate penetration to prevent pull out with the use of tieback anchors. Early efforts during preparation of plans and specifications will pursue a nonproprietary economical design solution.

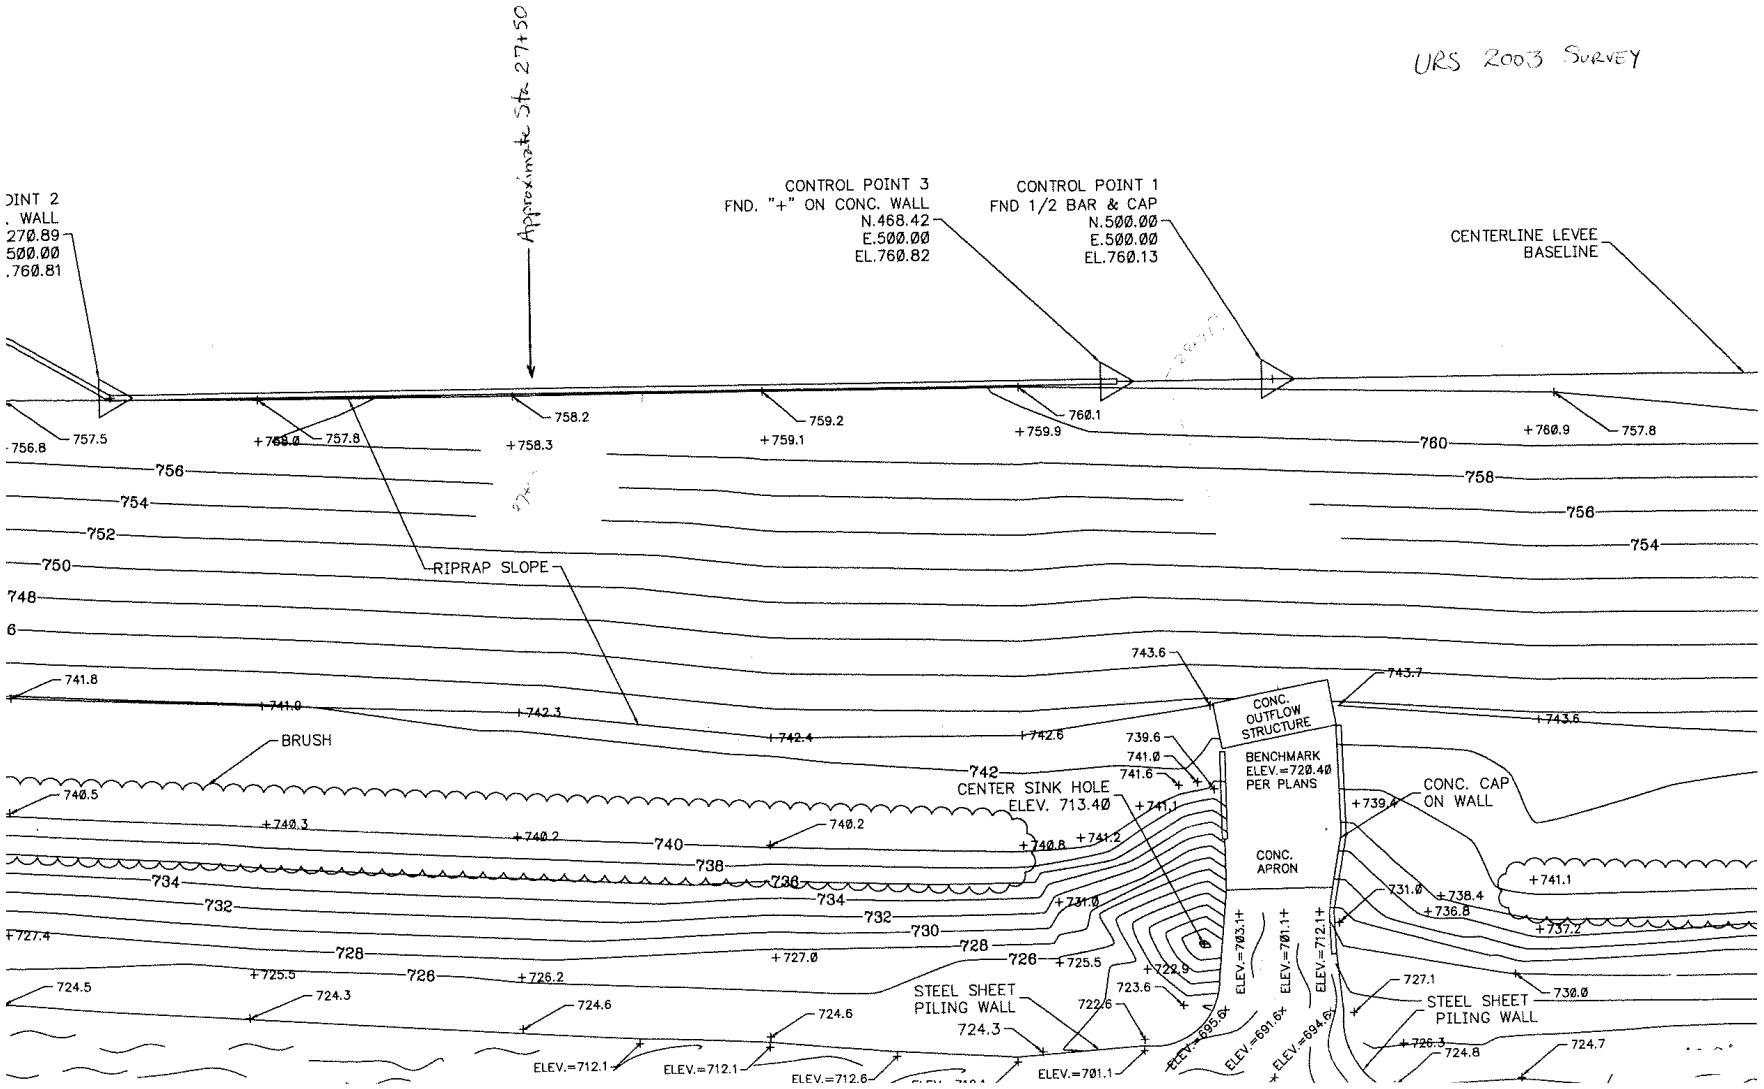
EXHIBIT A-8.16
Survey of Station 27+50 Area

An existing sheet pile wall supports the riverside foreshore. The as-built drawings for the reach from Station 23+30.6 to Station 29+98.9 indicate an original cross section with the top of the levee near elevation 755 feet (see Exhibit A-8.6). The riverside slope is shown as 1.0 vertical to 3.5 horizontal. This slope extended down to elevation 724 feet. The 1.0 vertical on 3.5 horizontal slope was originally supported by a

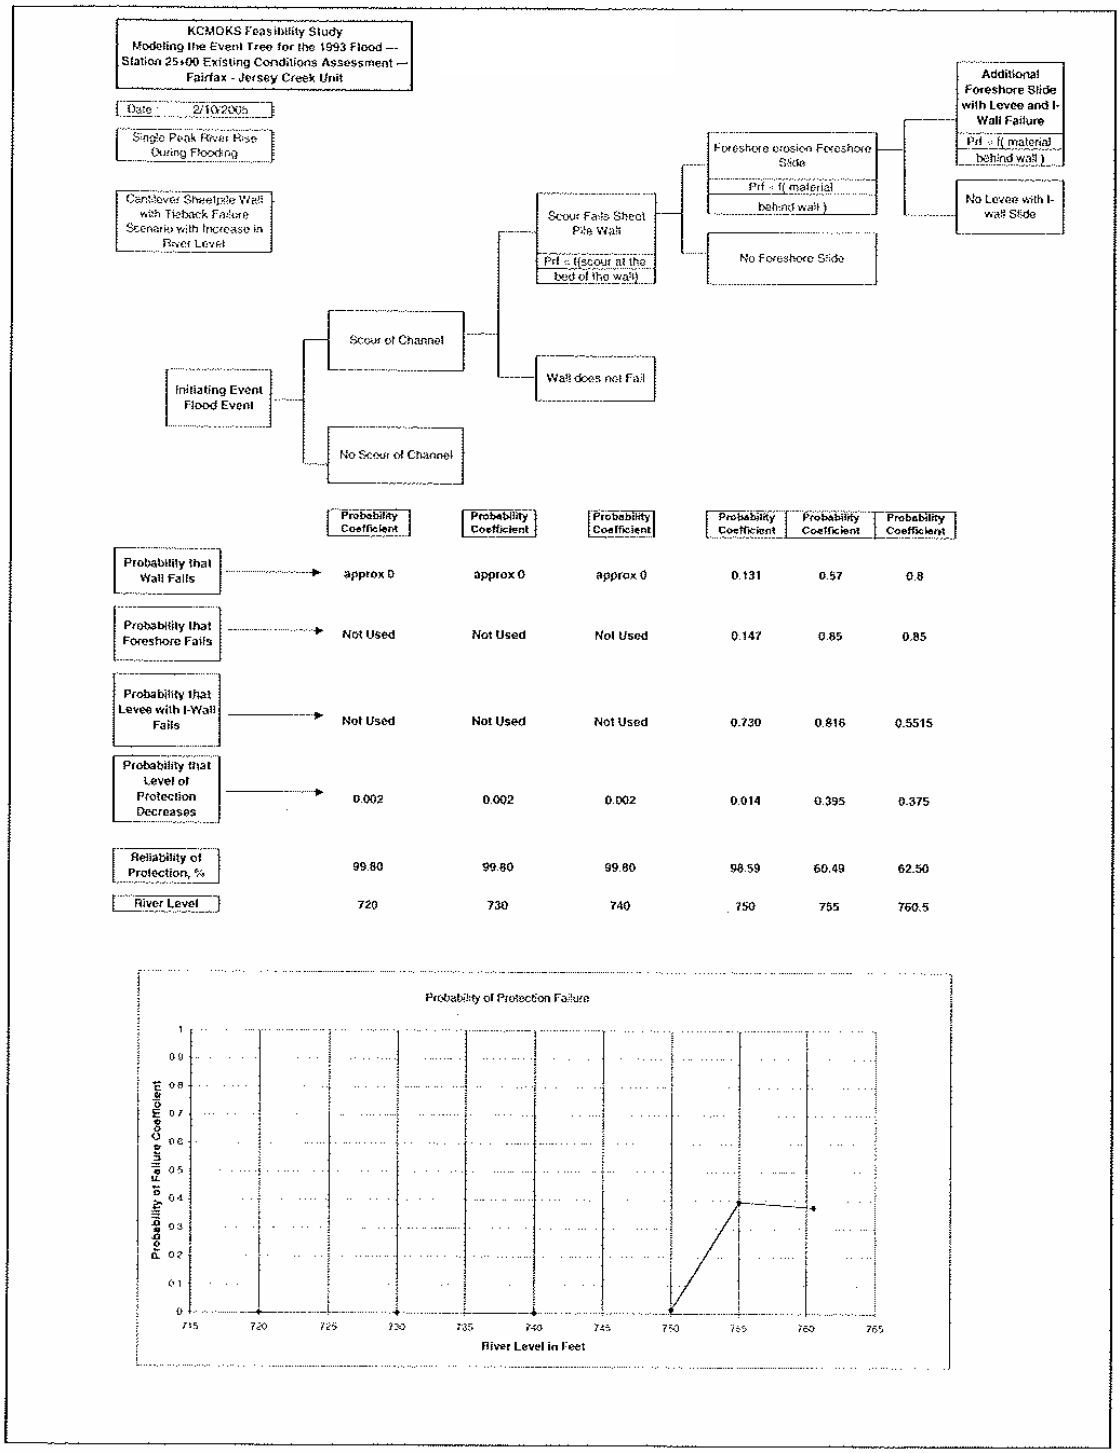
EXHIBIT A-8.18
Schematic of Failure Model

The failure of the Station 27+50 section could occur if a consecutive sequence of failure events occurs. This sequence of failure events would consist of 1) loss of the retaining wall due to loss of soils riverside caused by degradation of the channel and velocity scour, 2) loss of the riverside foreshore bank due to velocity scour leading to global instability, and 3) subsequent loss of levee and I-wall flood protection due to continued velocity scour causing additional global instability. The overall reliability is modeled using 3 failure mechanisms combined in parallel to evaluate the damages incurred for various high water stages, sheet pile wall failure, foreshore instability, and levee with I-wall bank instability. The failure is triggered by velocity scour and channel degradation. A schematic of the model with reliability analysis results is provided on Exhibit A-8.18.

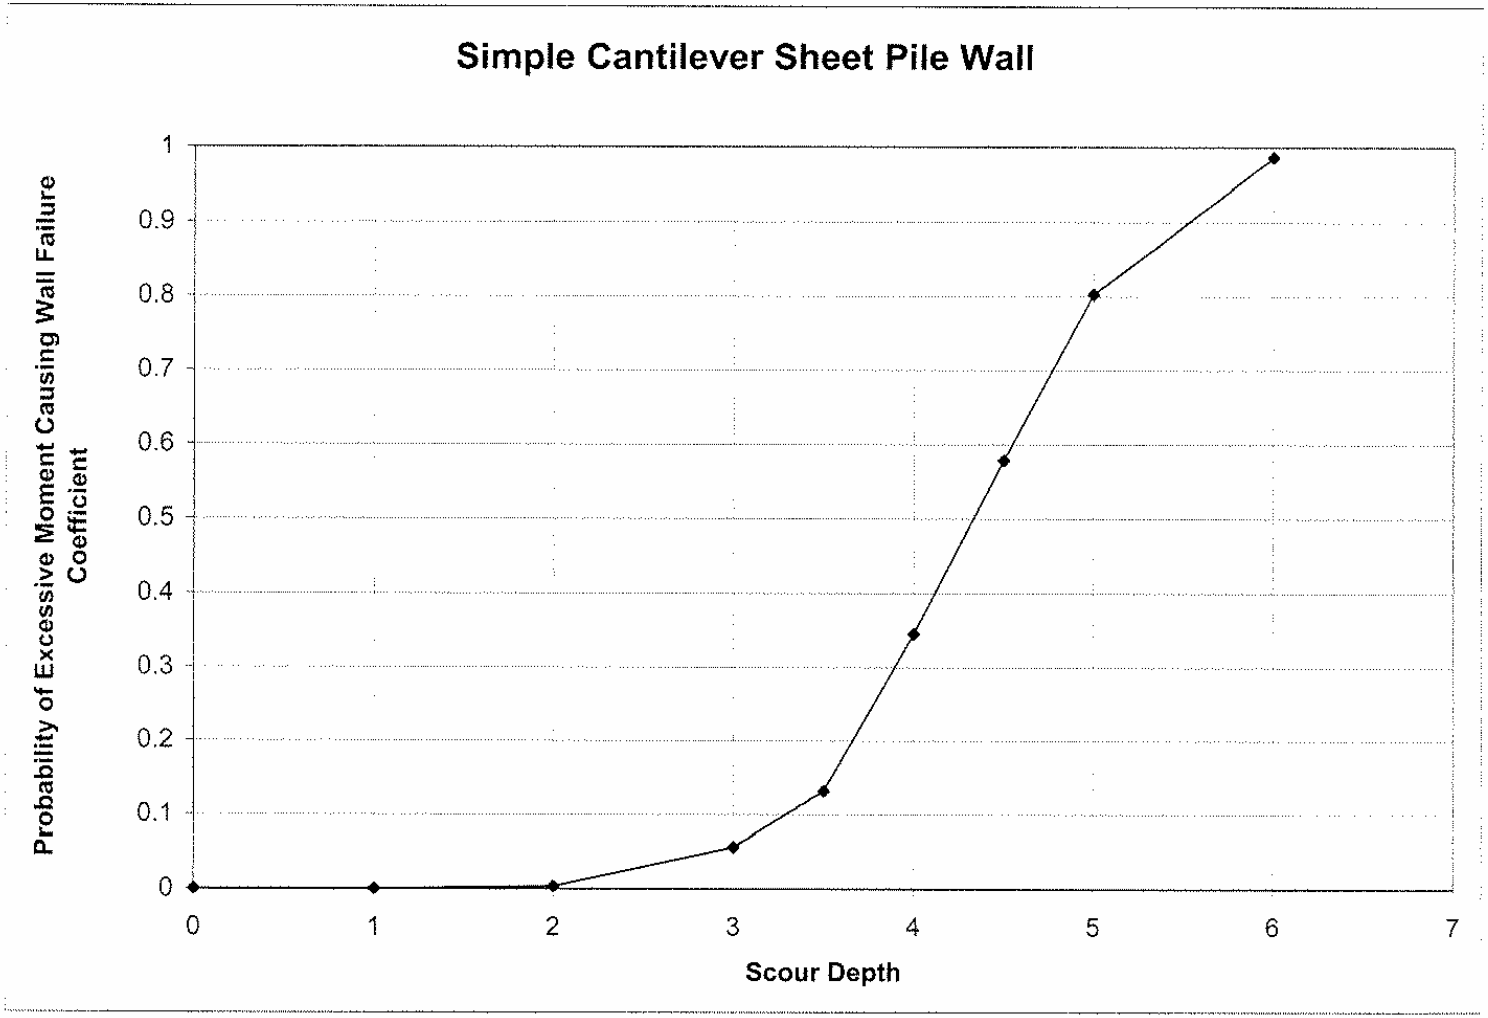
EXHIBIT A-8.20
Probability of Excessive Moment for Simple Cantilever Wall vs. Bed Scour

2) The wall will fail if scouring at the toe removes materials below the existing bed. (p1)

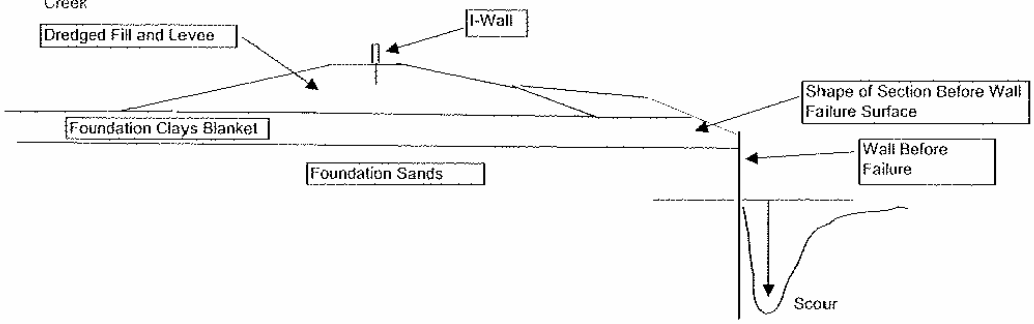
EXHIBIT A-8.21
Summary of Probability of Flood Protection Failure
Station 25+00 for River Elevation 750 Feet

Event	Prob of Failure	
	Scour potential	1	(scour :3.5 feet)
(p1)	Wall failure (p1) =	0.131	
(p2)	Foreshore slide (p2)=	0.1470	Loss of bank - progressive erosion/slouging
(p3)	Levee Slide (p3) =	0.725	
	Reliability of reach =		1-p1*p2*p3

0.1310	*	0.1470	*	0.7250	=	0.9860
Reliability	=	1.00	-	0.9860	=	**1.40%**

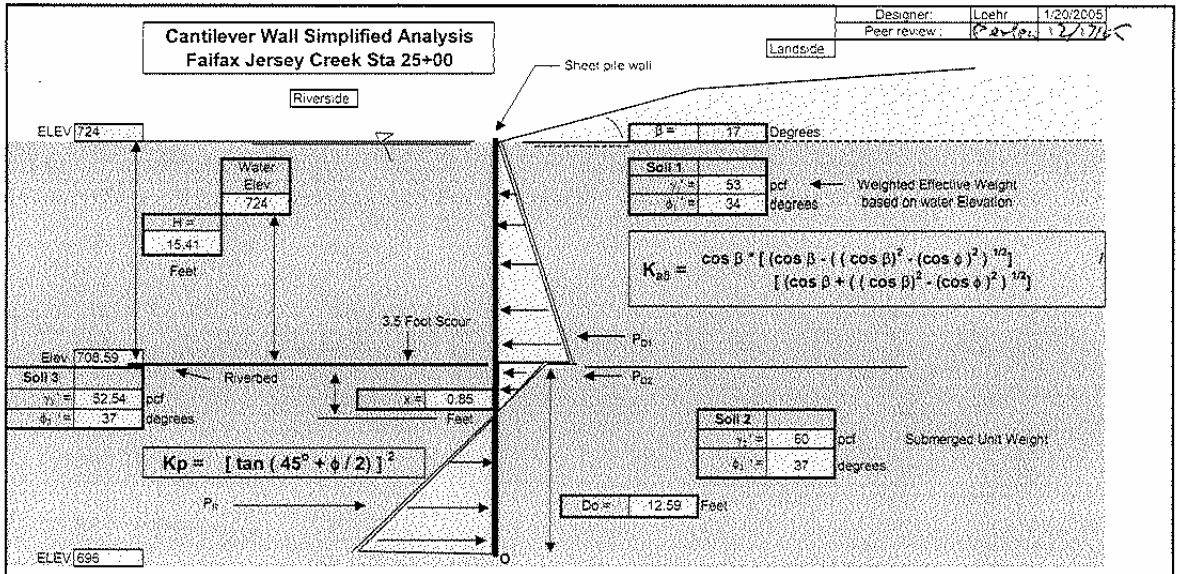
EXHIBIT A-8.22
Simple Cantilever Wall Model for River Elevation of 750 Feet

The Force and the Moment functions are dependent on the friction angle, the unit weight of the materials. These material properties will be assumed to be independent variables with mean and standard deviation values. Taylors Series can be used to determine the first order single moment about the mean values using one standard deviation. The capacity will be compared to the demand to determine the amount of risk for failure of the wall system modeled above given the geometrical dimensions shown.

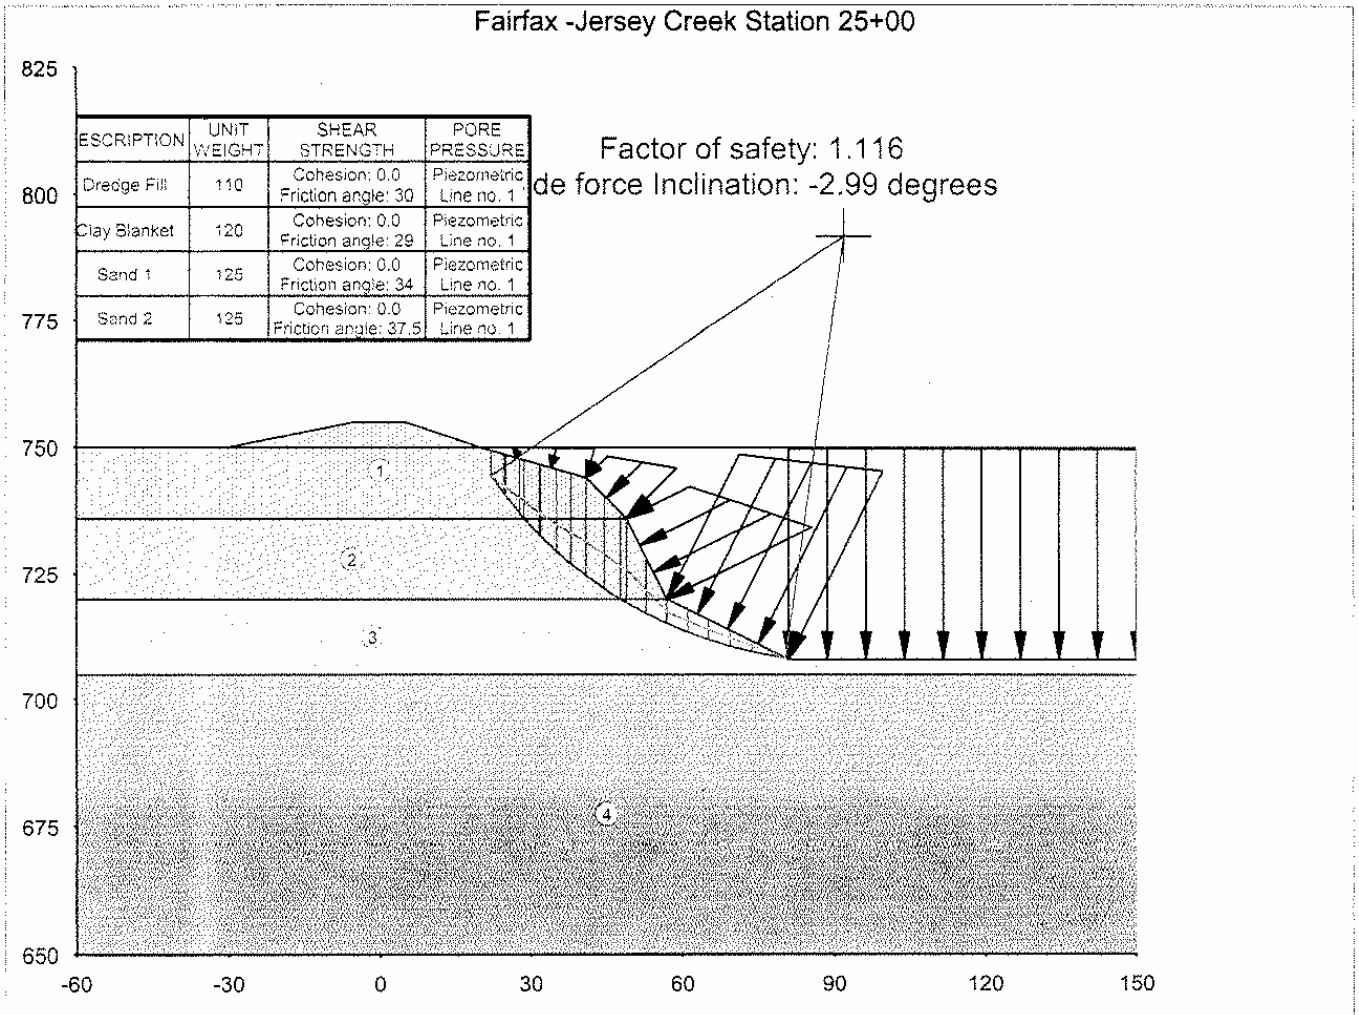
EXHIBIT A-8.24
Mean Value Analysis of Global Stability of Station 25+00 Foreshore
With River Elevation 750 Feet

3) If the wall fails, then part of the bank behind the wall will scour causing a foreshore slide. (p2)

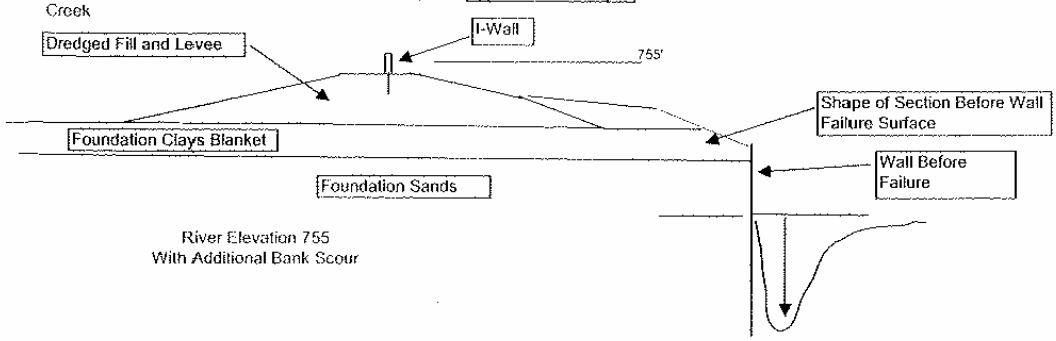
Probability that the Levee will fail is determine based on a parallel system for this reach. In a parallel system the system will only perform unsatisfactorily if all components perform unsatisfactorily.
Reliability = 1- p1*p2*p3

Event	Prob of Failure	
(p1)	Scour potential	1	4.5' Scour
(p2)	Wall failure (p1) =	0.5700	
(p3)	Foreshore slide (p2)=	0.8500	Loss of bank - progressive erosion/slouging
(p4)	Levee Slide (p3) =	0.8155	When this happens Fairfax gets wet
	Reliability of reach =	1-p1*p2*p3

Reliability = 1 - 0.6049 = 39.51%

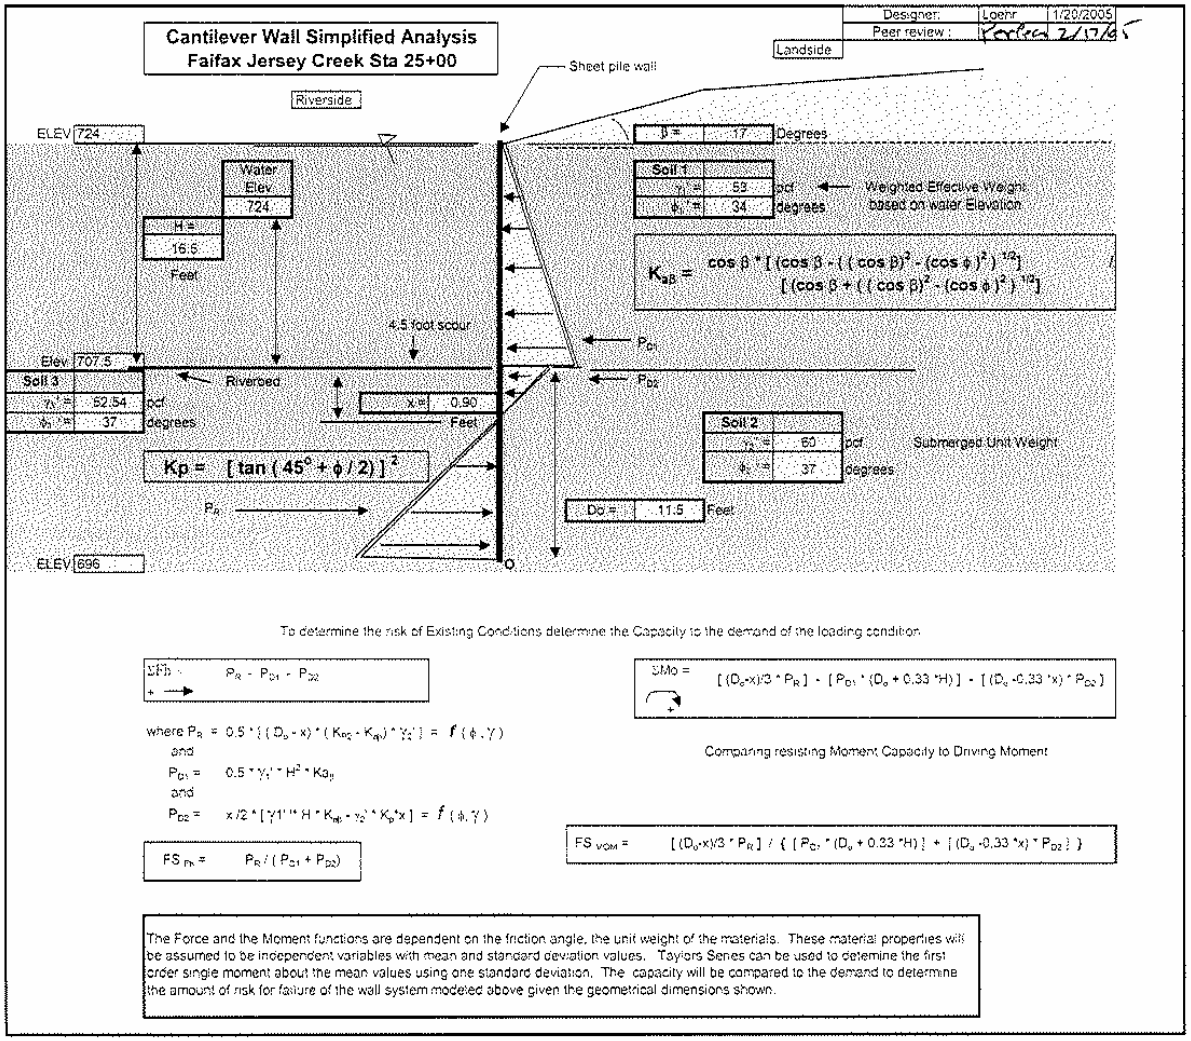
EXHIBIT A-8.30
Simple Cantilever Wall Model for River Elevation 755 Feet

4 - 5 foot scour

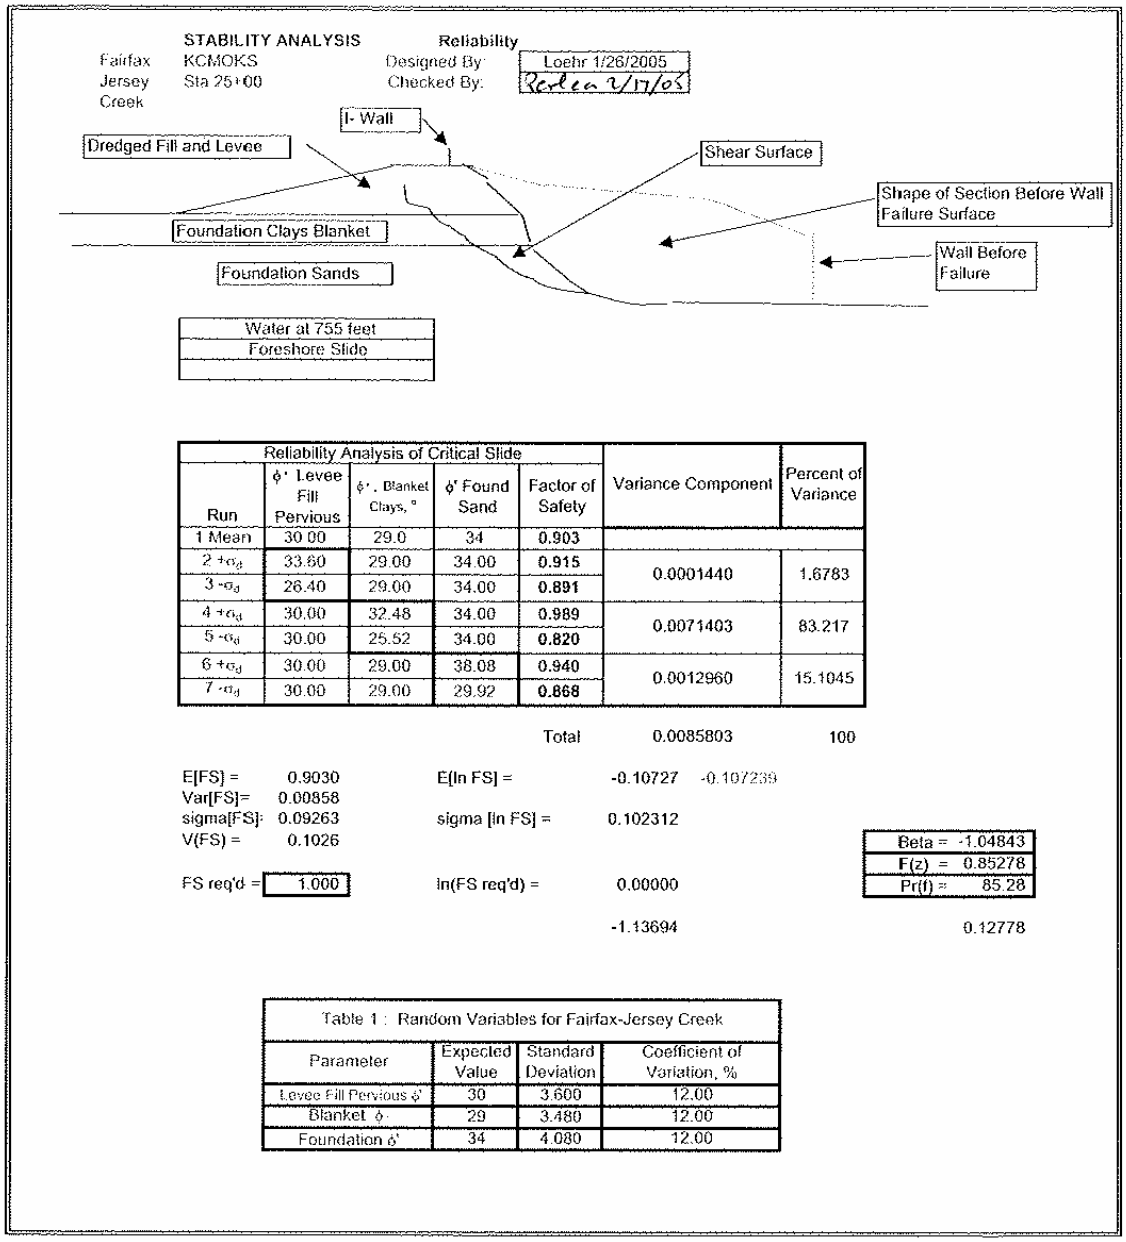
EXHIBIT A-8.31
Summary of Probability of Foreshore Global Stability
Failure Using River Elevation 755 Feet

E[FS] =	0.9030	E[ln FS] =	-0.10727	-0.107239	
Var[FS]=	0.00858				
sigma[FS]:	0.09263	sigma [ln FS] =	0.102312		
V(FS) =	0.1026				
				Beta =	-1.04843
				F(z) =	0.85278
FS req'd =	1.000	ln(FS req'd) =	0.00000	Pr(f) =	85.28
			-1.13694		0.12778

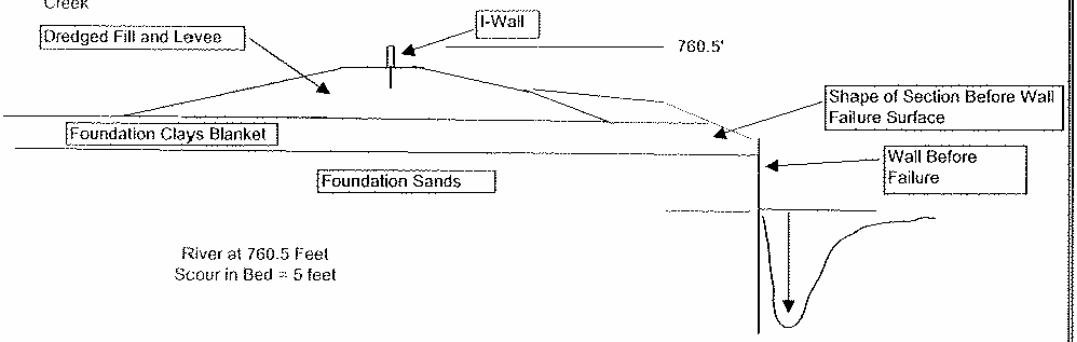
Probability that the Levee will fail is determine based on a parallel system for this reach. In a parallel system the system will only perform unsatisfactorily if all components perform unsatisfactorily.
Reliability = 1- p1*p2*p3

0.8000	*	0.8500	*	0.5515	=	0.6250
						or
Reliability =		1	-	0.625		**37.50%**

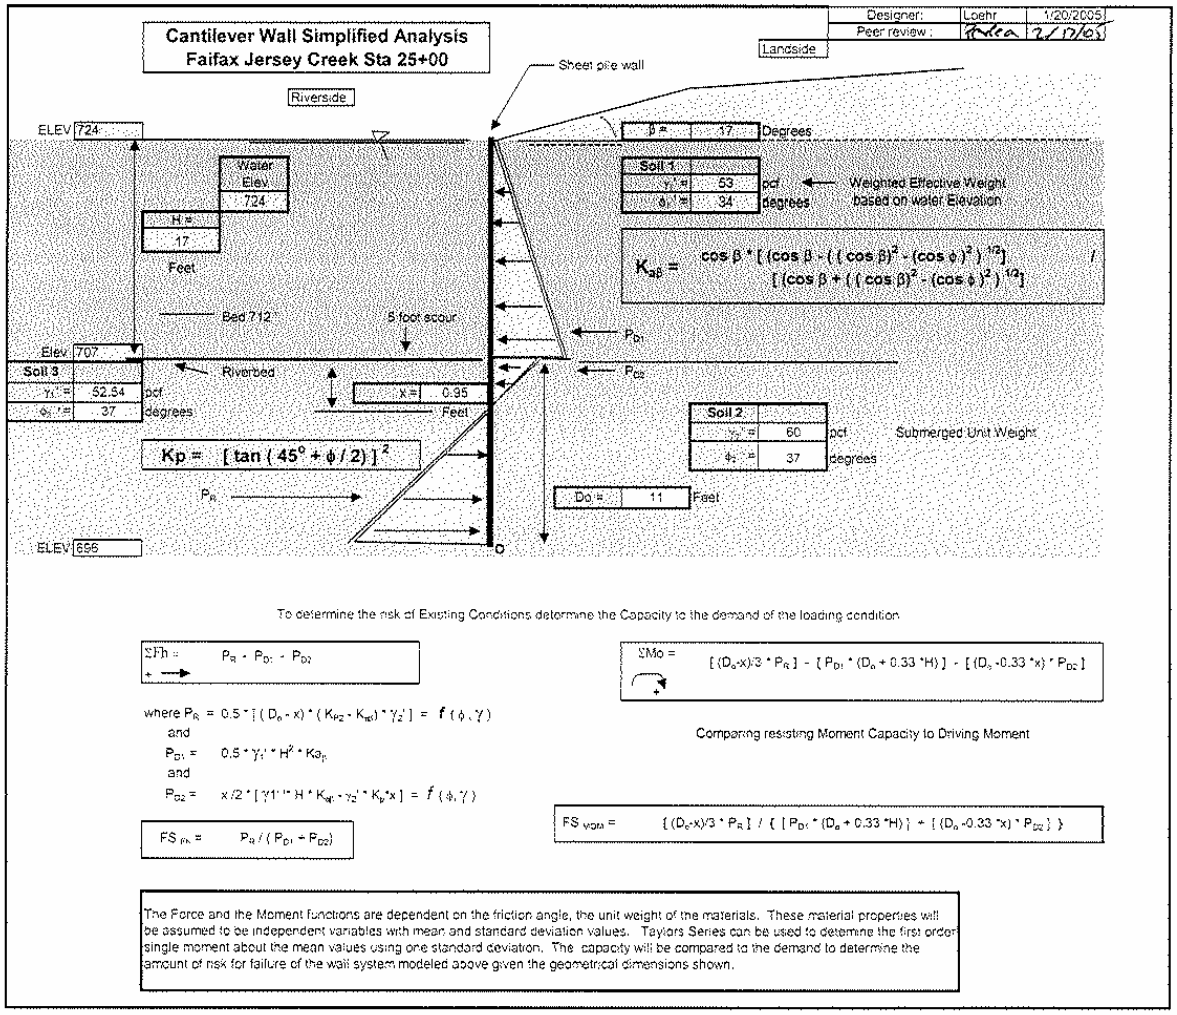
EXHIBIT A-8.38
Simple Cantilever Wall Model for River Elevation 760.5 Feet

5 foot scour

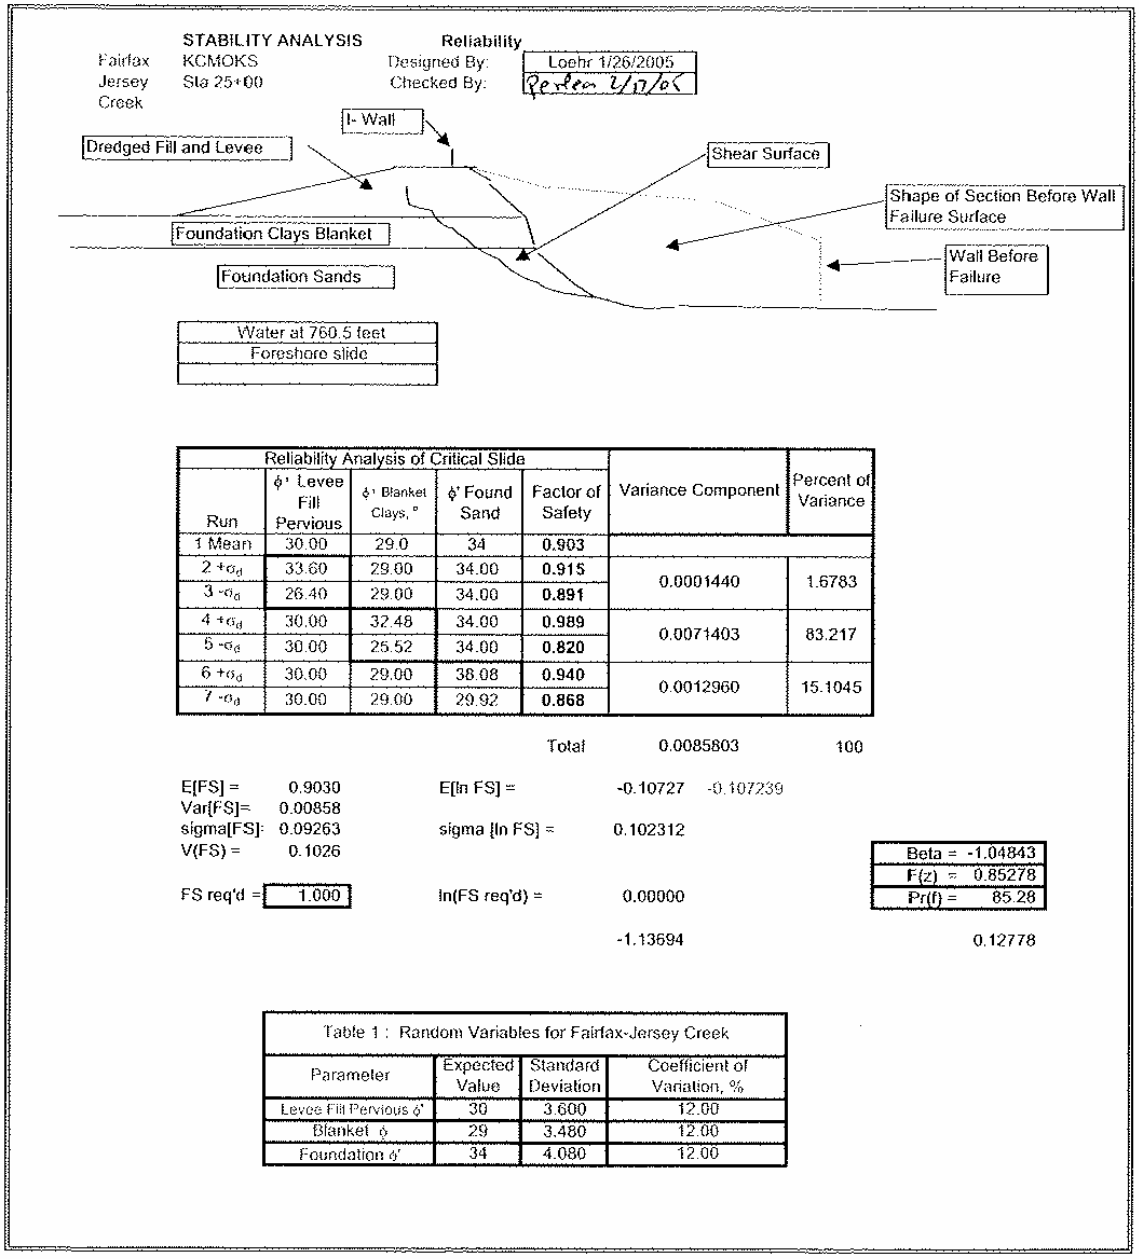
EXHIBIT A-8.39
Summary of Probability of Foreshore Global Stability
Failure Using River Elevation 760.5 Feet

E[FS] =	0.9030	E[ln FS] =	-0.10727	-0.107239	
Var[FS]=	0.00858				
sigma[FS]:	0.09263	sigma [ln FS] =	0.102312		
V(FS) =	0.1026				
				Beta =	-1.04843
				F(z) =	0.85278
				Pr(f) =	85.28
FS req'd =	1.000	ln(FS req'd) =	0.00000		
			-1.13694		0.12778

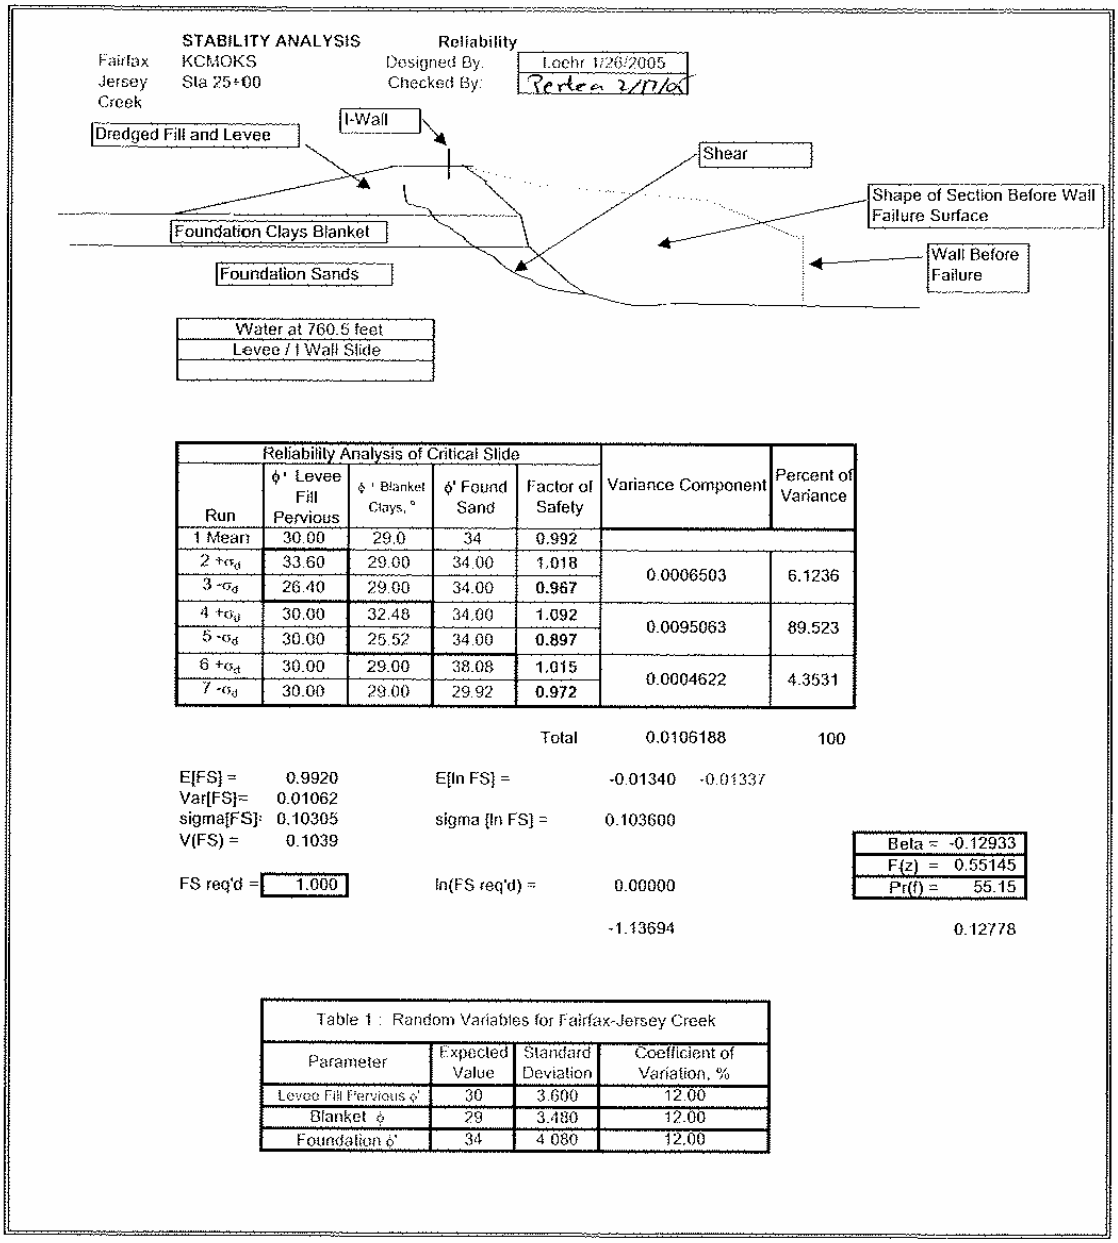
EXHIBIT A-8.40
Summary of Probability of Levee/I-Wall Global Stability Failure Using River Elevation 760.5 Feet

E[FS] = 0.9920
Var[FS]= 0.01062
sigma[FS]: 0.10305
V(FS) = 0.1039
