# Rock Creek Watershed Planning Final Feasibility Report

United States Army  
Corps of Engineers  
Northwestern Division  
Kansas City District  
700 Federal Building  
Kansas City, MO 64106

Black & Veatch  
6601 College Boulevard  
Overland Park, KS 66211

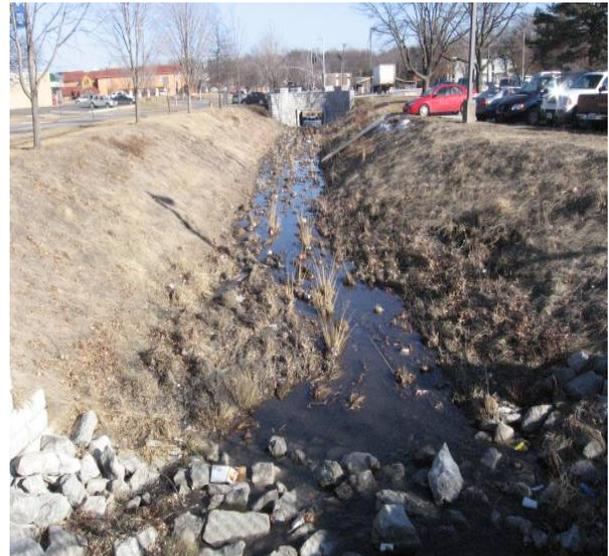
**Project 2**

- Some signs of erosion and instability on left and right banks.
- Lack of flood benches.
- Lack of vegetative material and bank structure.

- Limited vegetation of banks
- Provide rip rap/bank protection of channel

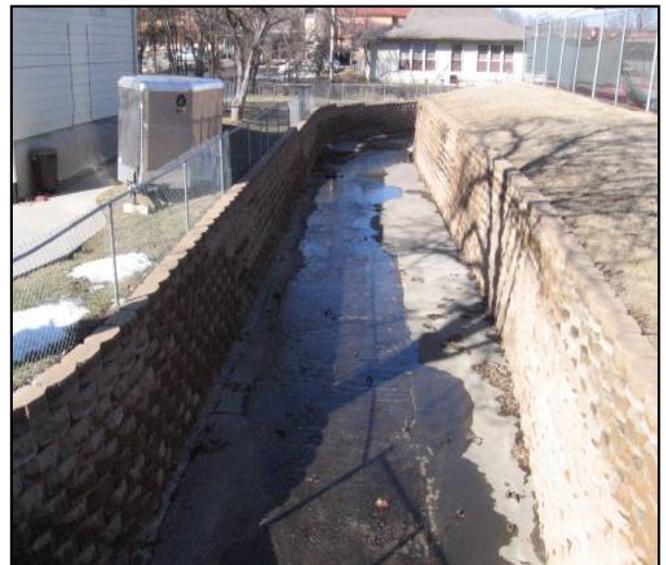
**Project 4**

- Concrete and keystone structure provides little habitat or water quality value, increases flow velocities and possibly contributes to downstream flooding concerns.

- Remove concrete and restore floodplain on right side.
- Limited vegetation of banks.
- Provide rip rap/bank protection of channel as necessary.

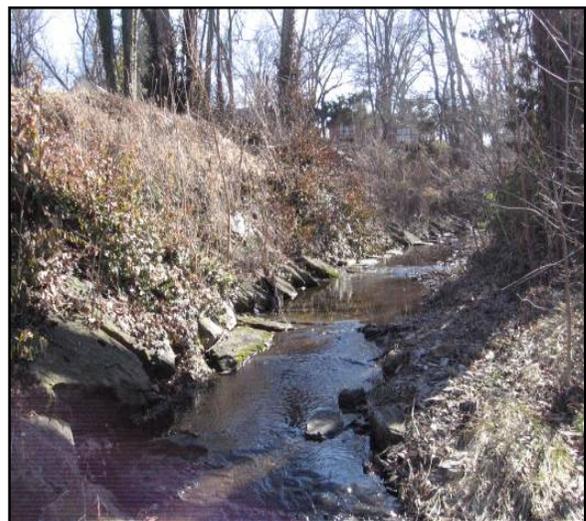
**Project 5**

- Limited signs of erosion and instability on left and right banks
- Lack of native understory vegetation.

- Limited vegetation of banks
- Provide rip rap/bank protection of channel as necessary.

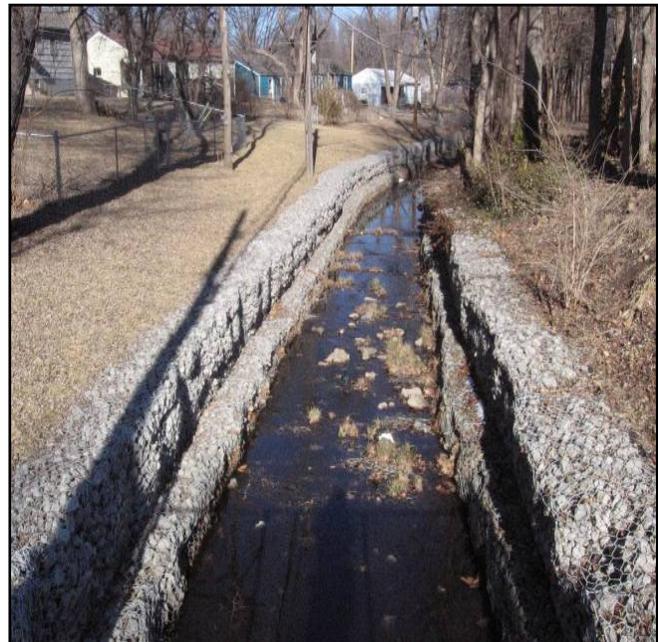
**Project 6**

- Lack of stream buffer and corridor
- Gabion basket walls provide little benefit to vegetation, habitat, and water quality.

- Replace gabion basket walls on right and left bank with recommended cross-section below.
- Limited vegetation of banks
- Provide rip rap/bank protection of channel

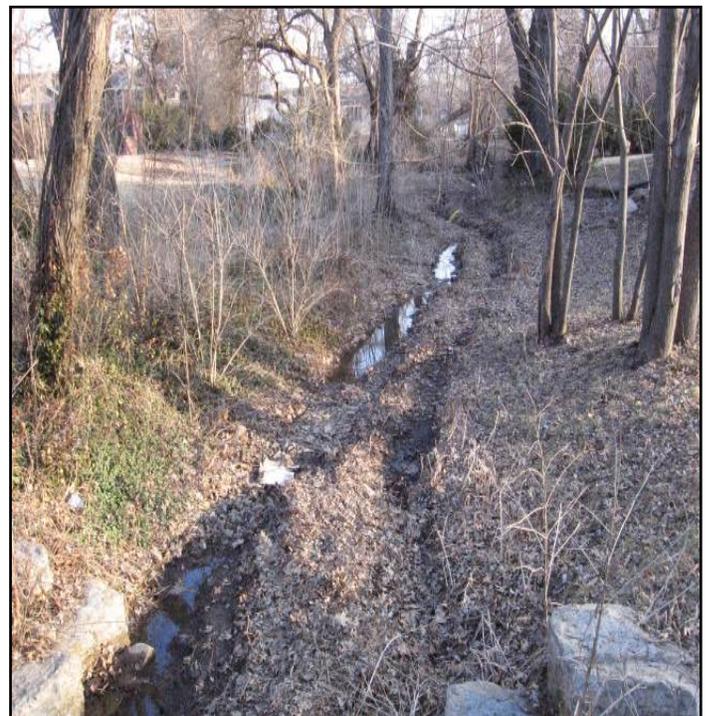
Project 8

- Significant erosion and instability on left and right banks
- Excessive sedimentation in channel.
- Lack of native vegetation.
- Absence of low flow channel.

- Limited vegetation of banks
- Provide rip rap/bank protection of channel

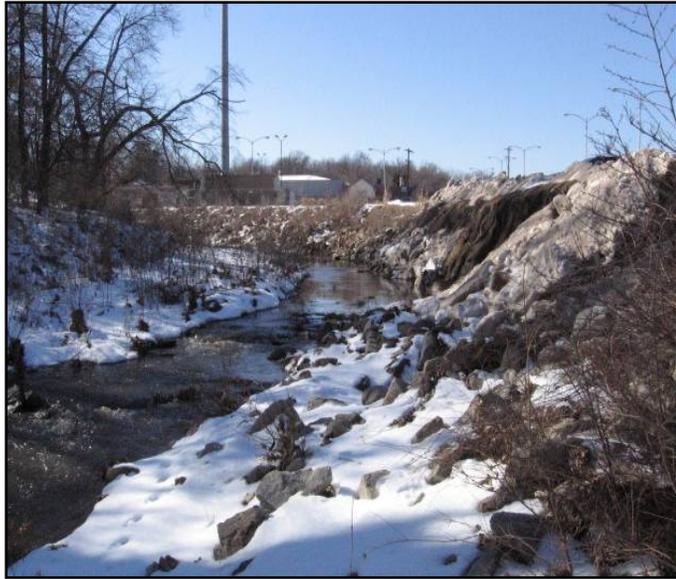
**Project 10 – Segment 1**

- Significant erosion and instability on left and right banks threaten existing parking lot and building infrastructure.
- Lack of native vegetation and stream corridor.

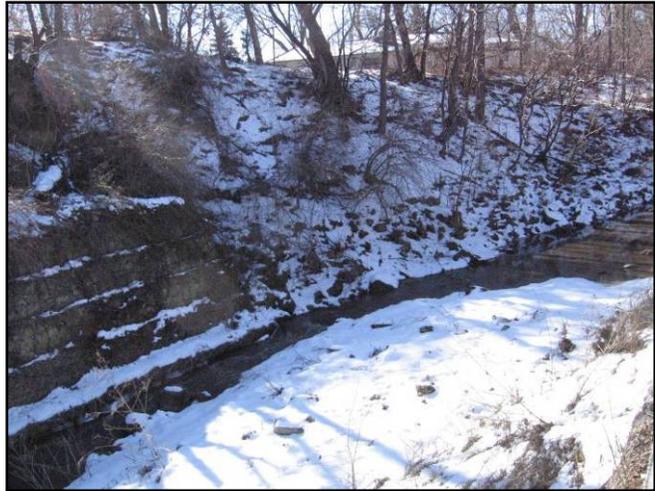
**Project 10 – Segment 3**

- Newer gabion basket walls on both banks provide little habitat or water quality value, increases flow velocities and possibly contributes to downstream flooding concerns.

- Limited vegetation of both banks.
- Develop conceptual cross section between existing bank structures.
- Provide rip rap/bank protection of channel

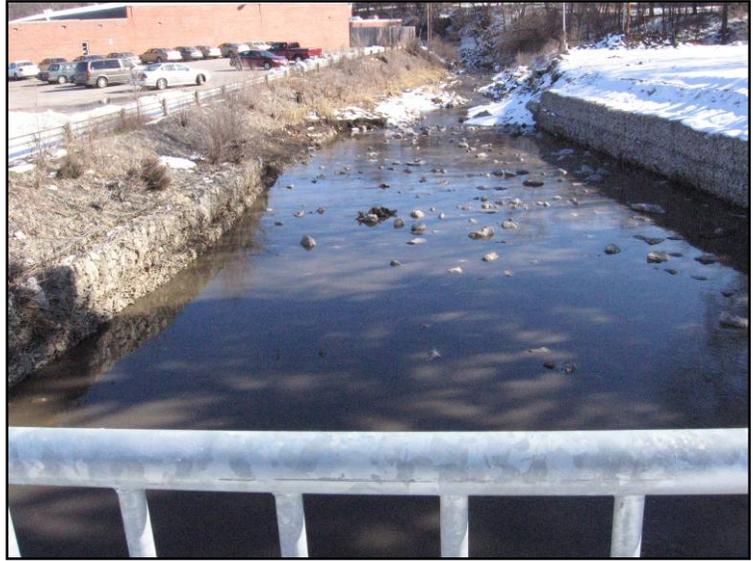
**Project 10 – Segment 4**

- Overwidening of cross section and lack of flood benching allows for excessive sediment deposition.
- Newer gabion basket walls on both banks provide little habitat or water quality value, increases flow velocities and possibly contributes to downstream flooding concerns.

- Limited vegetation of banks
- Develop a stable cross section based on Soar & Thorne methodology within existing gabion walls.
- Provide rip rap/bank protection of channel as necessary.

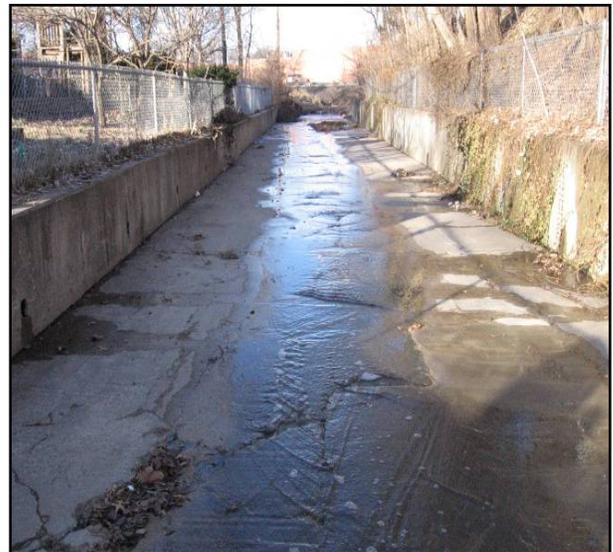
**Project 11**

- Right and left bank wall are aging.
- Absence of a stream corridor and native vegetation.
- Concrete channels provide little habitat or water quality value, increases flow velocities and possibly contributes to downstream flooding concerns.

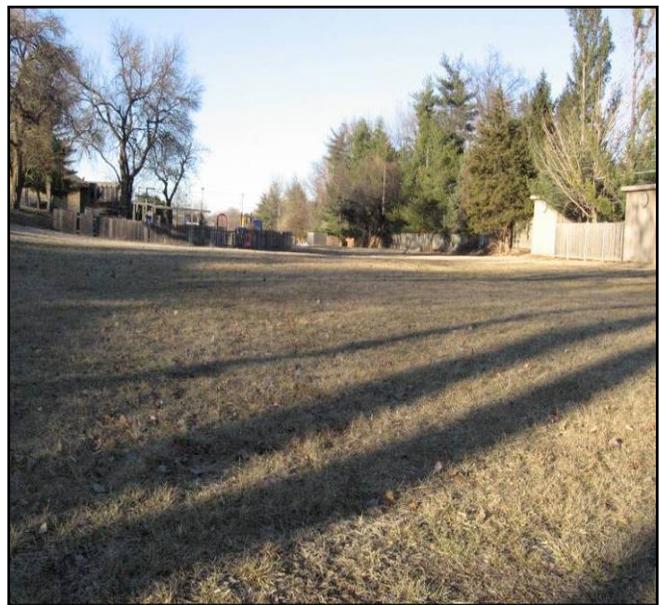
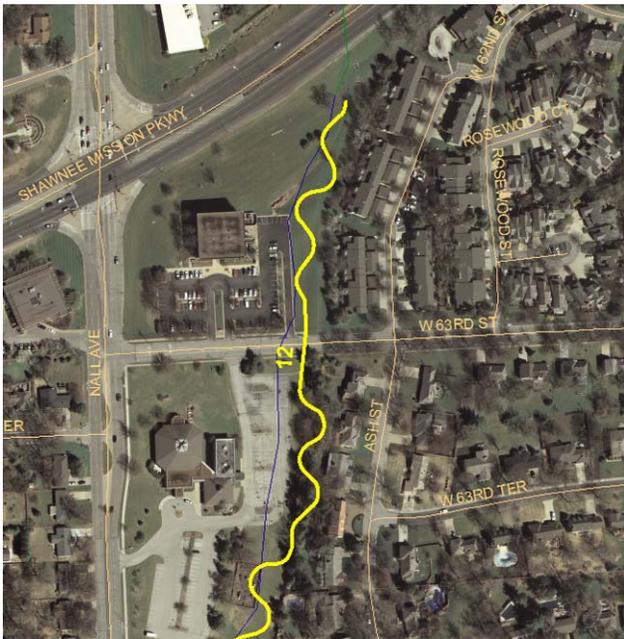
**Project 12**

- Underground structure is aging.
- Piped streams provide little habitat or water quality value, increase flow velocities and possibly contribute to downstream flooding concerns.

- Replace underground structure with open channel such as the stable cross section determined by Soar & Thorne's method.
- Add meandering pattern to channel
- Vegetate banks and create buffer zone
- Provide rip rap/bank protection of channel as necessary.

- Replace underground structure with open, stable cross section.
- Limited vegetation of banks
- Provide rip rap/bank protection of channel

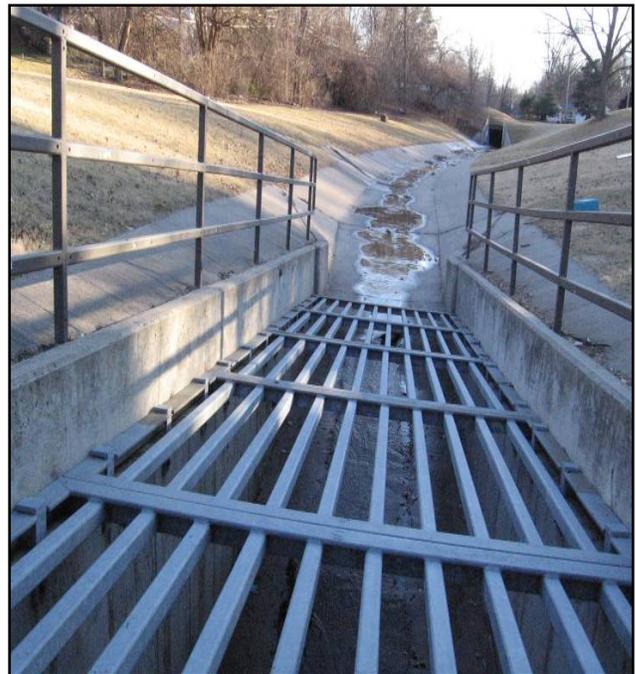
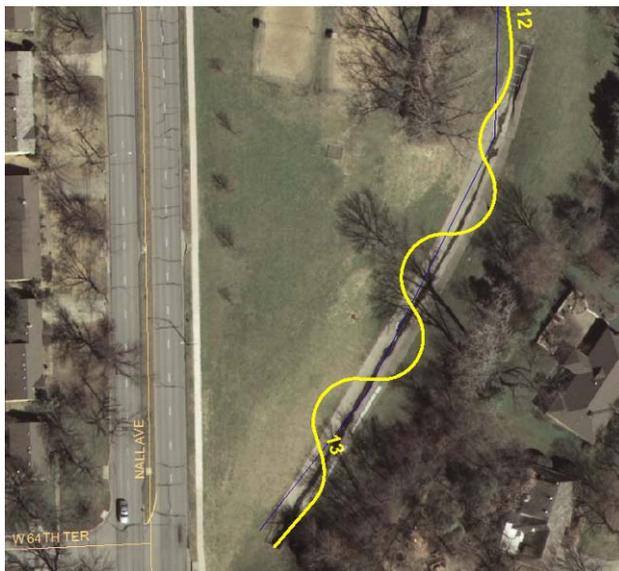
**Project 13**

- Concrete channels provide little habitat or water quality value, increase flow velocities and possibly contribute to downstream flooding concerns.
- Lack of stream corridor buffer

- Add meandering pattern to channel
- Replace concrete channel with stable cross section
- Vegetate banks and create buffer zone
- Provide rip rap/bank protection of channel

- Replace concrete channel with stable cross section
- Limited vegetation of banks
- Provide rip rap/bank protection of channel

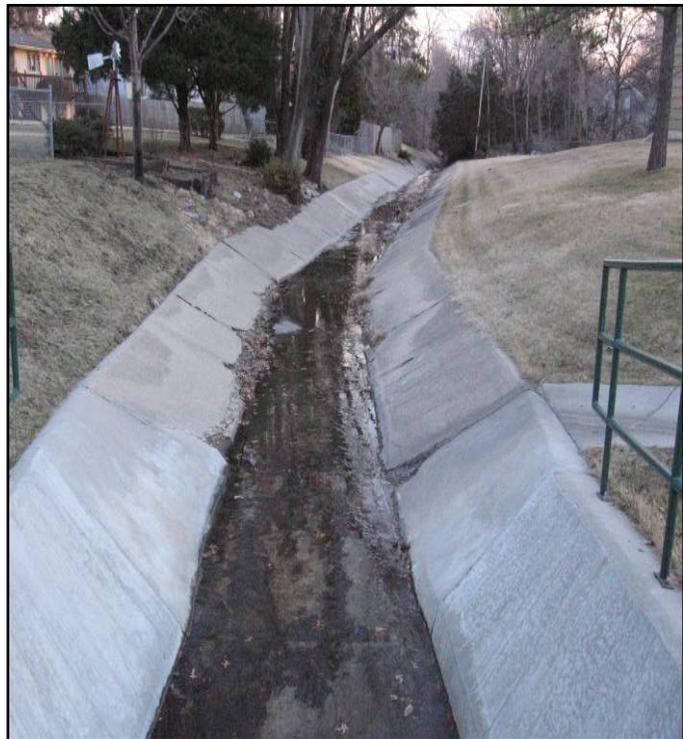
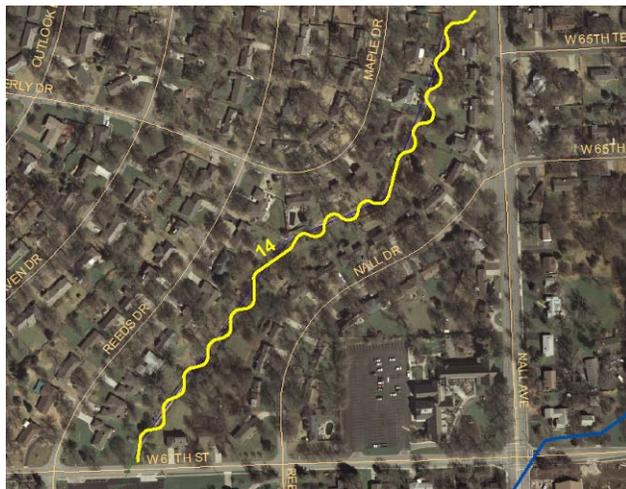
**Project 14**

- Concrete channels provide little habitat or water quality value, increase flow velocities and possibly contribute to downstream flooding concerns.
- Lack of stream corridor buffer

- Add meandering pattern to channel
- Replace concrete structure with stable cross section.
- Vegetate banks and create buffer zone
- Provide rip rap/bank protection of channel

- Replace concrete structure with stable cross section.
- Vegetate banks and create buffer zone
- Provide rip rap/bank protection of channel

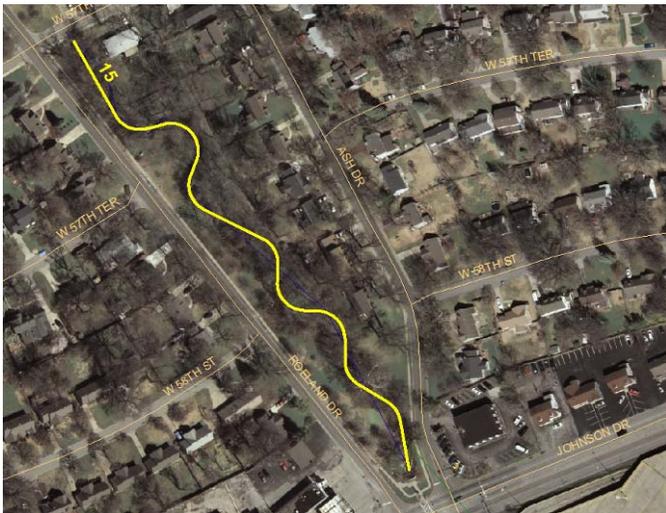
**Project 15**

- Observed instability and erosion on left and right banks
- Substrate is not well graded, consisting of mostly silts.

- Limited vegetation of banks
- Develop stable cross section
- Provide rip rap/bank protection of channel

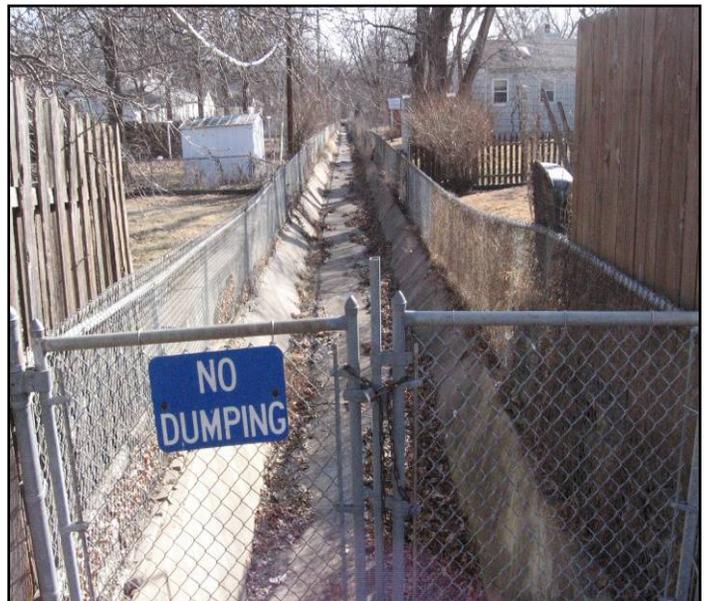
**Project 17**

- Concrete channel is aging.
- Lack of vegetated stream corridor.
- Lack of community awareness of watersheds, water quality, and stream corridors.

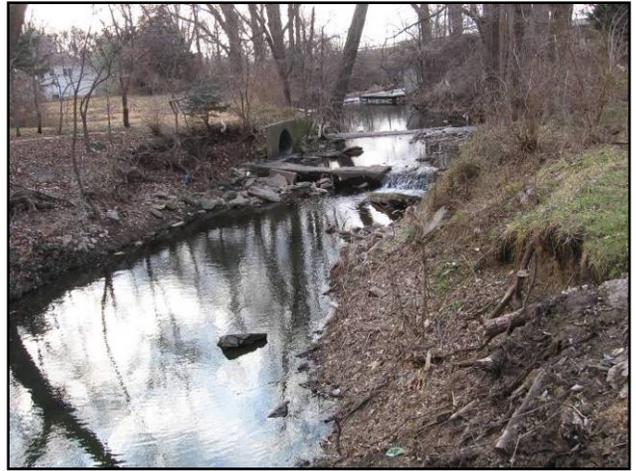
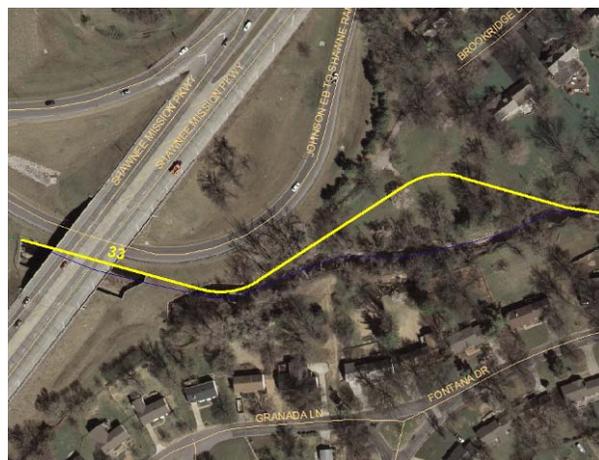
**Project 33 – Segment 2**

- Limited infrastructure is degrading
- Some signs of erosion on both banks
- Concrete channels provide little habitat or water quality value, increase flow velocities and possibly contribute to downstream flooding concerns.

- Add meandering pattern to channel
- Replace left and right channel wall with sufficient width to develop low flow channel and flood benches.
- Provide rip rap/bank protection of channel

- Replace left and right channel wall with sufficient width to develop low flow channel and flood benches.
- Provide rip rap/bank protection of channel

- Develop stable cross section, providing bank protection
- Limited vegetation of banks

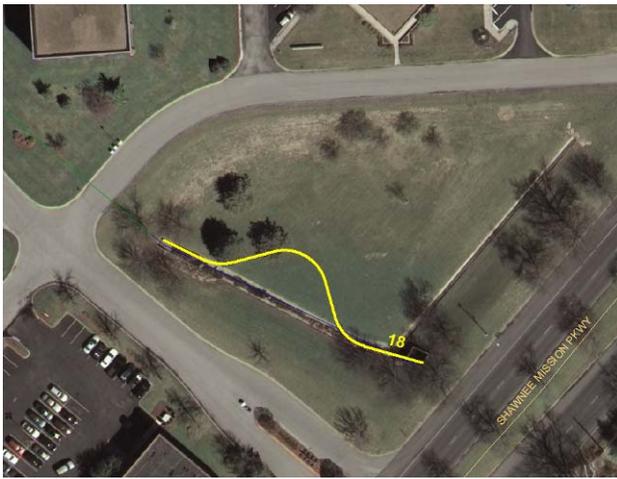
**Project 18**

- Existing channel experiencing degradation.
- Concrete channels provide little habitat or water quality value, increase flow velocities and possibly contribute to downstream flooding concerns.

- Add meandering pattern to channel
- Replace concrete channel with stable cross section.
- Vegetate banks and create buffer zone
- Provide rip rap/bank protection of channel

- Replace concrete channel with stable cross section
- Limited vegetation of banks
- Provide rip rap/bank protection of channel

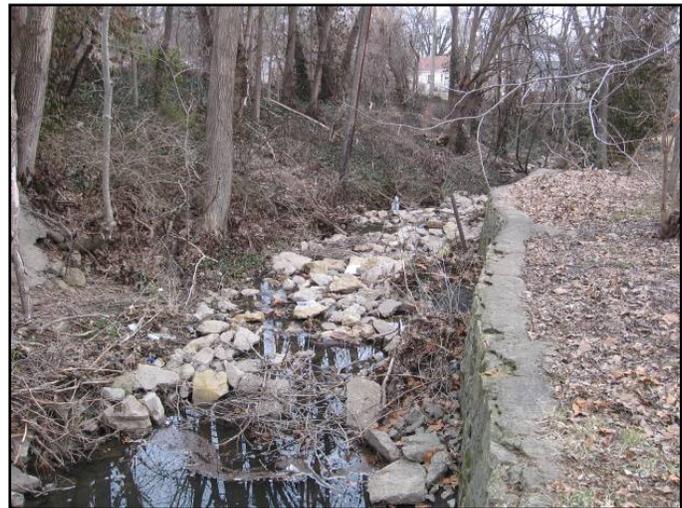
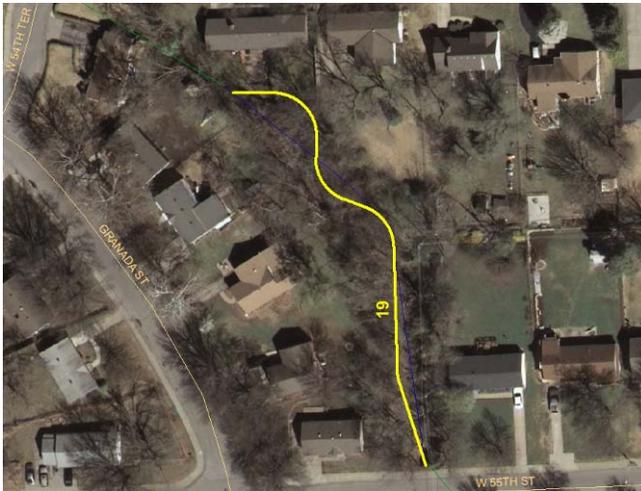
**Project 19**

- Some signs of instability and erosion on both banks

- Limited vegetation of banks
- Provide rip rap/bank protection of channel

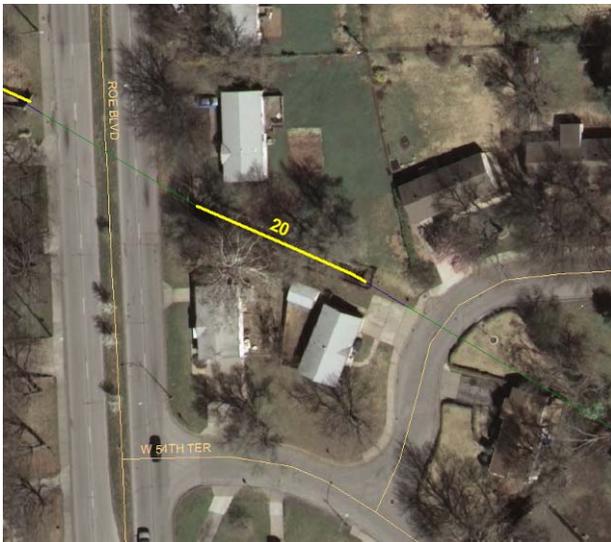
**Project 20**

- At upstream end, right bank should be stabilized.
- At downstream end, both right and left bank stabilization is deteriorating.
- Overwidened upstream section allows excessive sediment deposition.

- Replace right bank wall as necessary.
- Incorporate vegetation and stream buffer.
- Provide rip rap/bank protection of channel

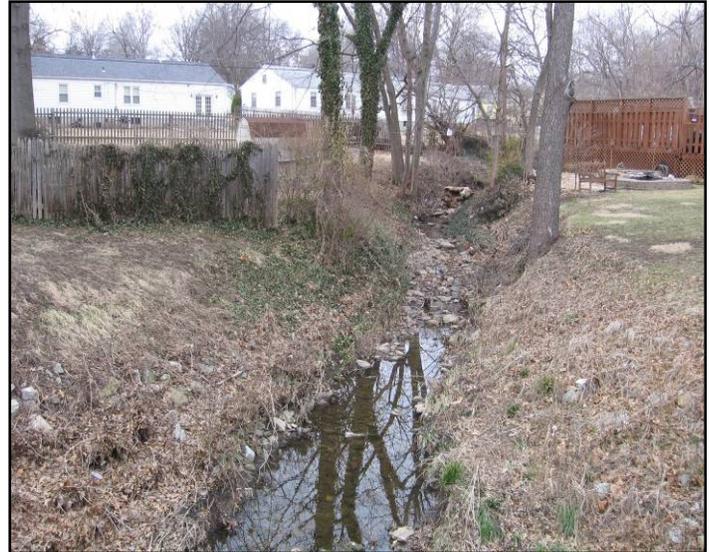
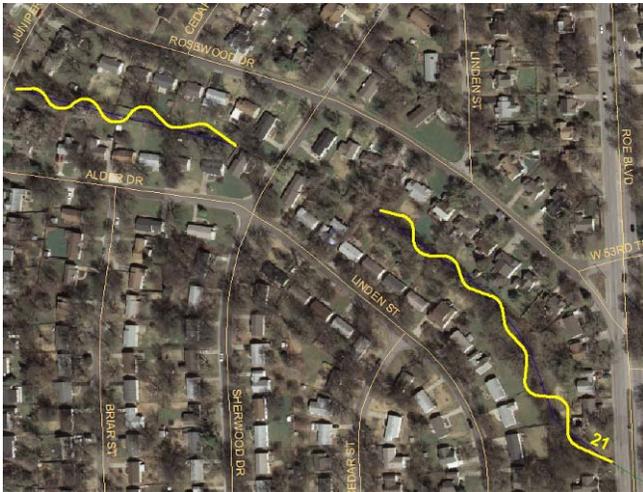
**Project 21 – Segment 2**

- Some signs of instability and erosion on banks
- Lack of native vegetation and stream corridor

- Add meandering pattern to channel
- Replace channel structures with stable cross section
- Vegetate both banks and create buffer zone
- Provide rip rap/bank protection of channel

- Replace channel structures with stable cross section
- Vegetate both banks and create buffer zone
- Provide rip rap/bank protection of channel

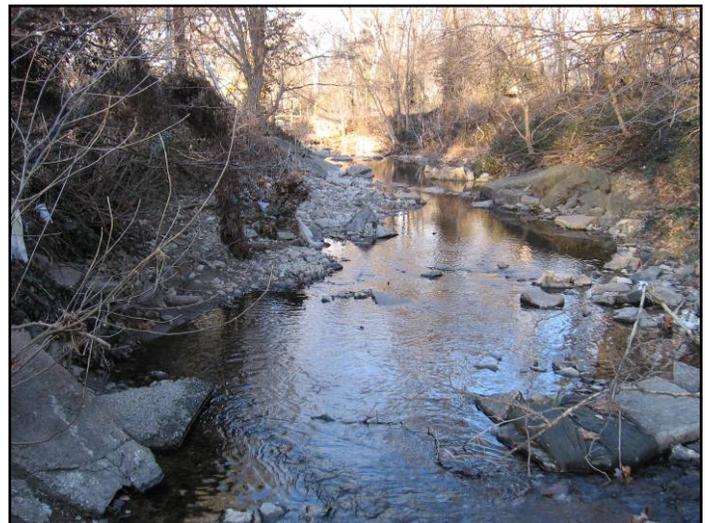
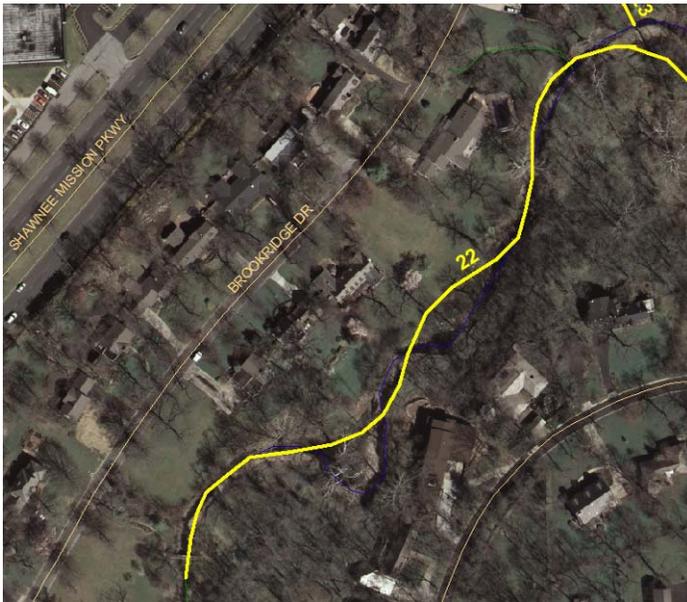
**Project 22**

- Significant erosion and instability on both banks

- Add meandering pattern to channel
- Integrate recommended stable cross section
- Vegetate banks and create buffer zone
- Provide rip rap/bank protection of channel

- Integrate recommended stable cross section
- Limited vegetation of banks
- Provide rip rap/bank protection of channel as necessary

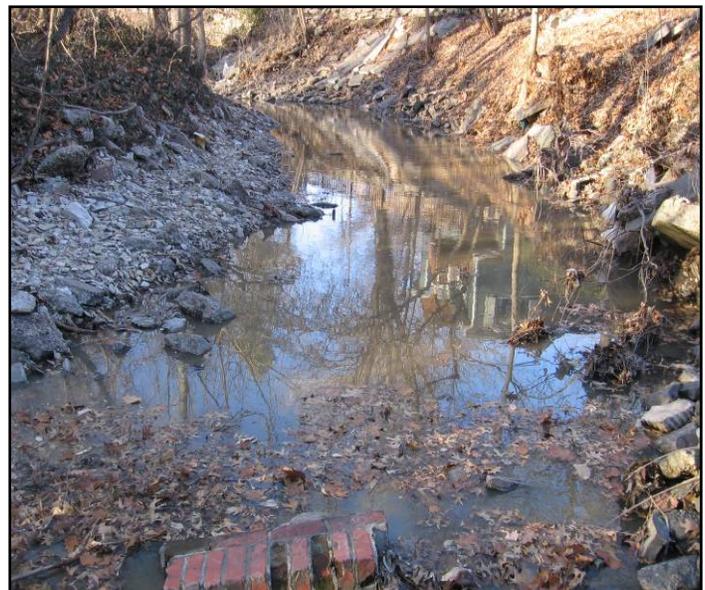
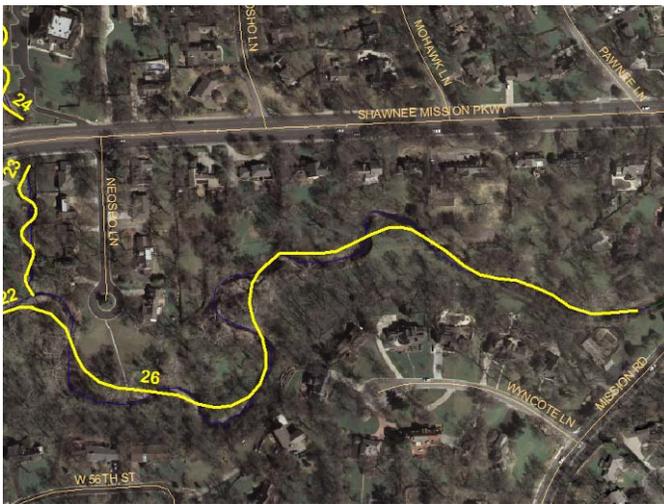
**Project 26**

- Instability and erosion in key areas along project length as stream is naturally attempting to transition into a stable form.
- Lack of consistent stream buffer between creek and neighborhood lawns.

- Limited vegetation of banks
- Provide rip rap/bank protection of channel

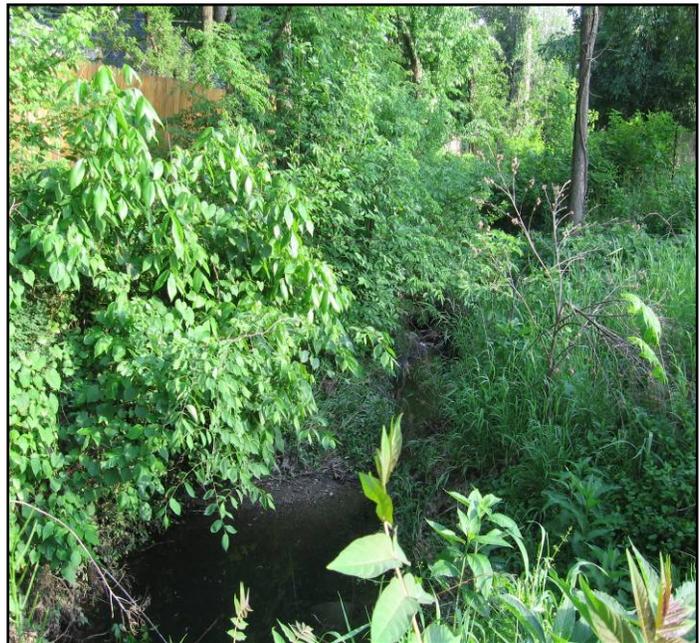
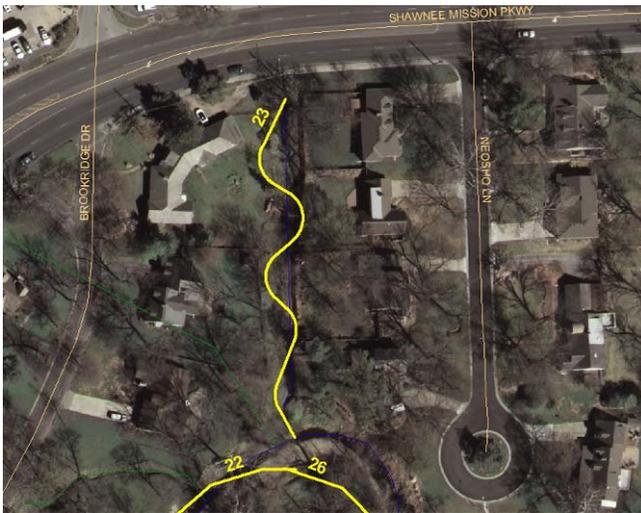
**Project 23**

- Some signs of instability and erosion on both banks.
- Significant sediment deposition of silts, limiting soil gradation.

- Limited vegetation of banks
- Provide rip rap/bank protection of channel

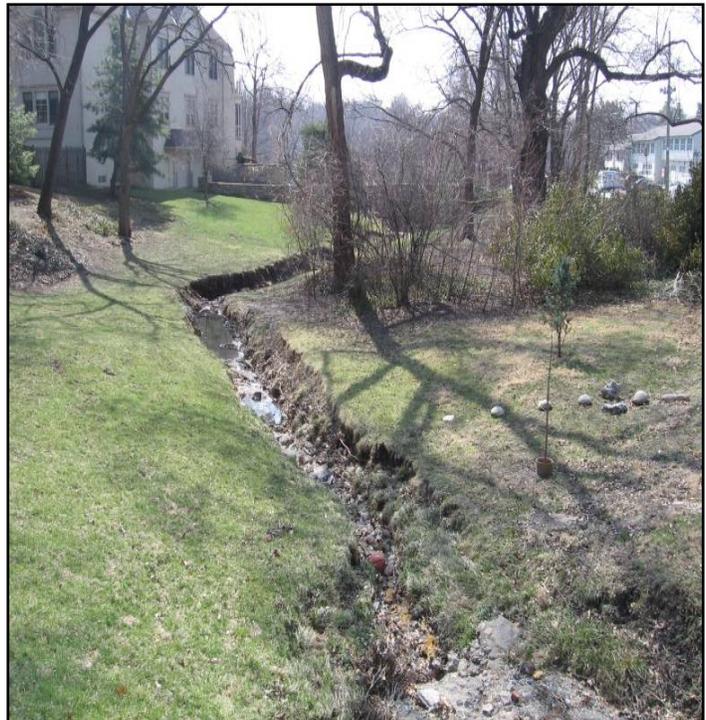
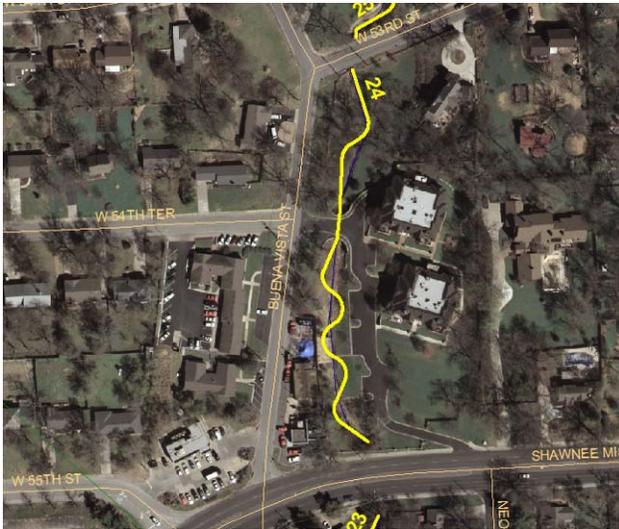
**Project 24**

- Significant down-cutting, instability and erosion
- Lack of native vegetation and stream corridor.

- Limited vegetation of banks
- Provide rip rap/bank protection of channel as necessary

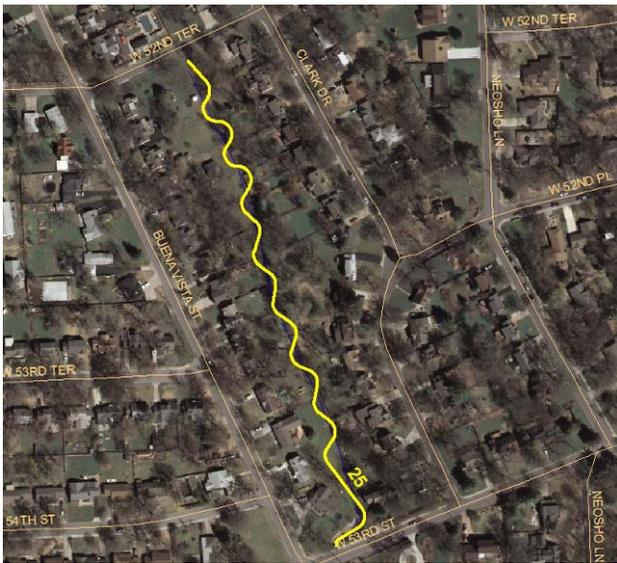
Project 25

- Some signs of erosion and instability.
- Channelized flow path.
- Existing swale is planted with turf grass, limited infiltration capacity.

- Limited vegetation of swale
- Provide rip rap/bank protection if necessary

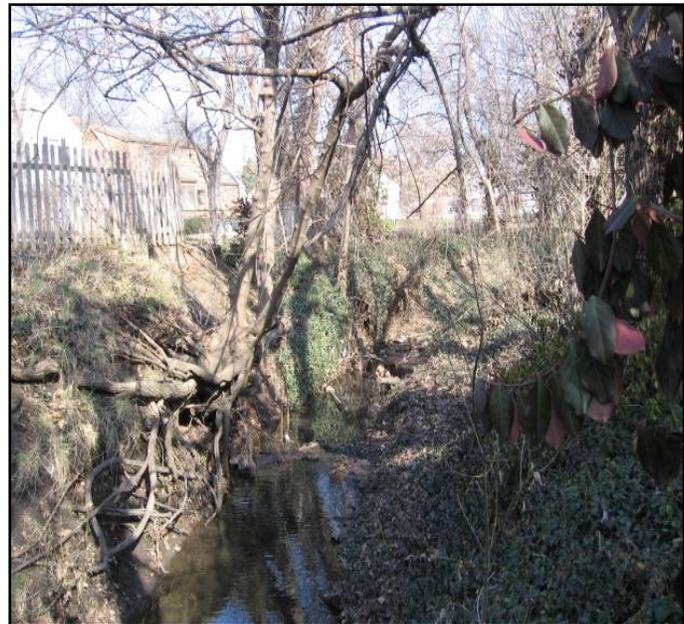
**Project 28**

- Some signs of instability and erosion on both banks
- Lack of native vegetation

- Add channel wall on left bank
- Limited vegetation of both banks
- Provide rip rap/bank protection of channel as necessary

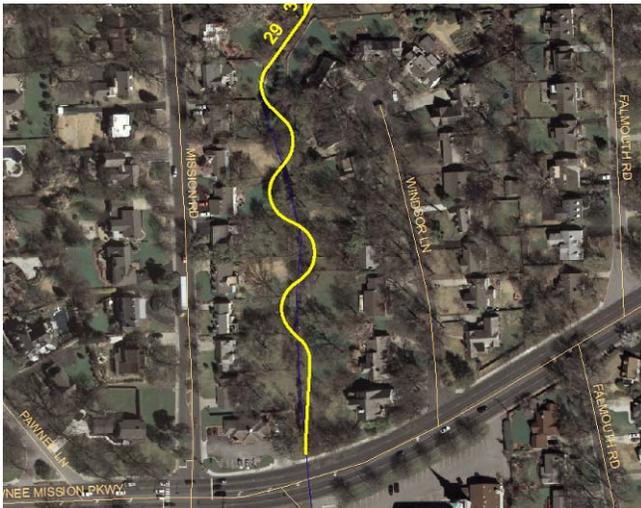
**Project 29**

- Observed instability and erosion on both banks

- Develop stable cross section
- Limited vegetation of banks
- Provide rip rap/bank protection of channel

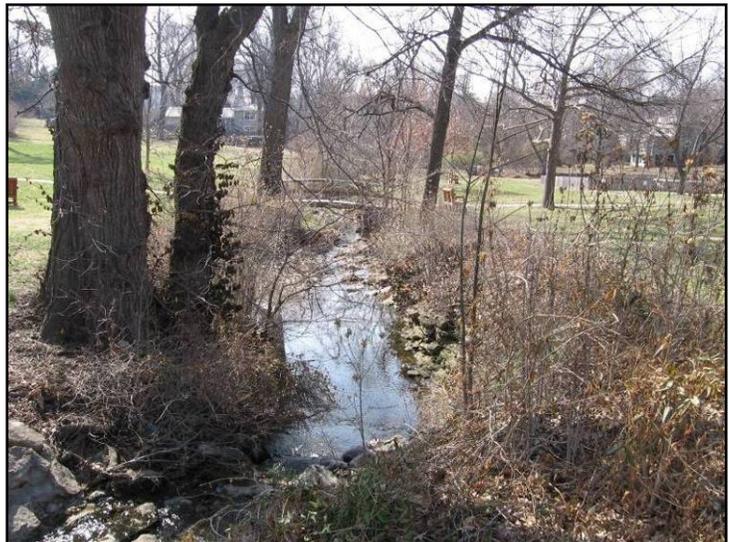
**Project 30**

- Some signs of instability and erosion on both banks
- Lack of vegetated stream corridor

- Limited vegetation of banks
- Provide rip rap/bank protection of channel

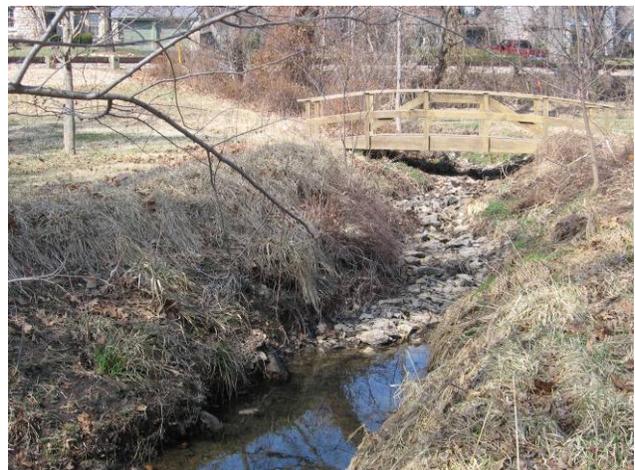
**Project 36**

- Some signs of instability and erosion on both banks

- Limited vegetation of banks
- Provide rip rap/bank protection of channel

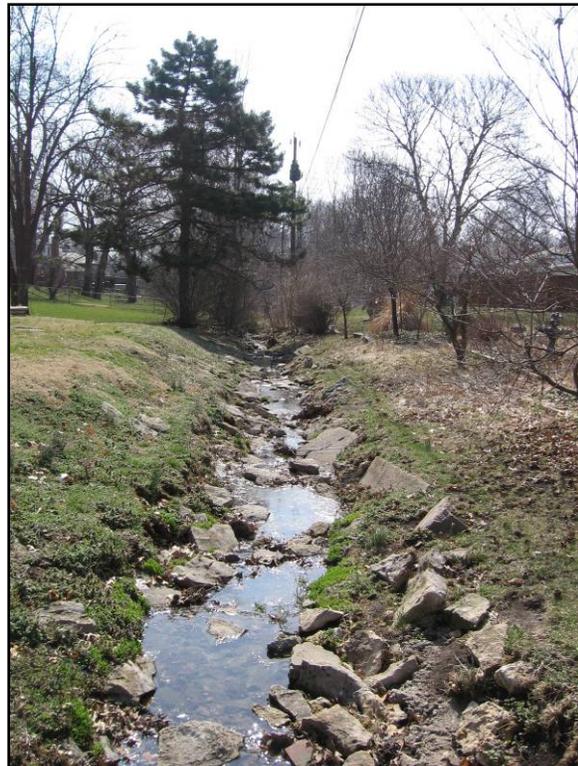
Project 31 – Segment 1

- Some signs of instability and erosion on both banks
- Channelized section lacking meander pattern

- Limited vegetation of banks
- Provide rip rap/bank protection of channel
- Develop stream corridor buffer

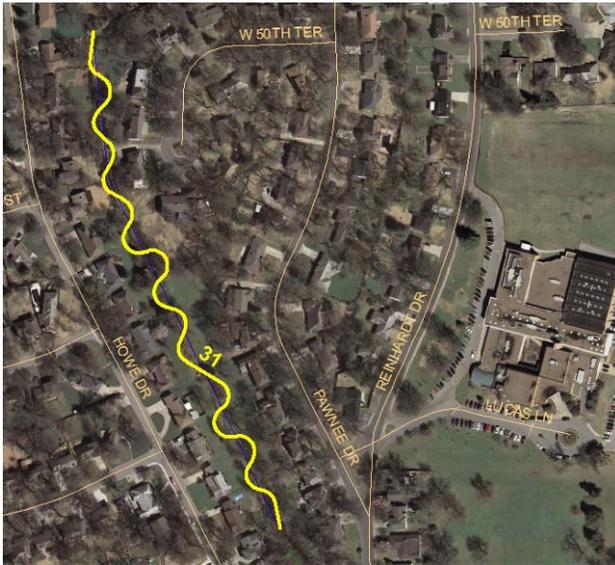
**Project 31**

- Large scour hole at end of concrete channel.
- Observed erosion and lack of stream buffer

- Add meandering pattern to channel
- Replace concrete with stable cross section
- Vegetate banks and create buffer zone
- Provide rip rap/bank protection of channel

- Replace concrete with stable cross section
- Limited vegetation of banks
- Provide rip rap/bank protection of channel
