WATER DISTRICT NO. 1
OF
JOHNSON COUNTY, KANSAS

**KANSAS RIVER INTAKE
JETTY IMPROVEMENTS STUDY**

PROJECT NO. 99409.108

May 20, 2005

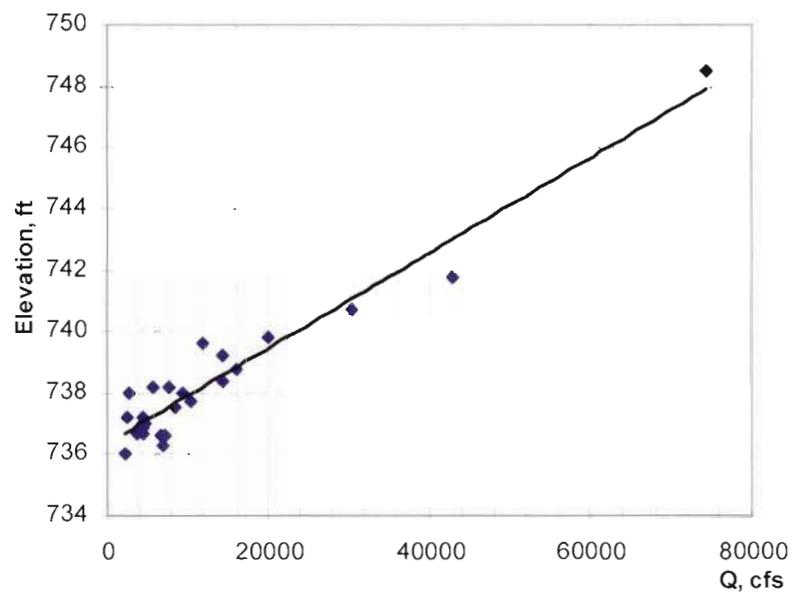
Figure 2. Rating Curve for WaterOne Jetty, 1985

A breach of the jetty occurred sometime during March 14 - 15, 2004. Prior to the breach, the US Army Corps of Engineers (COE) made a large release of flow (approximately 20,000 cfs) from Tuttle Creek Reservoir because the lake level had risen 11 feet from rainfall. This release, plus added inflows from rainfall in other portions of the Kansas River basin, caused the total flow in the Kansas River at DeSoto to rise from approximately 1,500 cfs to over 35,000 cfs in about one day around March 5th. The flow diminished to about 17,000 cfs around March 7 and remained there until March 10. From March 10 to March 12, the flow increased to about 27,000 cfs and the jetty breach appears to have occurred with a flow of about 26,000 cfs as shown on Figure 1. Using the rating curve shown in Figure 2, the flow appears to have been at least 2 to 3 feet over the top of the jetty.

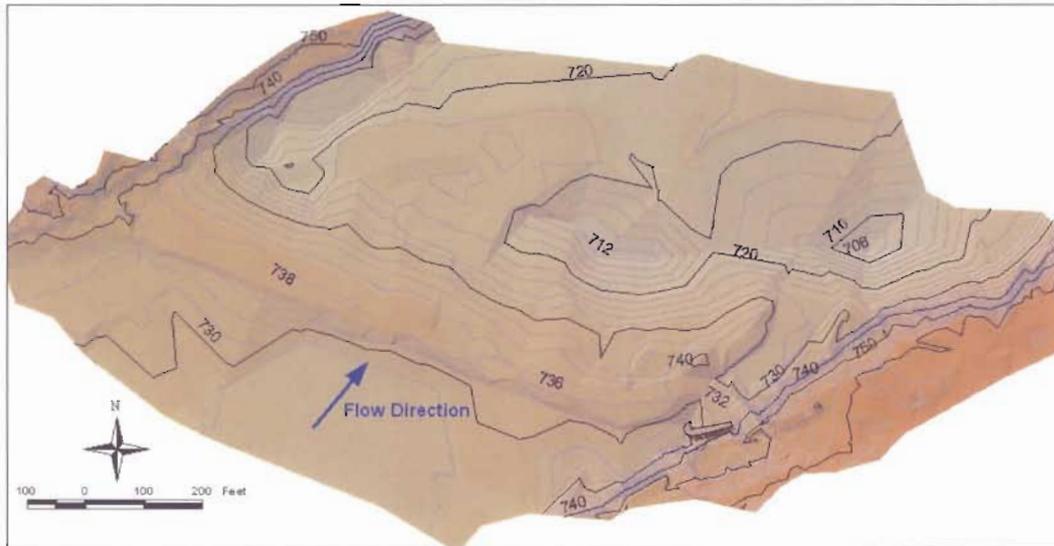
Figure 4. DTM, before breach

The different survey points were combined and used as the basis to create two digital terrain models (DTMs). The DTMs provide a visual description of the jetty geometry before and after the breach (Figure 4 and Figure 5). The "before" DTM was also used to cut cross sections for the hydraulic model and for geotechnical analysis.

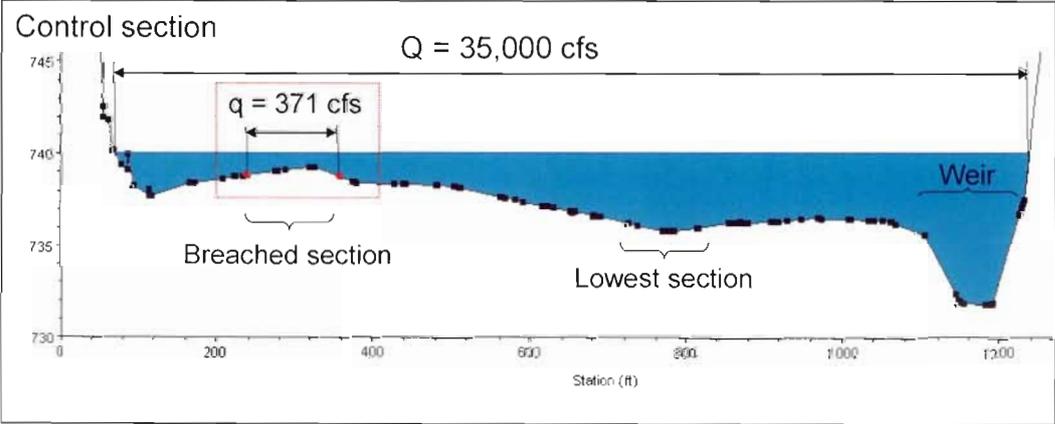
Figure 6. Model test locations.

The second stage consisted of a localized hydraulic analysis of segments of the structure. This second stage assumes that the flow (q) conveyed by a segment of the crest of the structure will flow perpendicular to the crest and that the flow remains constant over the downstream slope of the jetty. Figure 6 illustrates the situation where a total flow (Q) of 35,000 cfs flows over the jetty. In this example, a local flow (q) of 371 cfs would flow over the selected segment. It also assumes that for a given flow the headwater and tailwater elevations are the same for all sections along the jetty crest. In this stage 1-foot sections representative of different locations along the jetty and weir were selected.

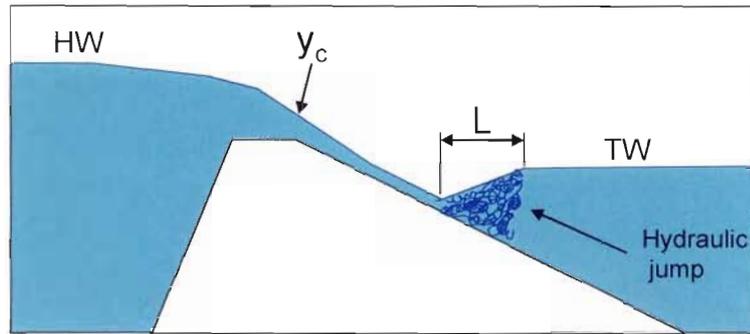
Figure 7. Hydraulic jump on a sloping apron schematic.

The second stage is based on basic open channel flow principles that include the development of a hydraulic jump on sloping aprons (Figure 7). It provides velocity estimates just before the jump occurs. This velocity is required to estimate recommended rock sizes. Rock size recommendations were obtained based on the COE Hydraulic Design Criteria Sheet 712-1 Stone Stability Velocity vs. Stone Diameter (Sheet 712-1).

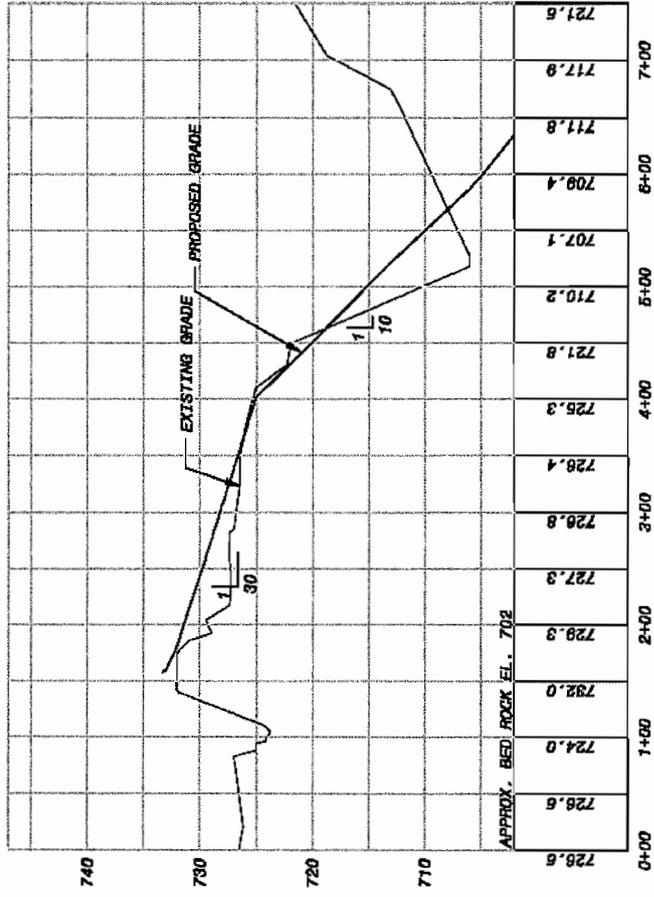
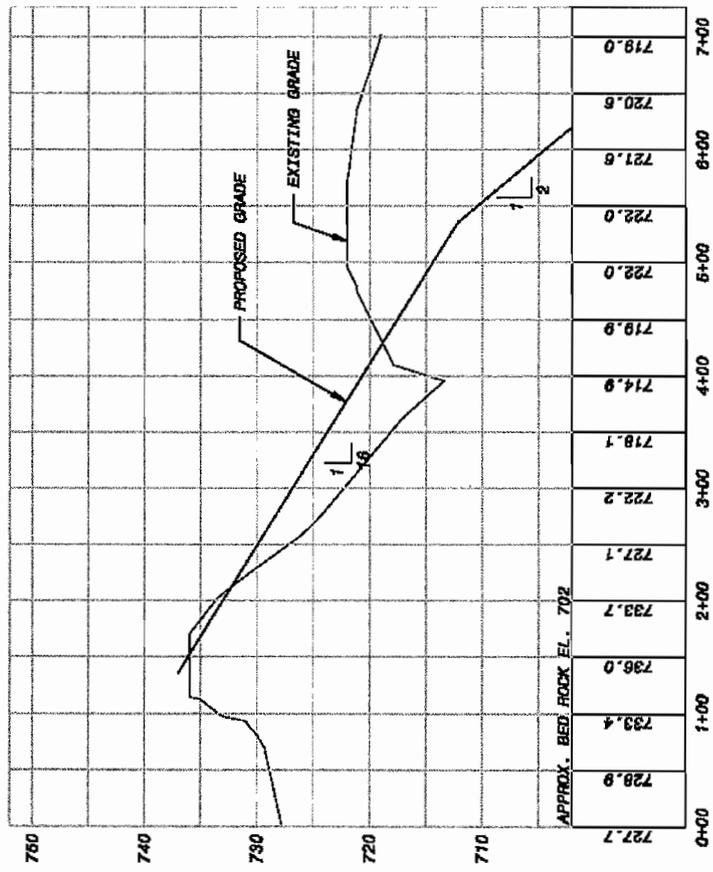
FIGURE 13

Figure 11 shows a plan view for this alternative. The shaded region shows the area that would have to be filled before the armoring is laid. Figure 12 and Figure 13 show profiles of the proposed 16:1 layout.

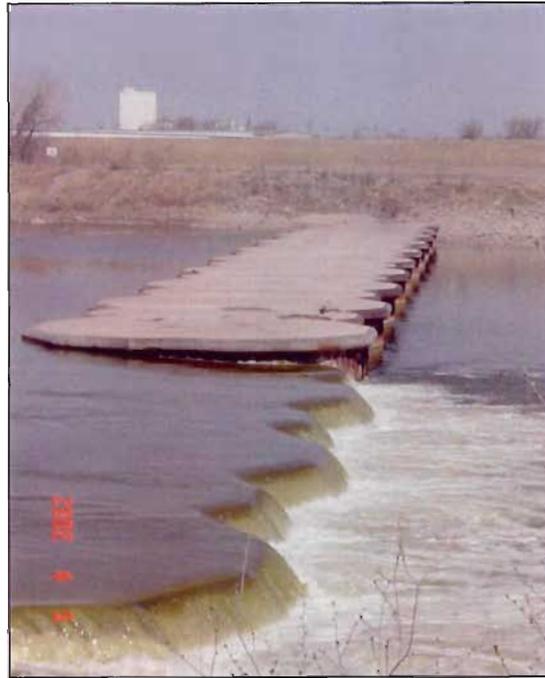
Figure 15. Cofferdam in the Kansas River in Topeka, Kansas.

Plan D from the 1988 Black and Veatch report is by far the most permanent solution. This plan proposes the construction of a sheet pile cellular cofferdam downstream from the structure (Figure 15 and Figure 16). The proposed cofferdam would look similar to the one presented in Figure 15; which is a photograph of the cofferdam built in the Kansas River in Topeka, Kansas. The proposed cofferdam would substitute for the existing jetty. The existing jetty would not need to be removed.

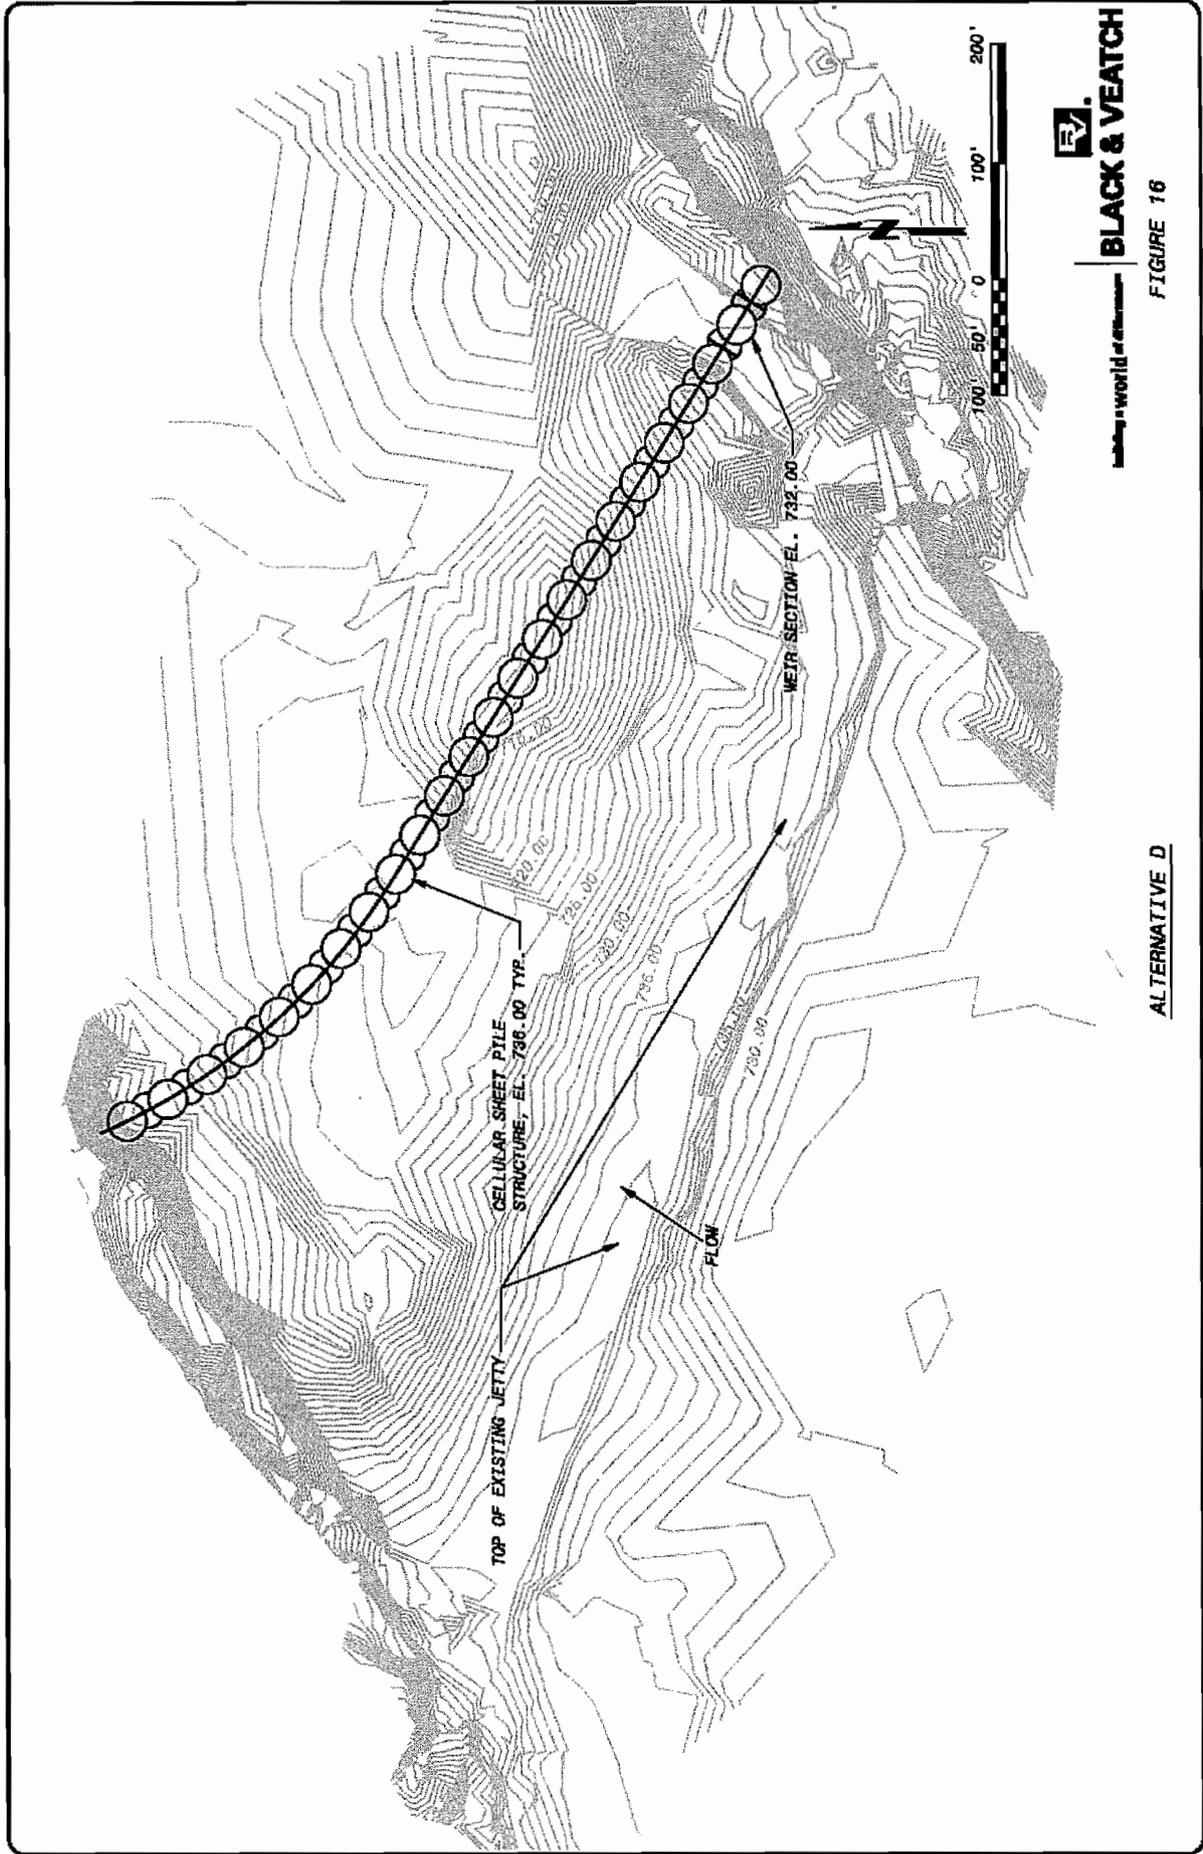
Preliminary calculations indicate that the coffer dam cell size should be of 34 ft in diameter. A total of 24 cells and 23 interconnecting arcs would be needed to build the cofferdam across the river (Figure 16). The coffer dam would have a crest elevation of 736.0 across the river. It would include a low water weir near the south bank with a crest elevation of 732.0. The weir would be formed by lowering one of the cells of the coffer dam. The cofferdam would be curved to form an angle greater than 90° with respect to the riverbanks to divert flow away from the riverbanks and toward the center of the river. This curved shape would reduce erosion potential to the riverbanks.

Hydraulic simulation in HEC-RAS indicates that lowering one of the cells down to elevation 732.0 would maintain the headwater elevation above the minimum level required for operation of the intake (Elevation 734.0), for stream flows above 400 cfs. If additional head is required the low water weir length can be reduced by adding concrete walls on the sides of the sill.

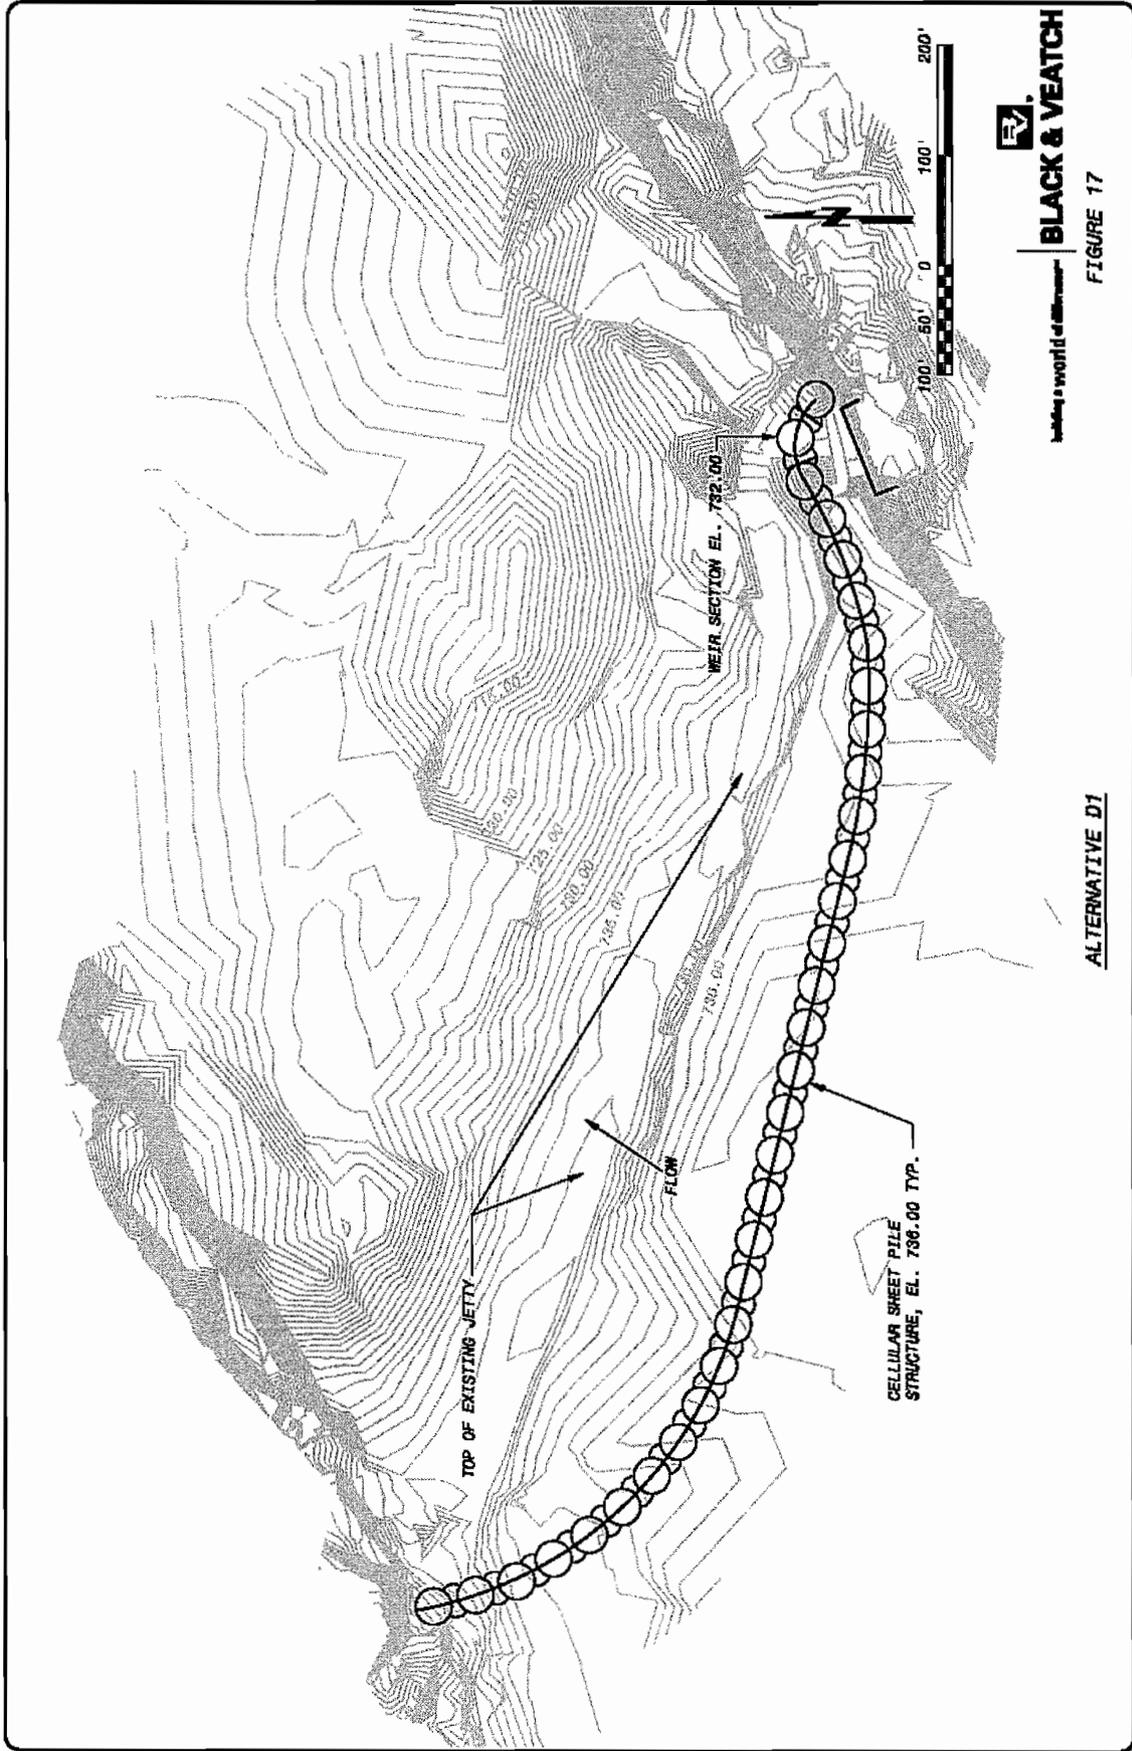
FIGURE 17

Alternative D1 consists of building the cofferdam just upstream of the structure instead of downstream (Figure 17). The size and specifications are essentially the same as with Alternative D. A total of 33 cells will be required.

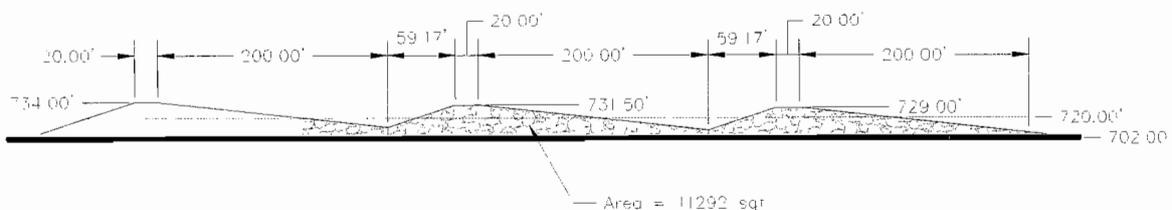
Figure 18. Stepped dams schematic

Under existing conditions the maximum step that would have an effect on improving the jetty stability is 2.9 ft. A larger step would not impact the stability of the existing jetty because the flow conditions on its downstream face would remain unchanged. A 2.9 ft step would make conditions marginally better, thus a shorter step is desirable. If a 2.5 ft step is used two more dams would be required.
