Post 2019 Flood Area of Concern (AOC)
Repairs CONCEPT DESIGN MAPS for
3 Phase Approach

21 AOC Sites

4 Additional MRRP Sites

U.S. ARMY ENGINEER DISTRICT
CORPS OF ENGINEERS
KANSAS CITY, MISSOURI

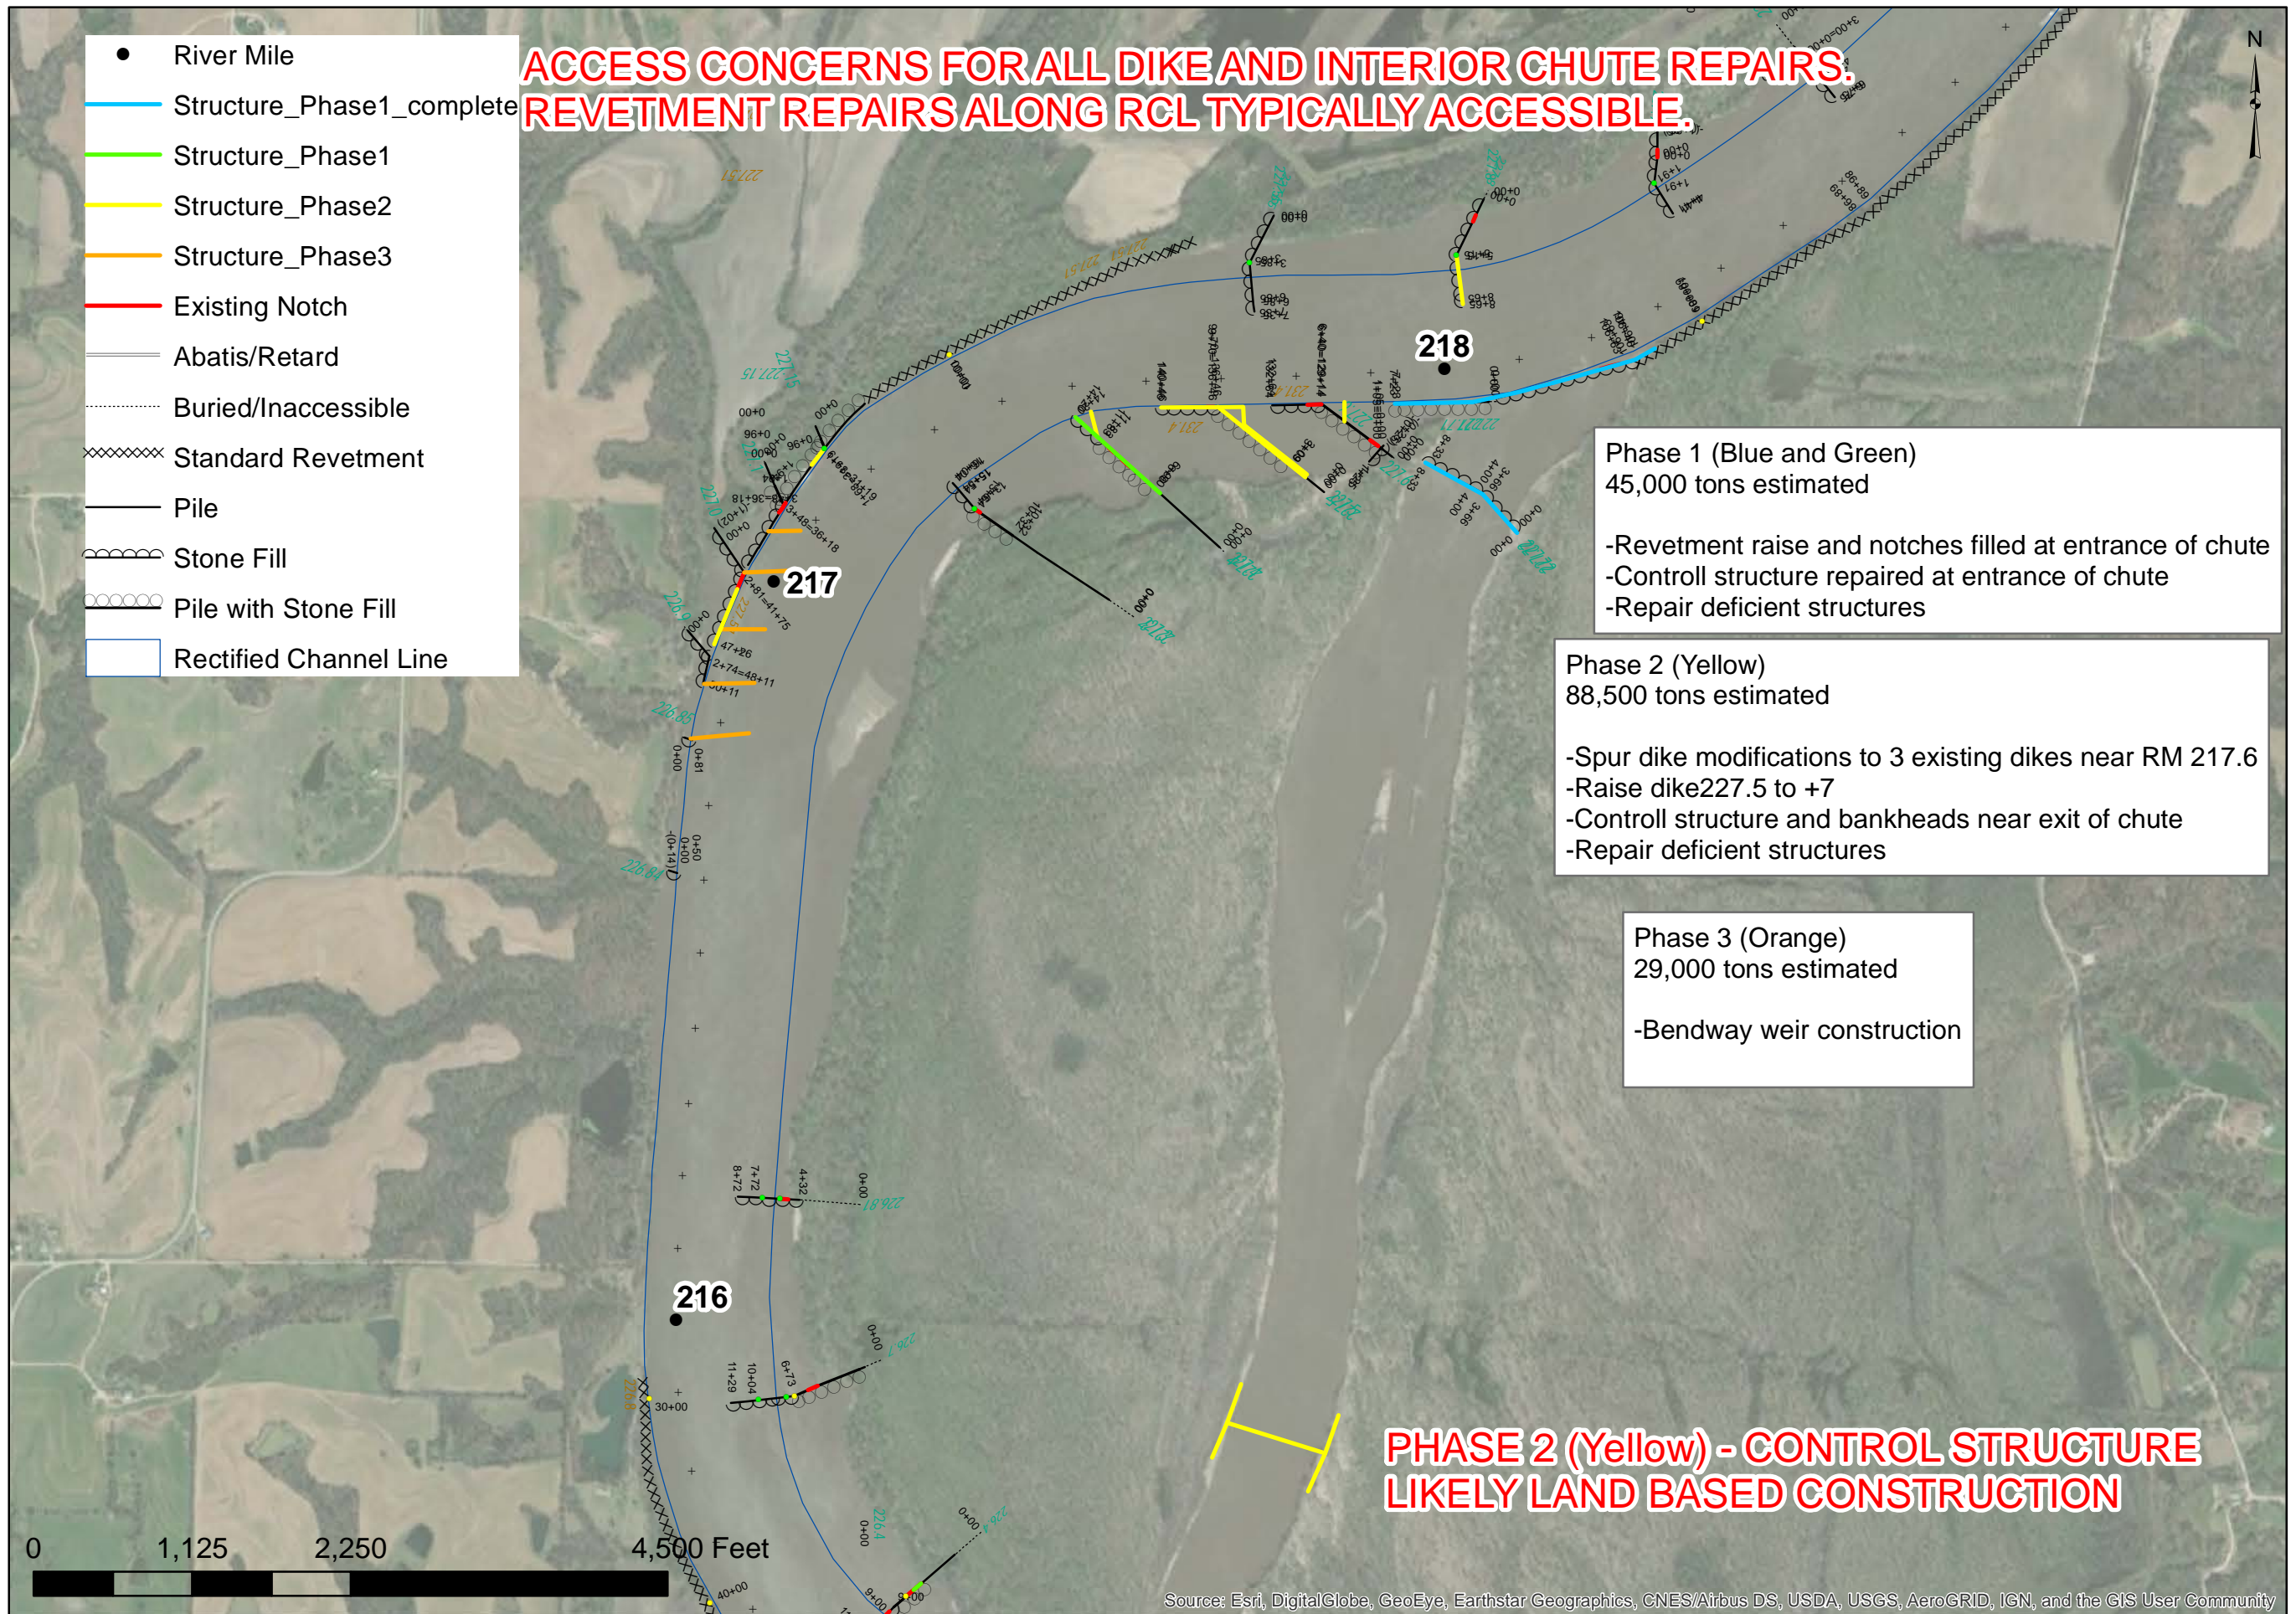
Sheet Reference Number:
C-100

ACCESS CONCERNS FOR ALL DIKE AND INTERIOR CHUTE REPAIRS. REVETMENT REPAIRS ALONG RCL TYPICALLY ACCESSIBLE.

- Repair control structure
- Revetment raise and repair at entrance of chute
- Dikes 225.0 and 224.7 repair and connect to bank
- Repair deficient structures

- Remove 150ft of dike 255.1
- Kicker extension revetment 226.8
- Revetment protecting island tip and connecting dike 225.0 to existing control structure
- Two new dikes at RM 213 to prevent inner bend channel
- Bank protection to prevent closure structure flanking
- Revetment raise at chute exit
- Repair deficient structures
