**MISSOURI RIVER LEVEE SYSTEM
RIVERSIDE-QUINDARO BEND LEVEES AND STRUCTURES
LEVEE UNIT L-385**

**US Army Corps
of Engineers** ®
Kansas City District

RIVERSIDE-QUINDARO BEND
LEVEE DISTRICT

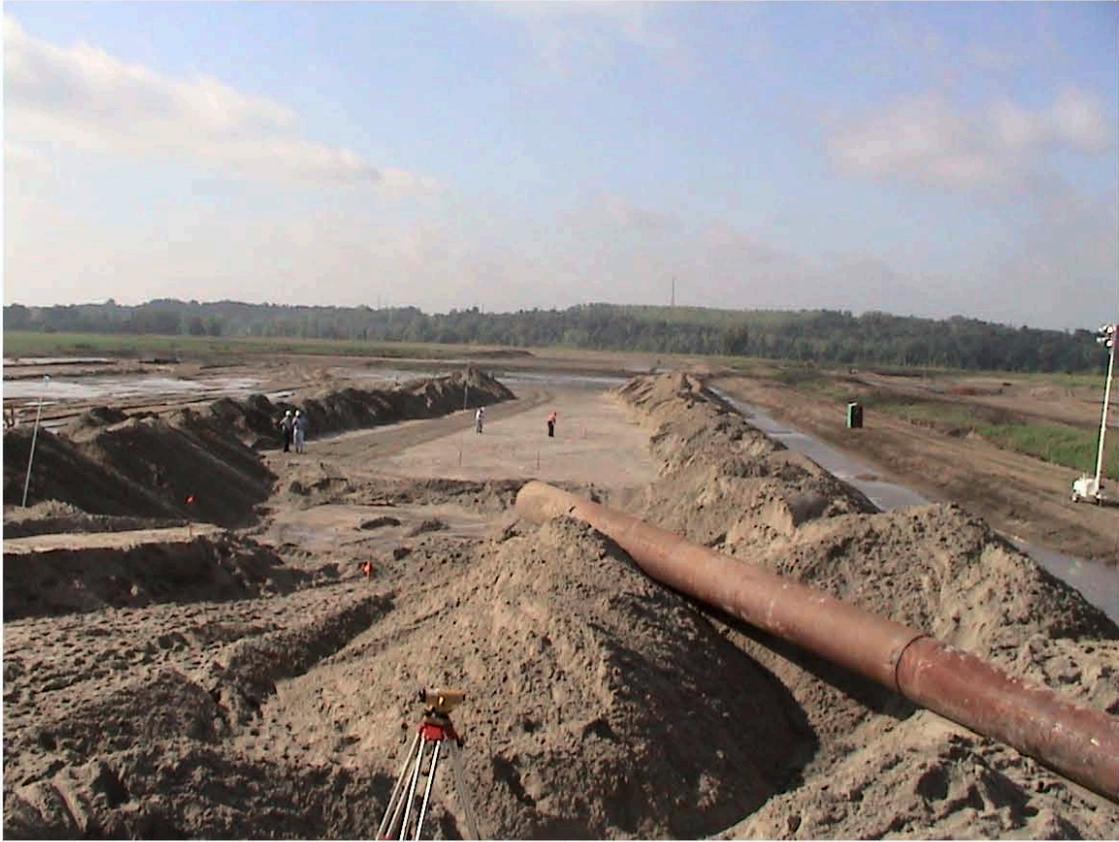
Dredging sand from the Missouri River for levee construction.

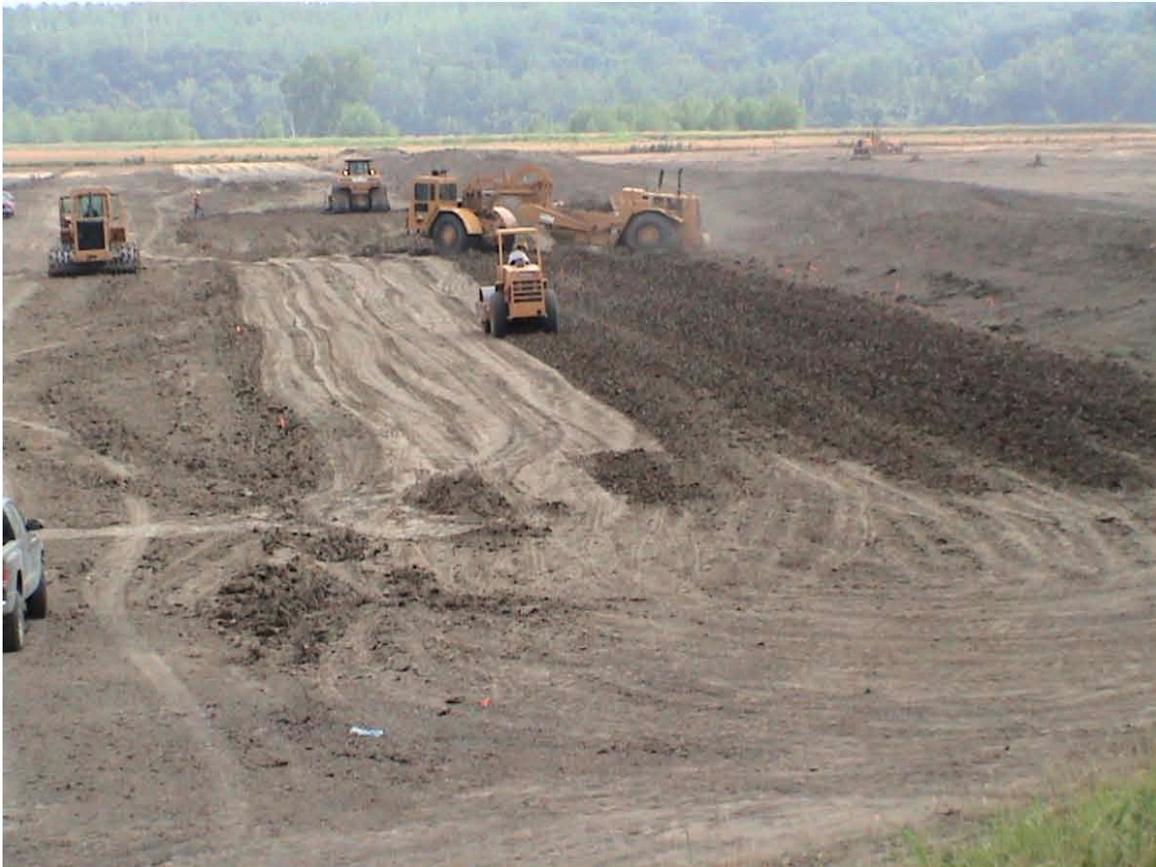
Typical earthwork operations during levee construction.

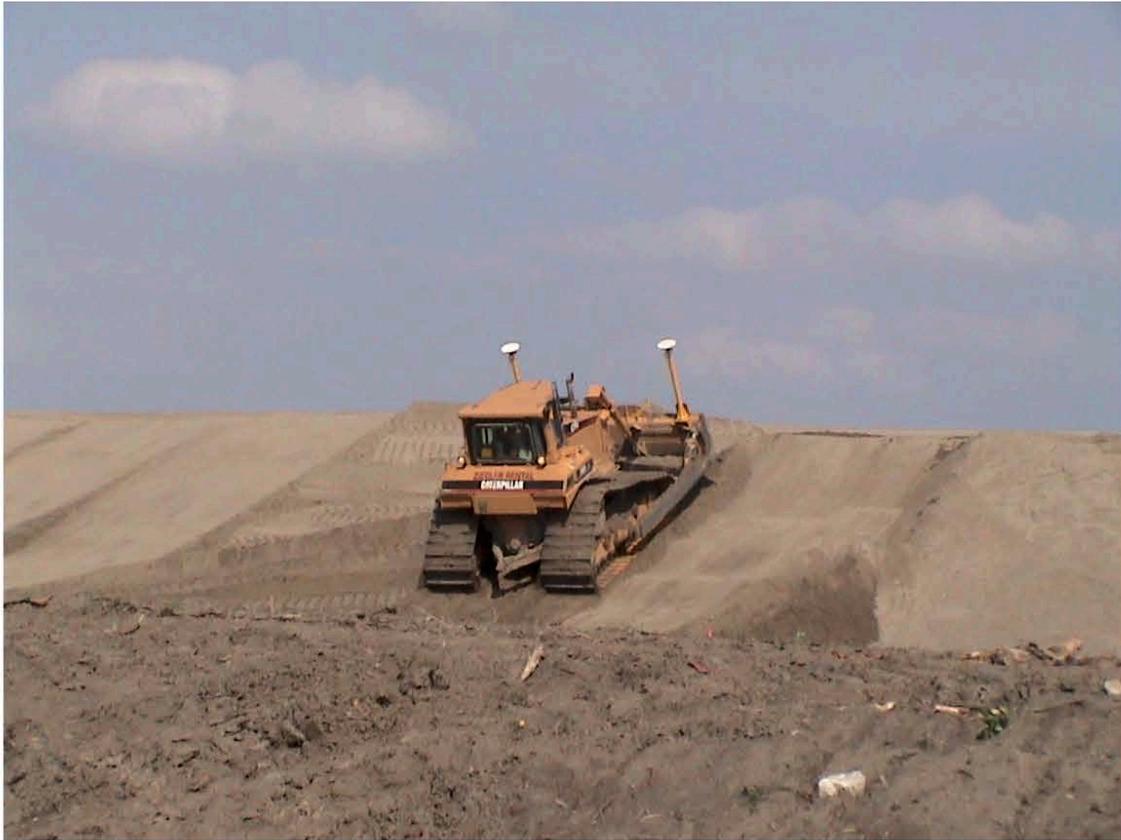
A dozer setting final grade of levee using GPS receivers on blade.

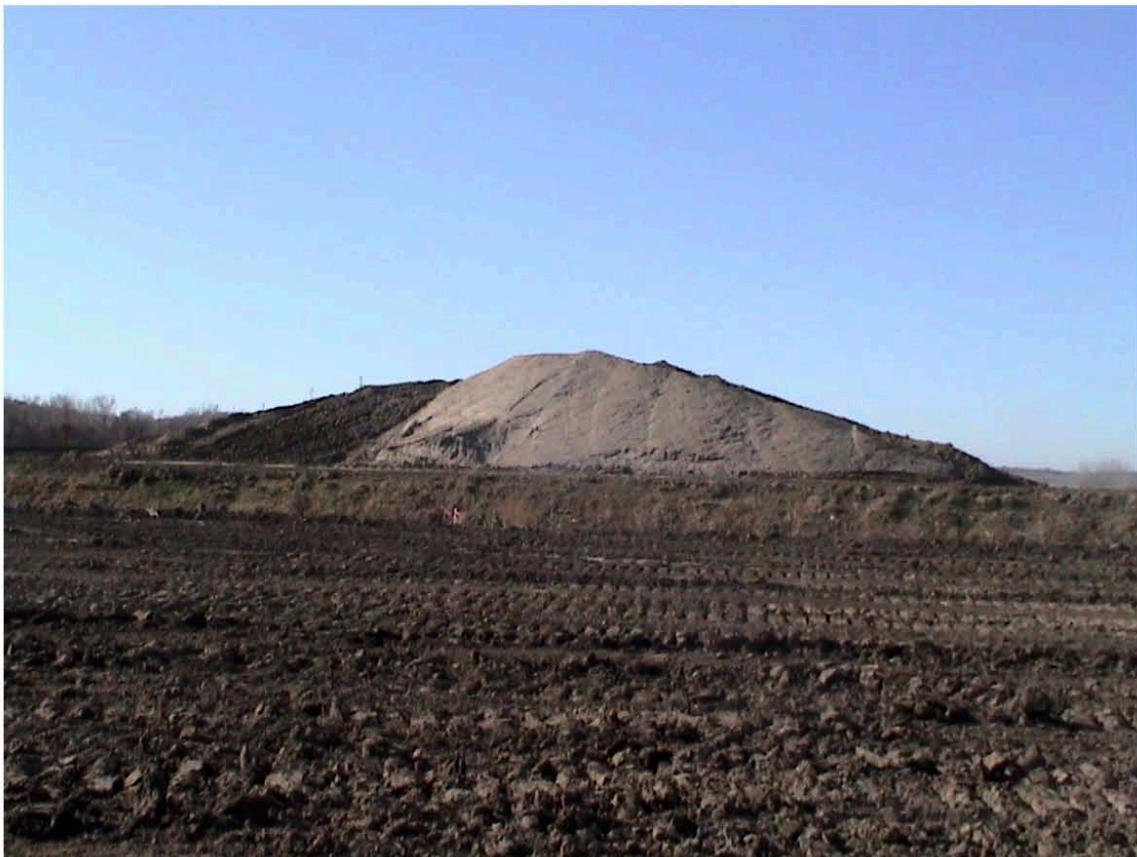
A typical cross section of levee showing random & impervious fill.

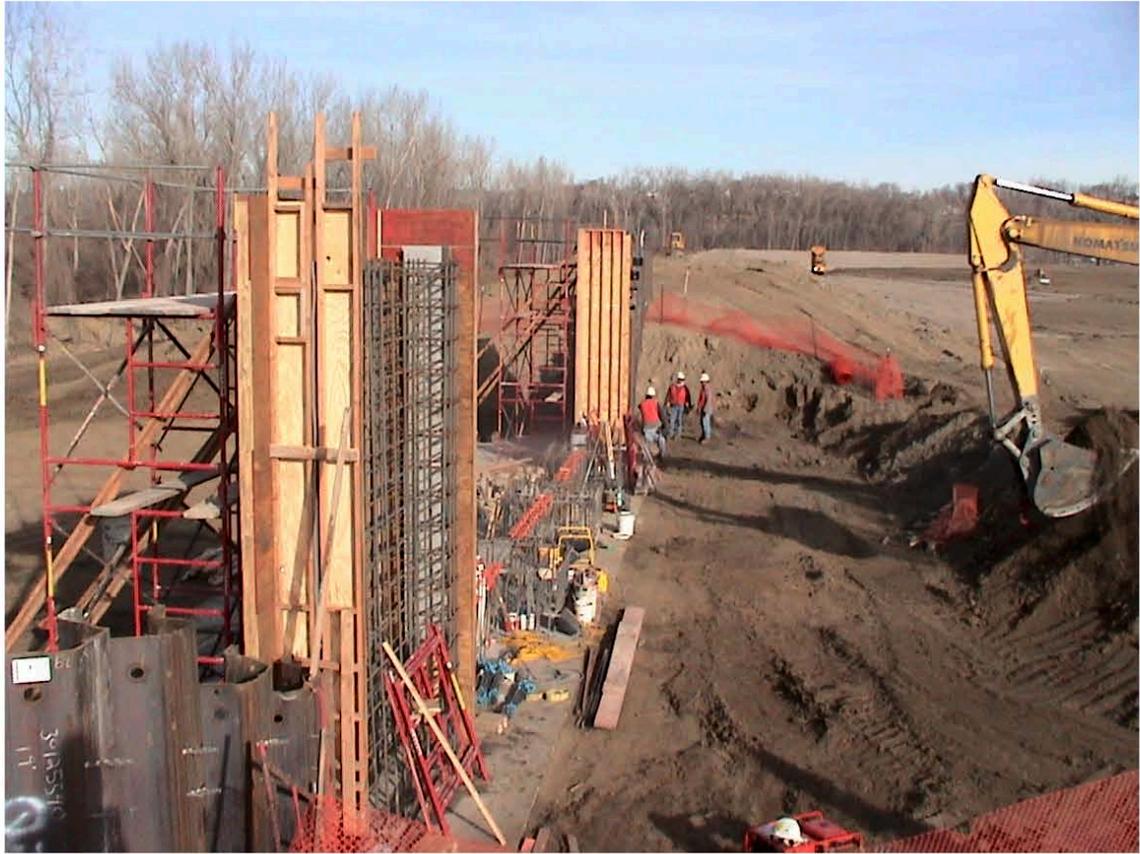
A stoplog gap under construction.

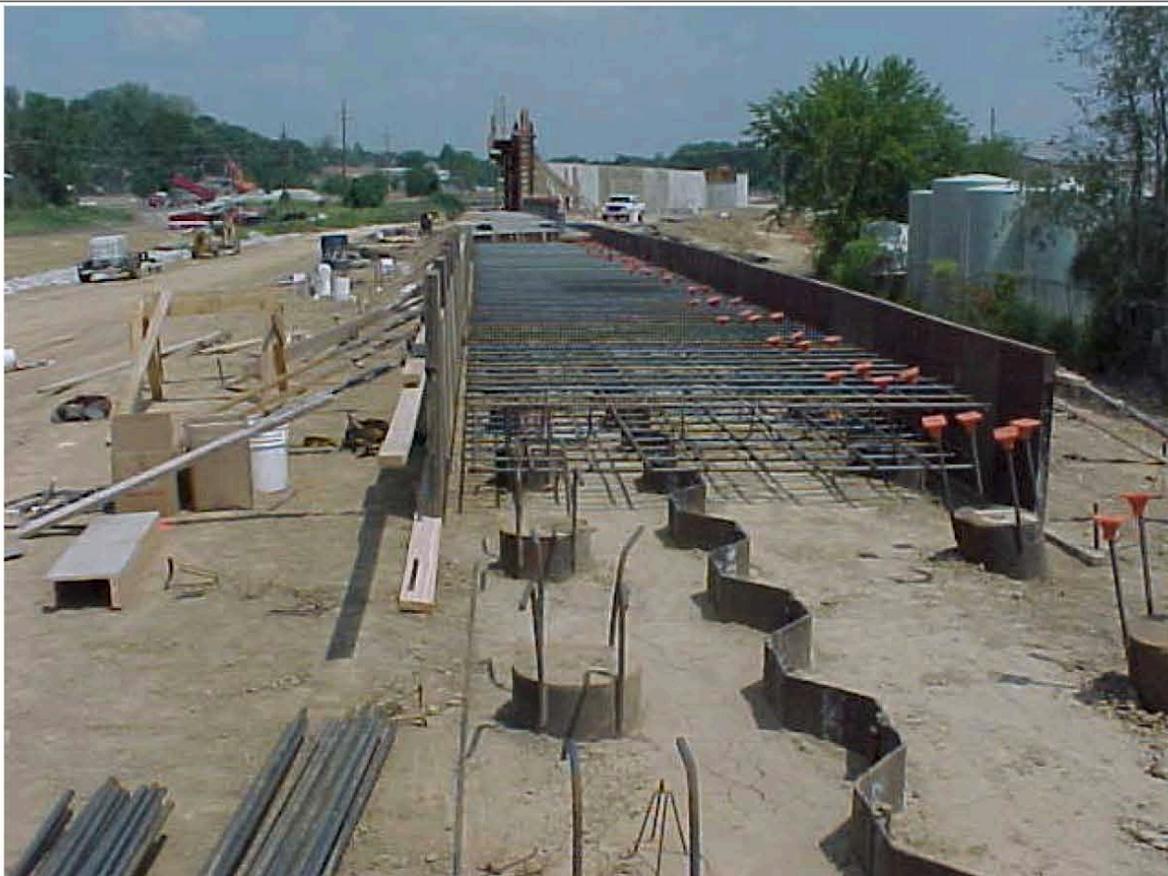
Line creek floodwall-Note the pipe piles, steel sheet-pile cutoff, pipe cap & completed floodwall in background.

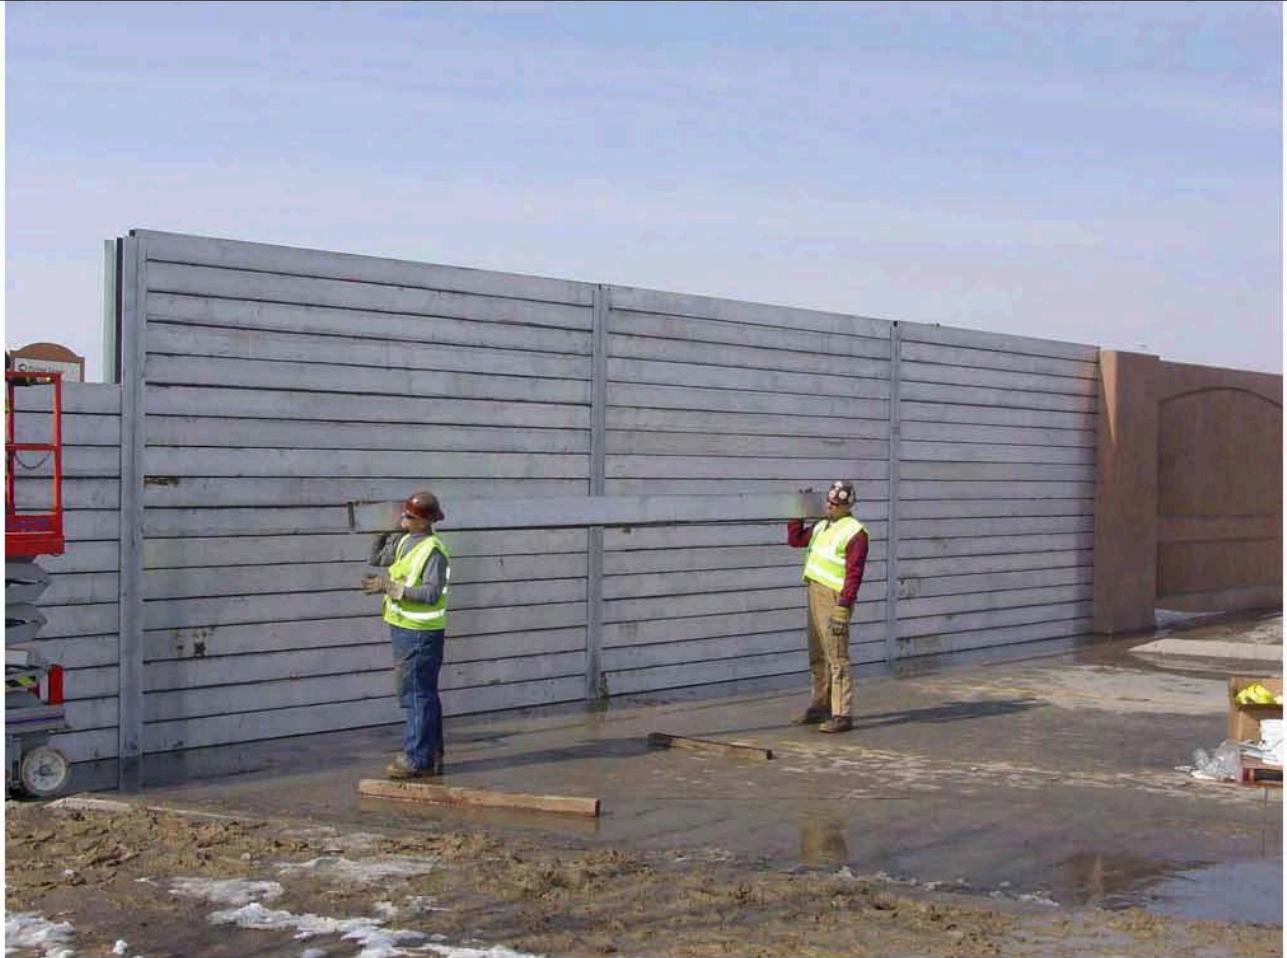
Stoplog gap being closed for the first time.

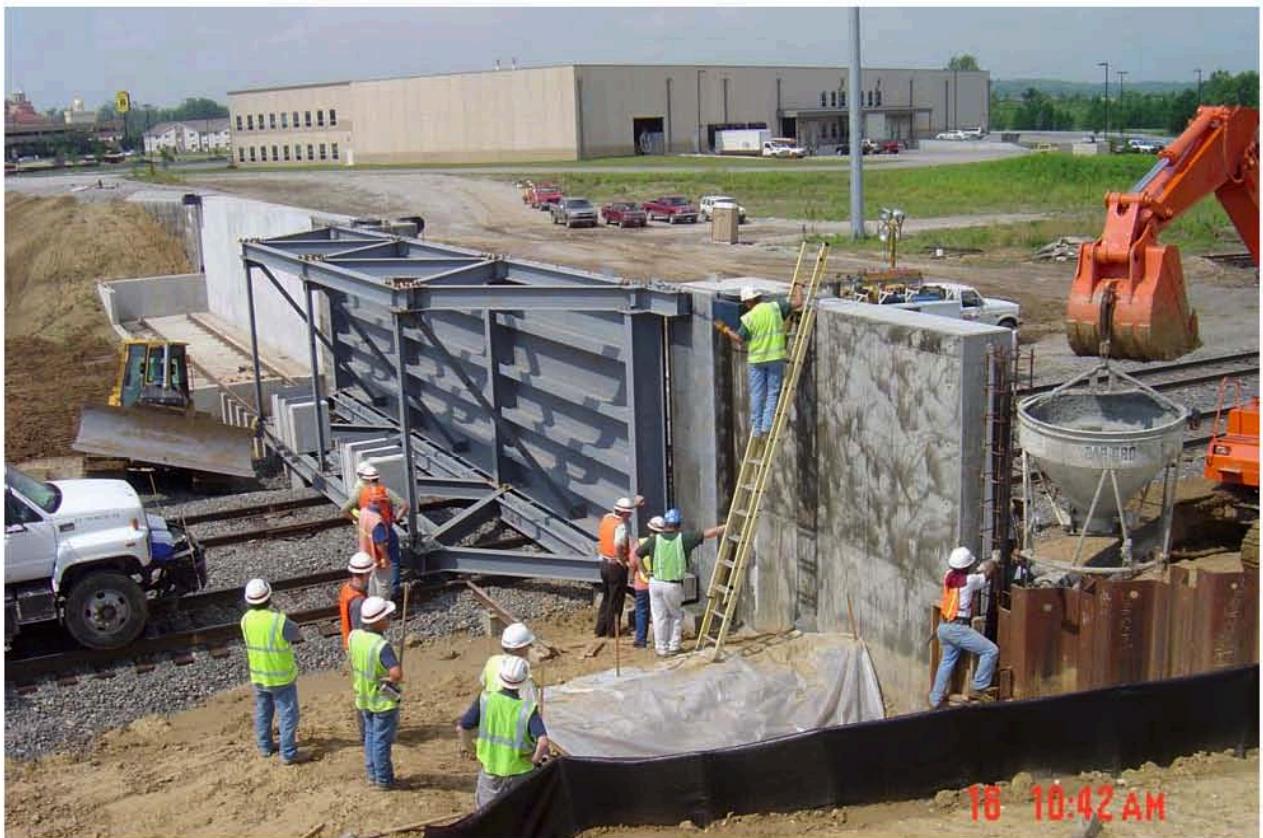
Rolling gate being constructed over the railroad tracks.

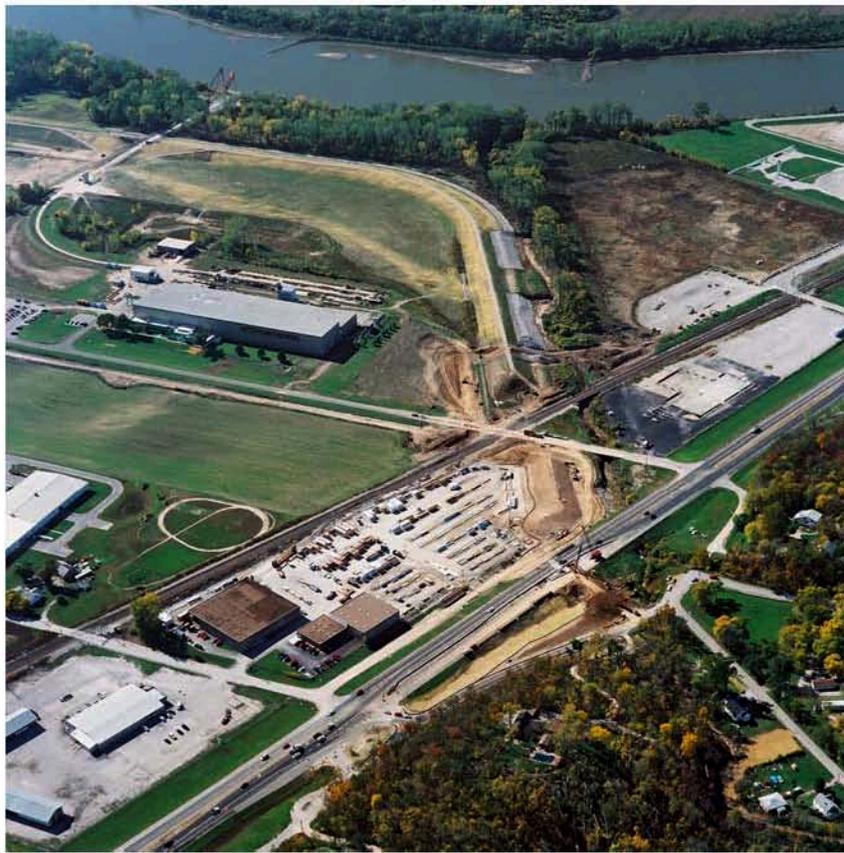
Aerial photo showing levee under construction in tight quarters between the railroad and MO Hwy 9.

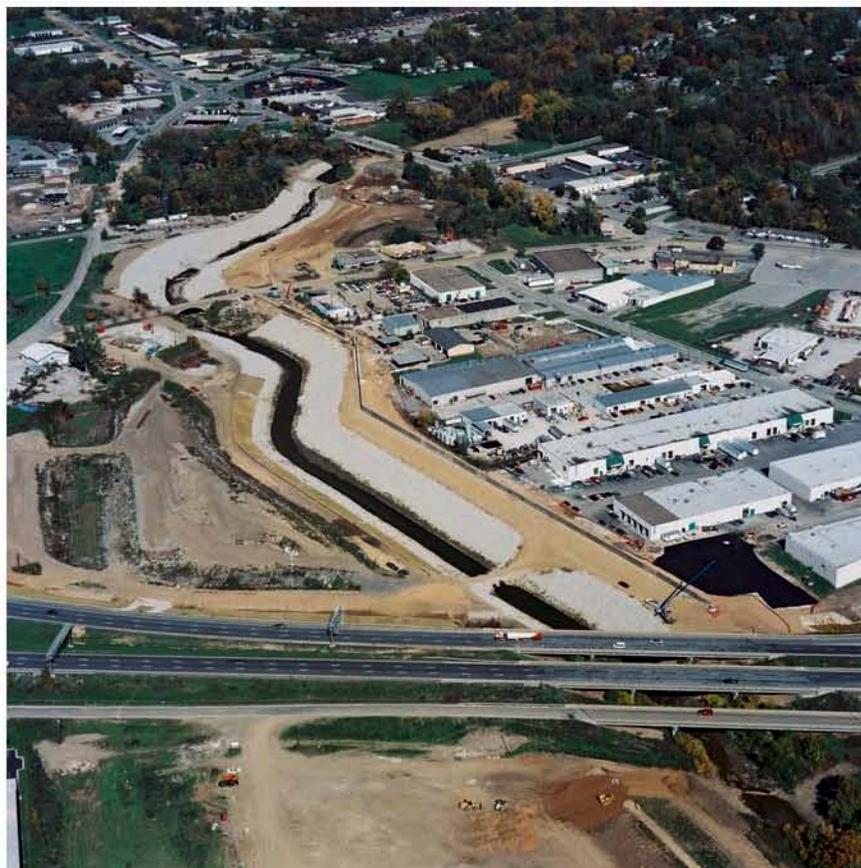
Aerial photo showing Line Creek-Note the floodwall running along the bank near the industrial park.
