RECURRING REVIEW REPORT
Former Jefferson Barracks Post Dumping Grounds
St. Louis County, Missouri

Defense Environmental Restoration Program
Formerly Used Defense Site
Site ID: B07MO0143

September 2014

U.S. Army Corps of Engineers
Kansas City District
Kansas City, Missouri

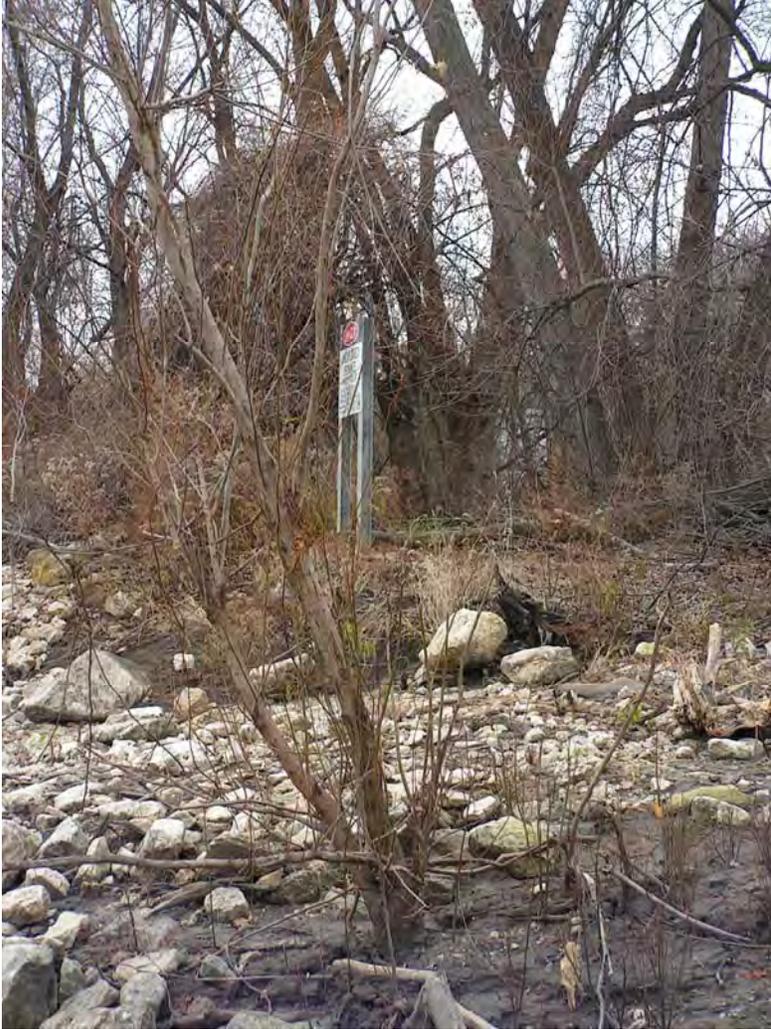
Newly installed warning sign

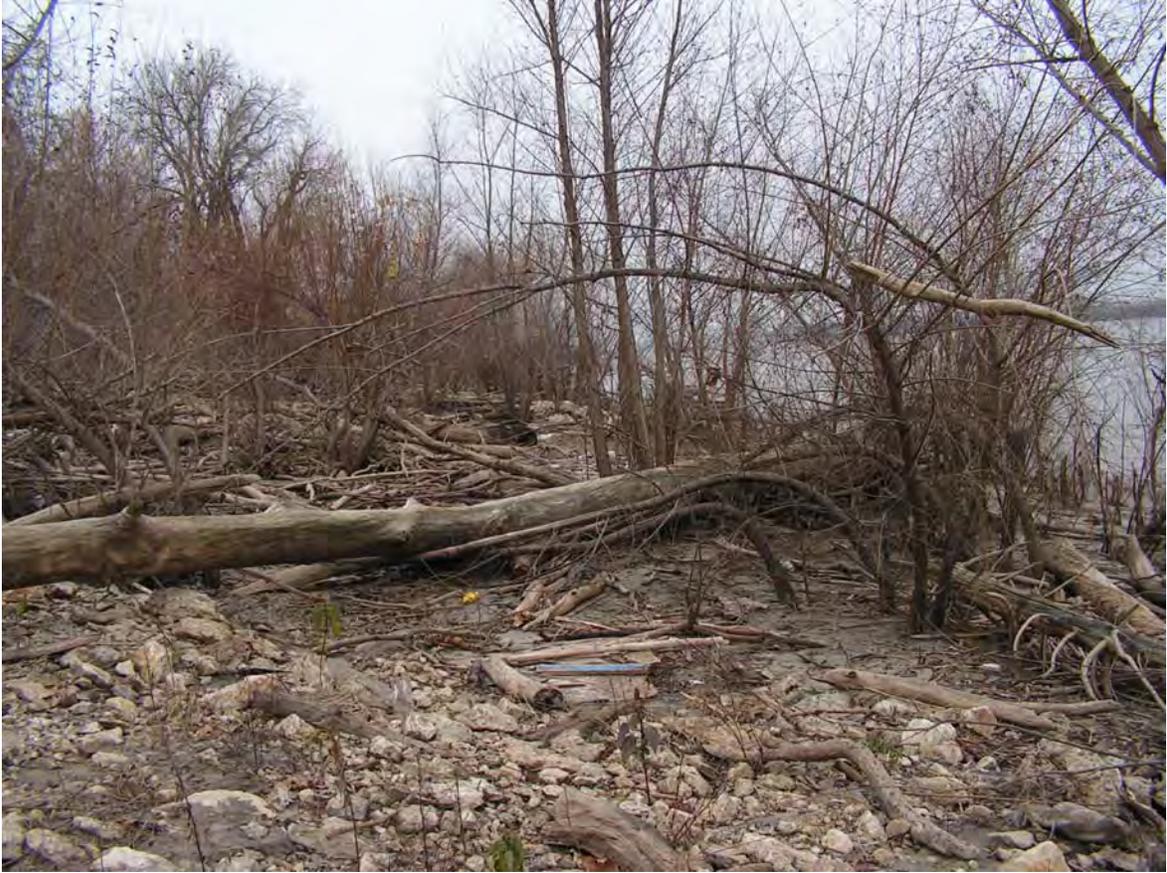
Extensive tree growth on riprap

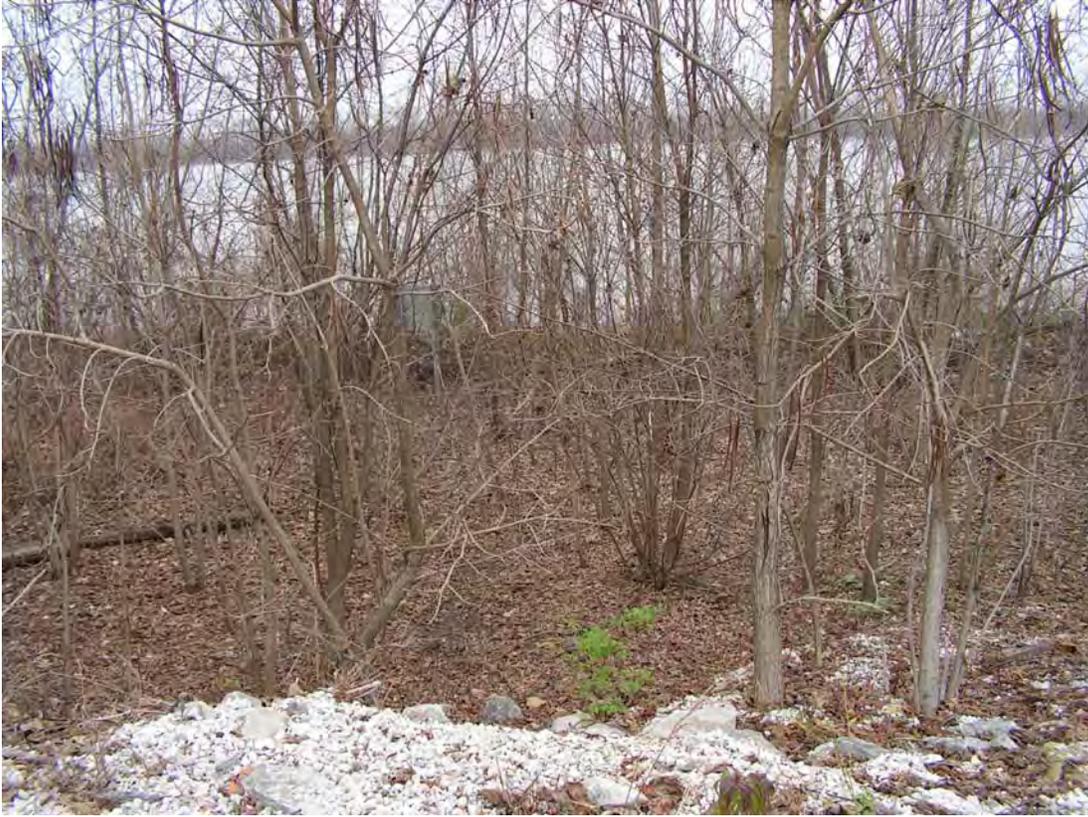
Extensive tree growth on top of riprap

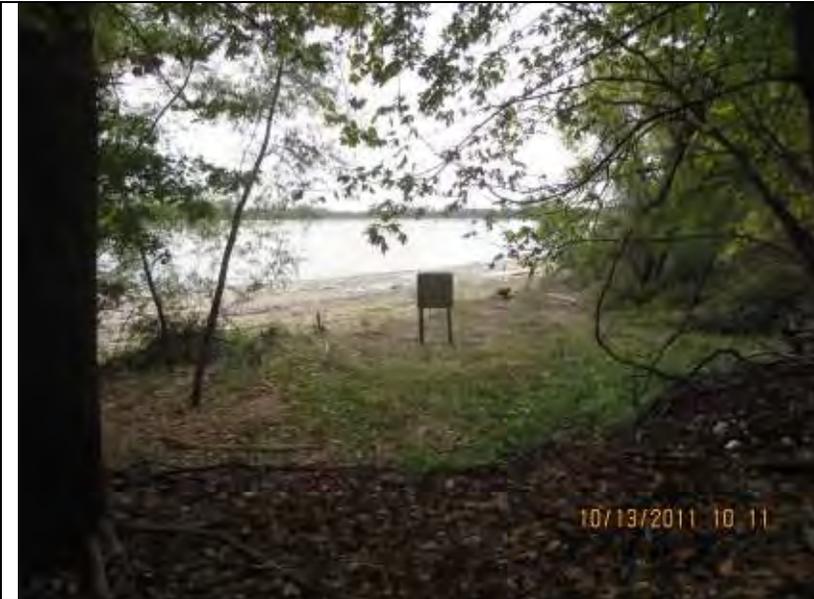
Back of sign 7, facing southeast.

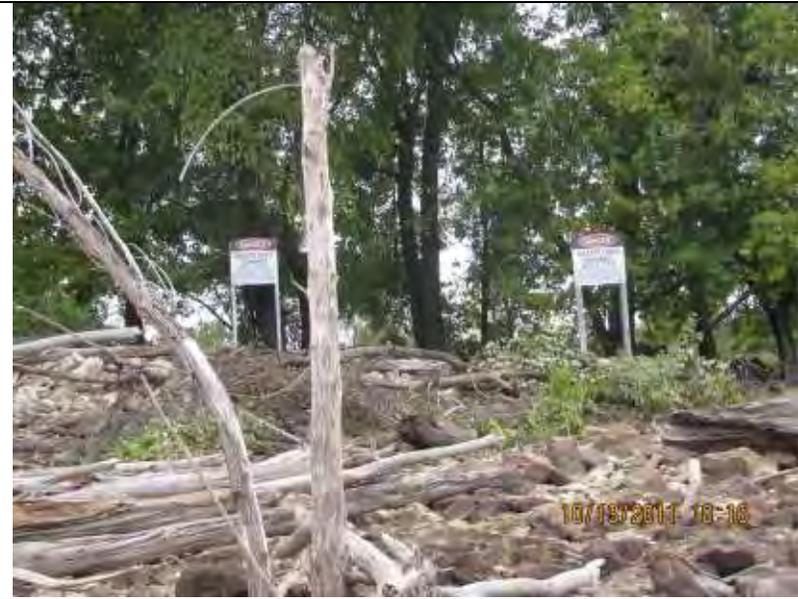
Sign 8, facing west. Sign on left is new sign.

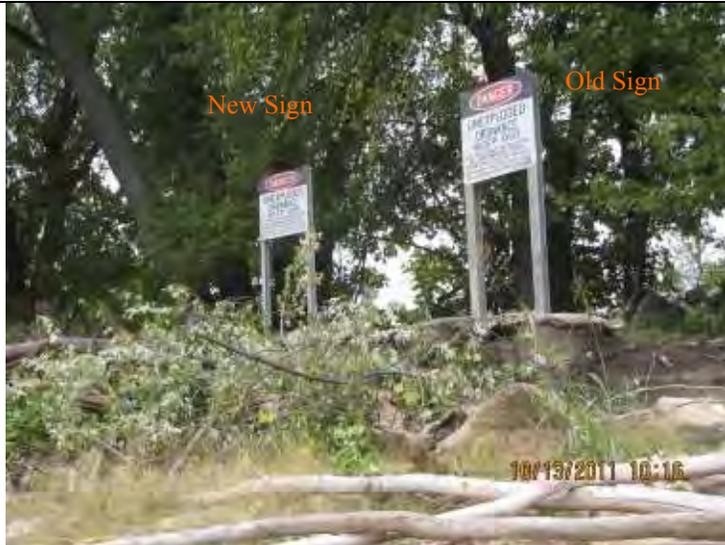
Sign 8 facing southwest. Undercutting visible on old sign pad.

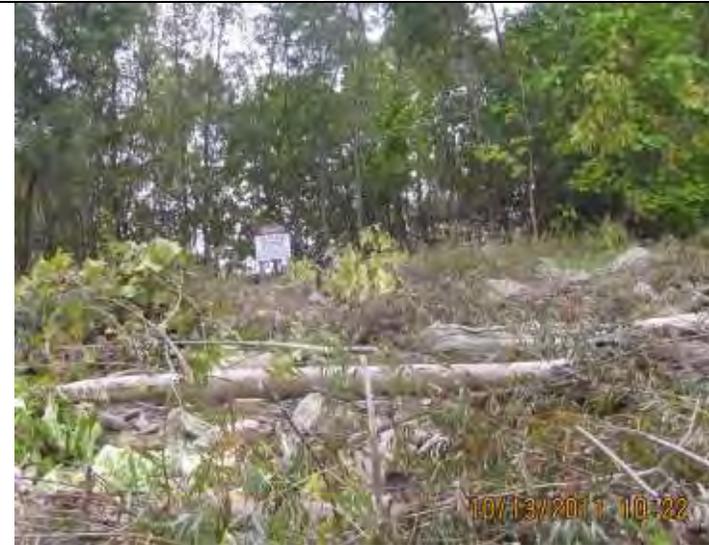
Sign 9, facing west.

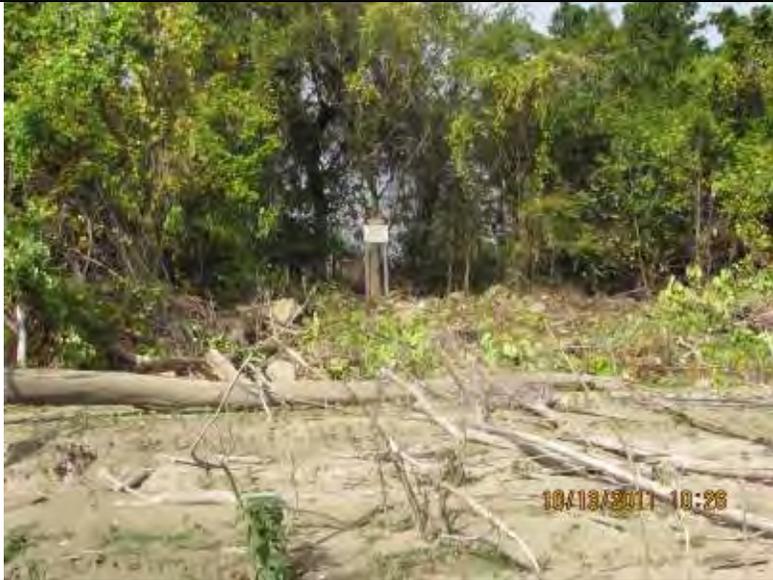
Sign 10, facing west.

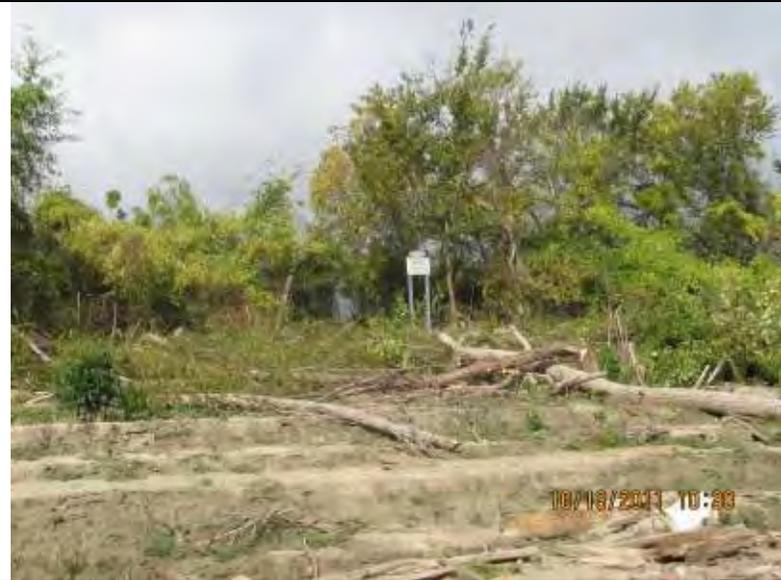
Sign 11, facing west.

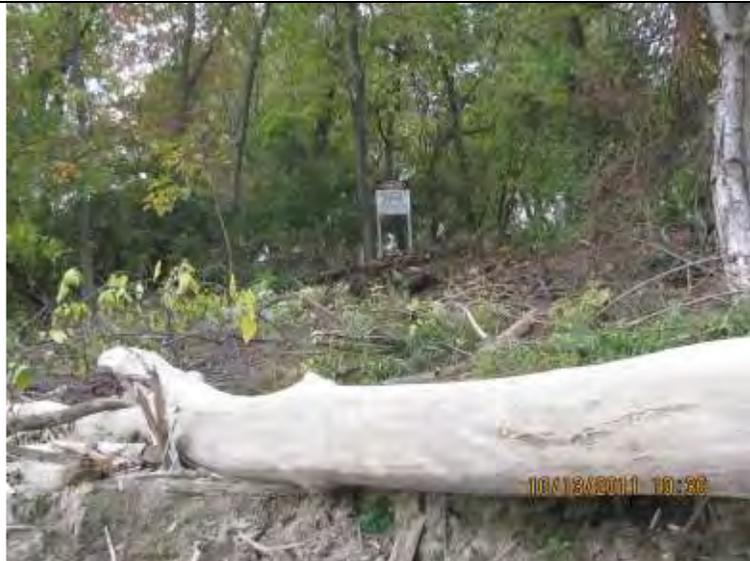
Sign 12, facing southwest.

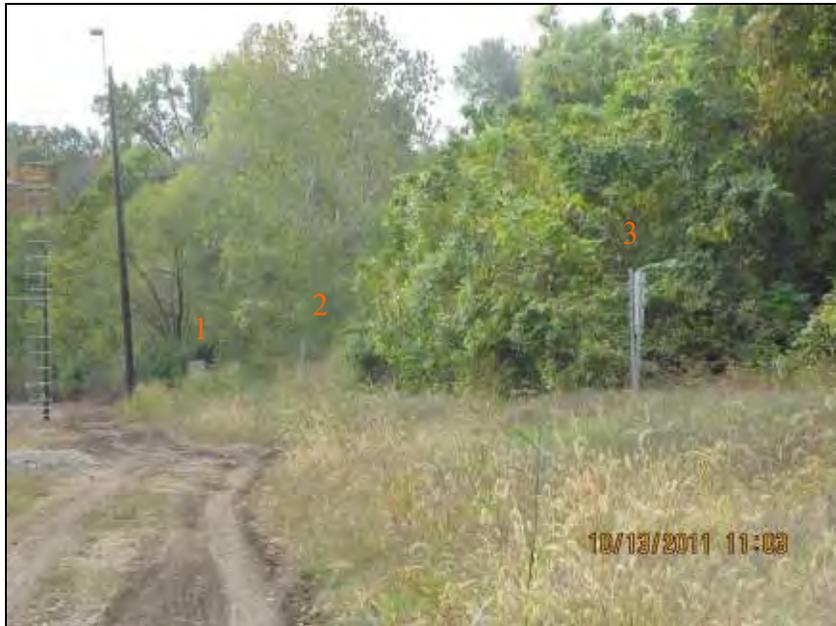
Signs 1-3, facing southwest.

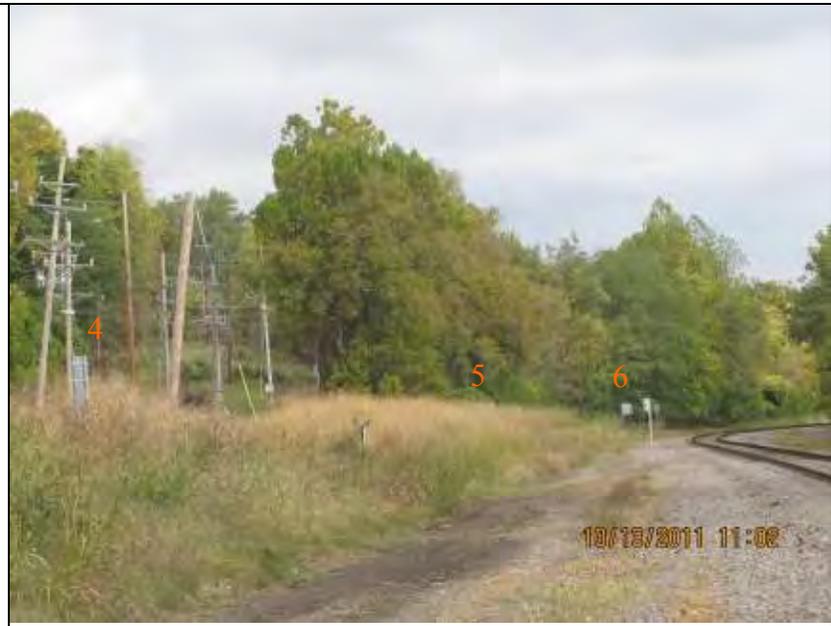
Signs 4-6, facing northwest.

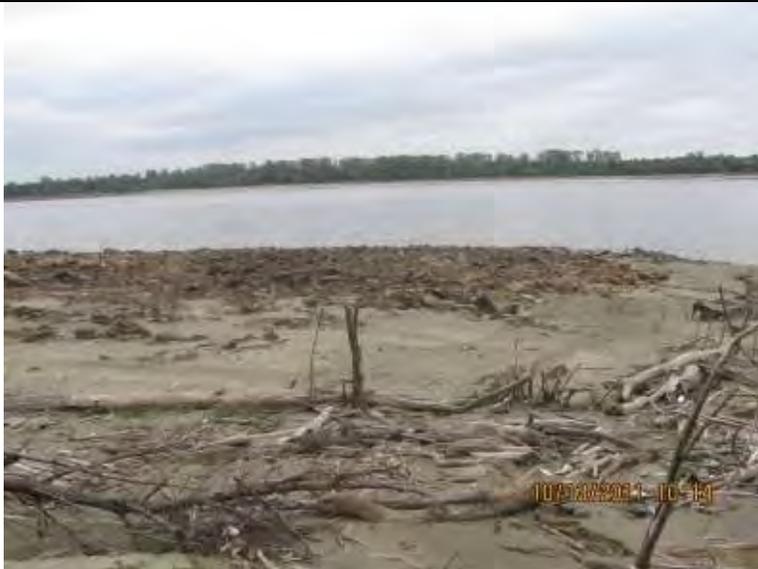
Beginning of rip-rap, facing east.

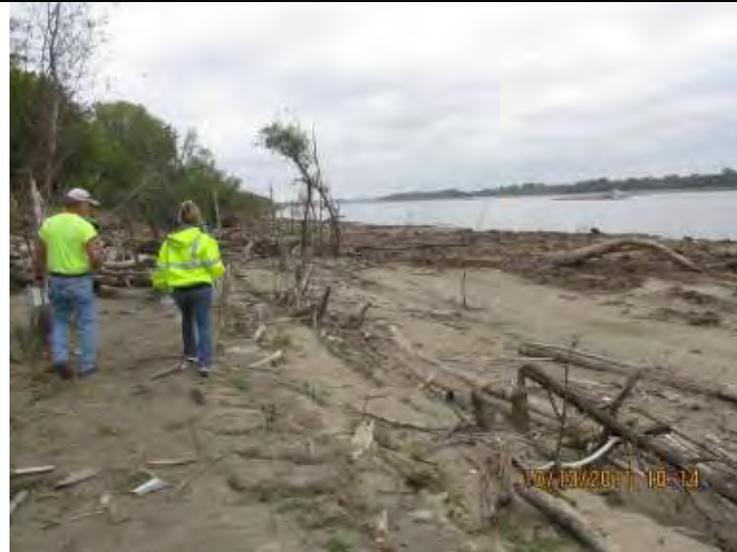
Beginning of rip-rap, facing northeast.

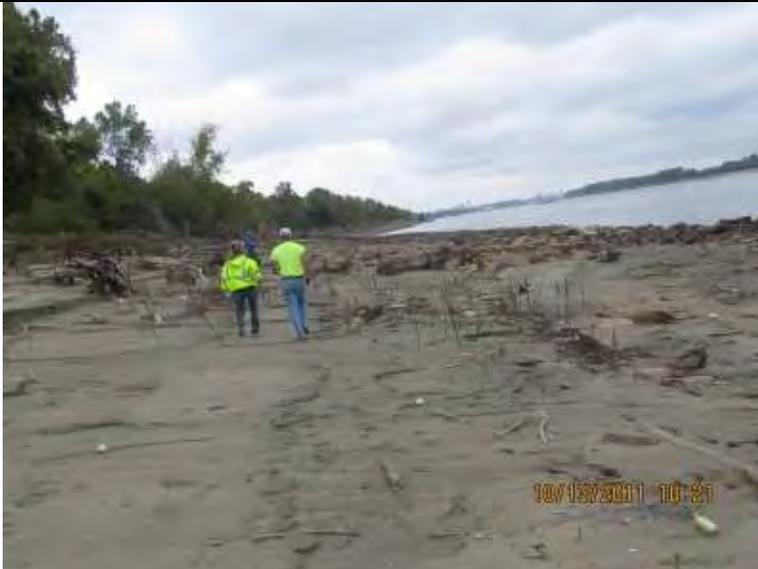
Rip-rap, facing north.

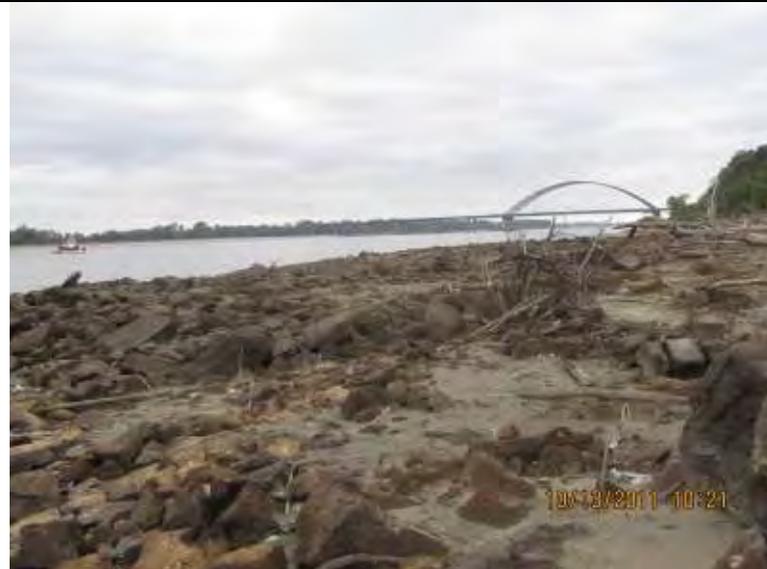
Rip-rap, facing south.

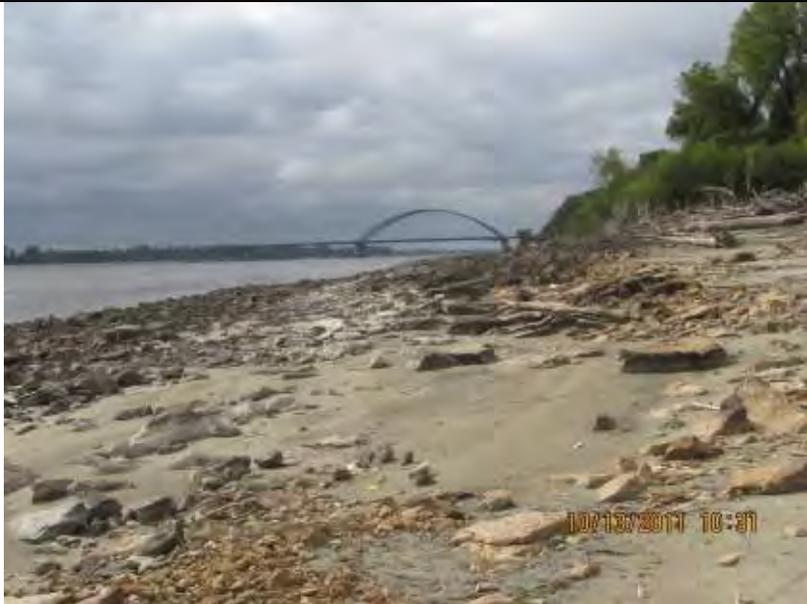
End of rip-rap, facing south.

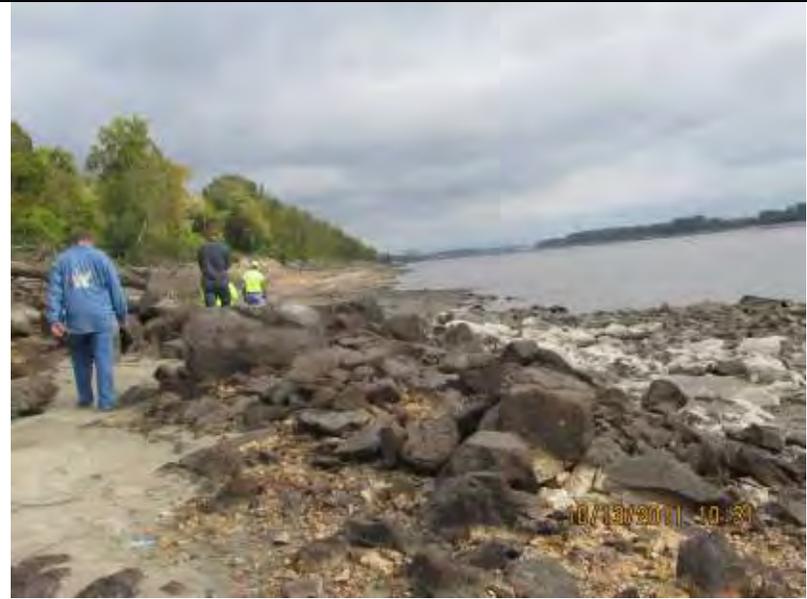
End of rip-rap, facing north.

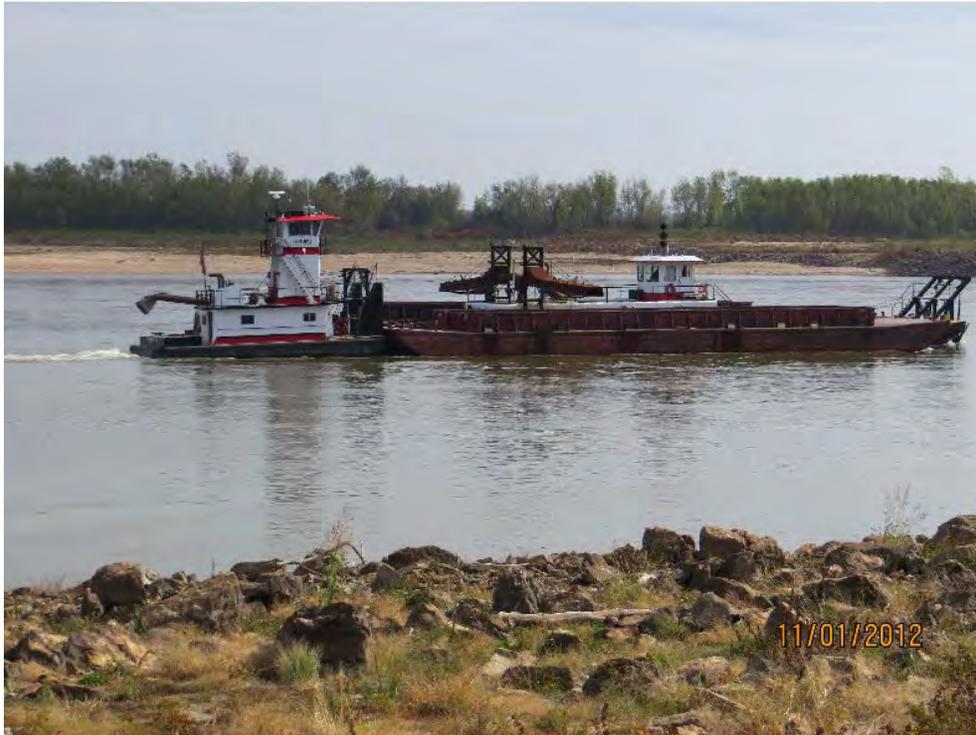
Lower riprap area looking east with barge in the background
photos courtesy of Ramona Huckstep, MDNR

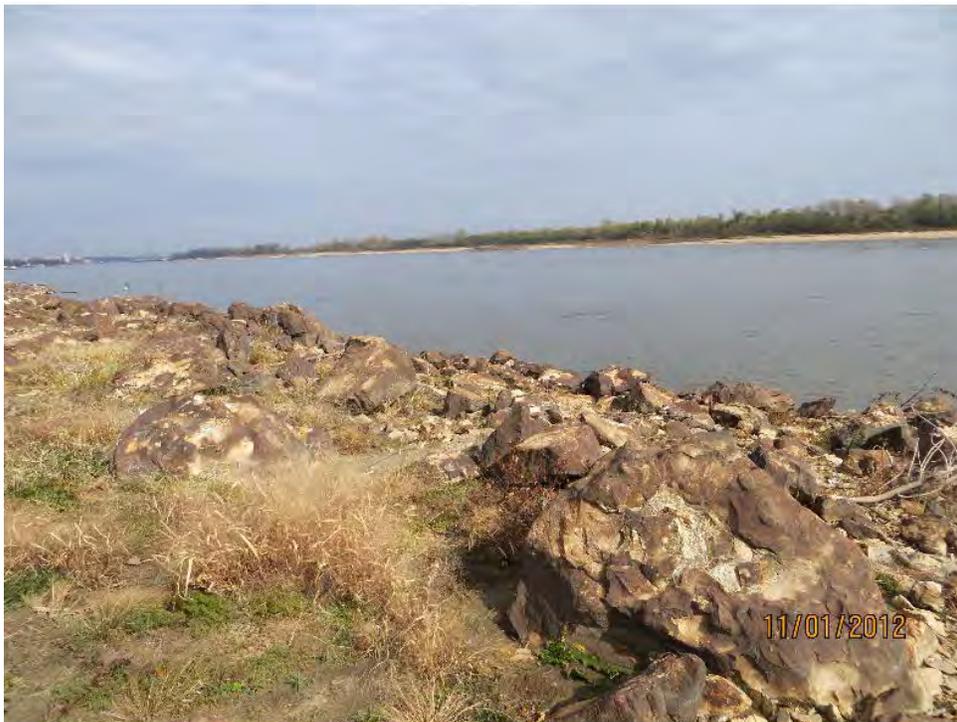
Lower riprap area looking northeast

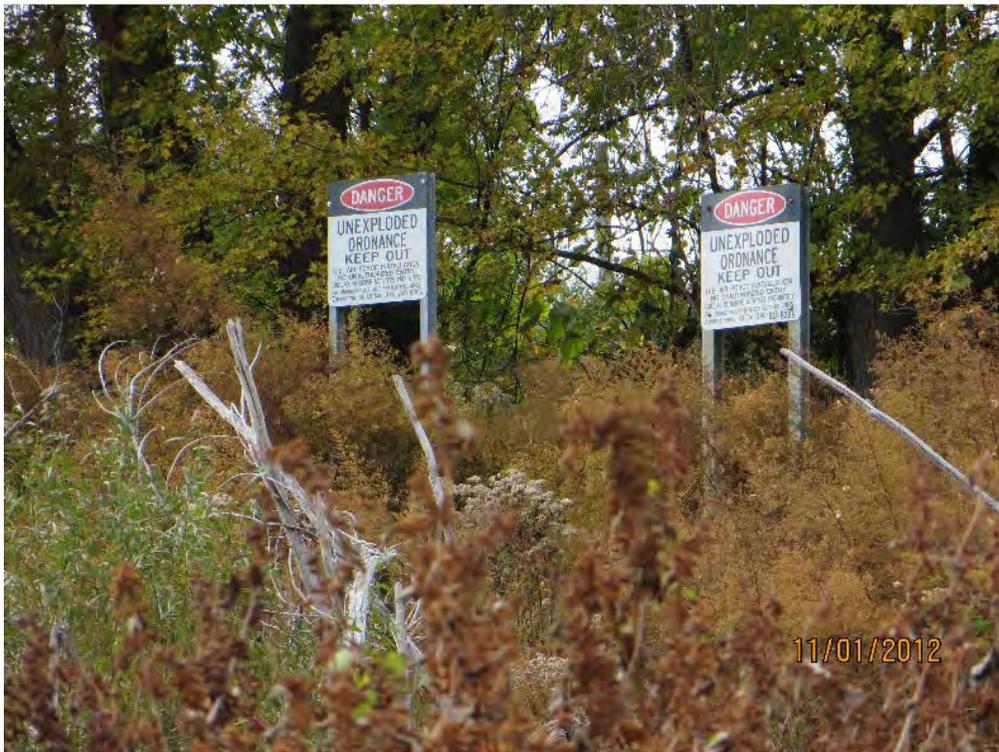
Replacement warning sign on left. Older warning sign still stands even though base has eroded.

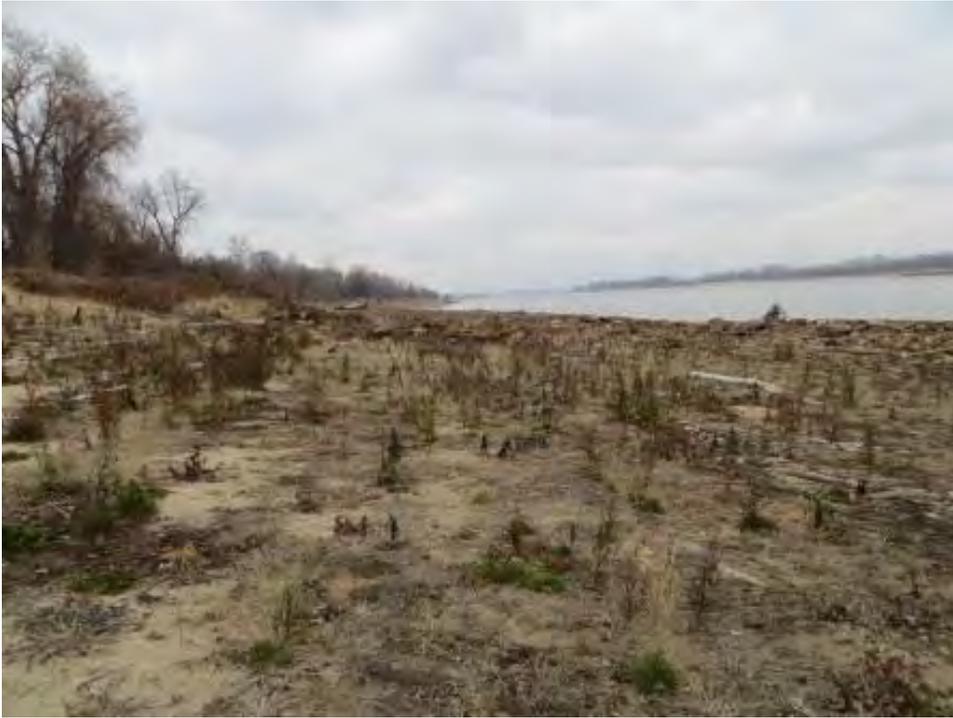
Lower riprap looking north-extensive siltation
photos courtesy of Ramona Huckstep, MDNR

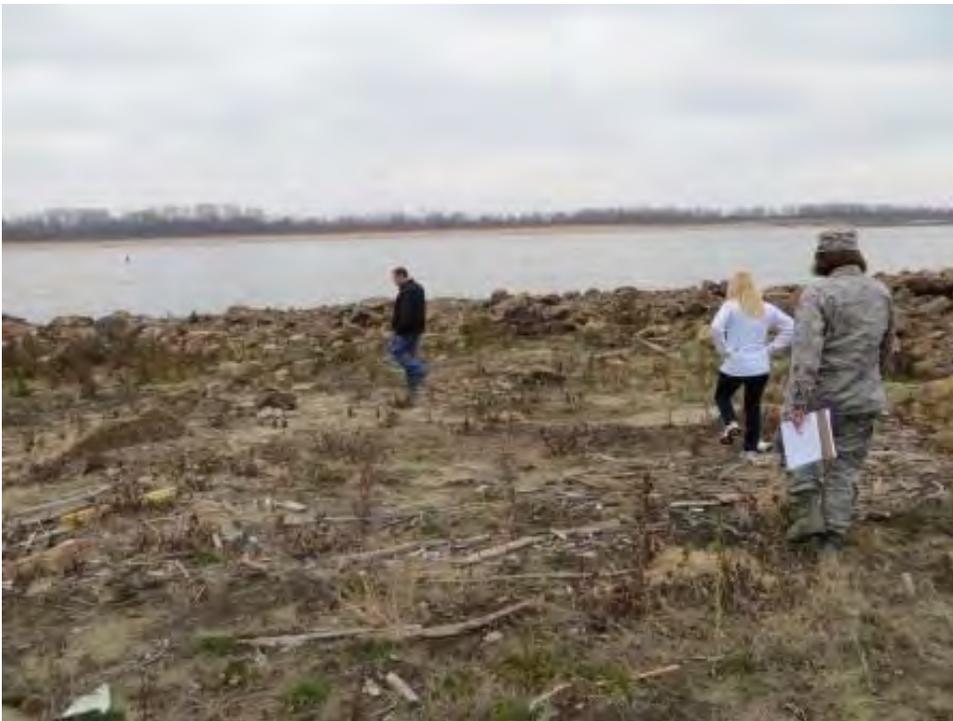
Lower riprap area looking southeast- extensive siltation

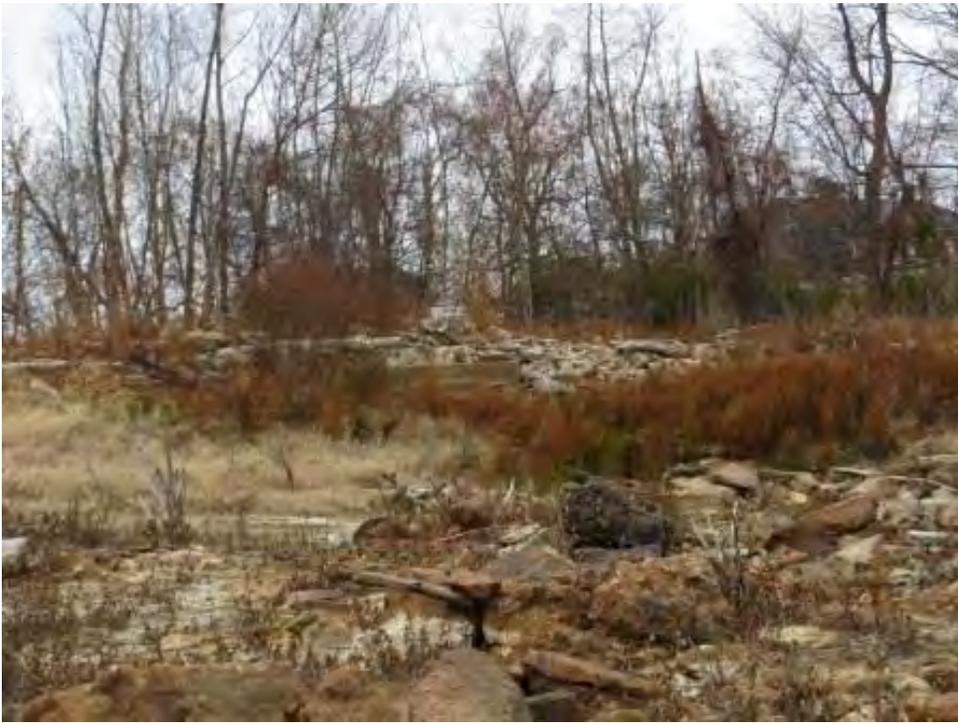
Looking west at upper riprap- extensive vegetation

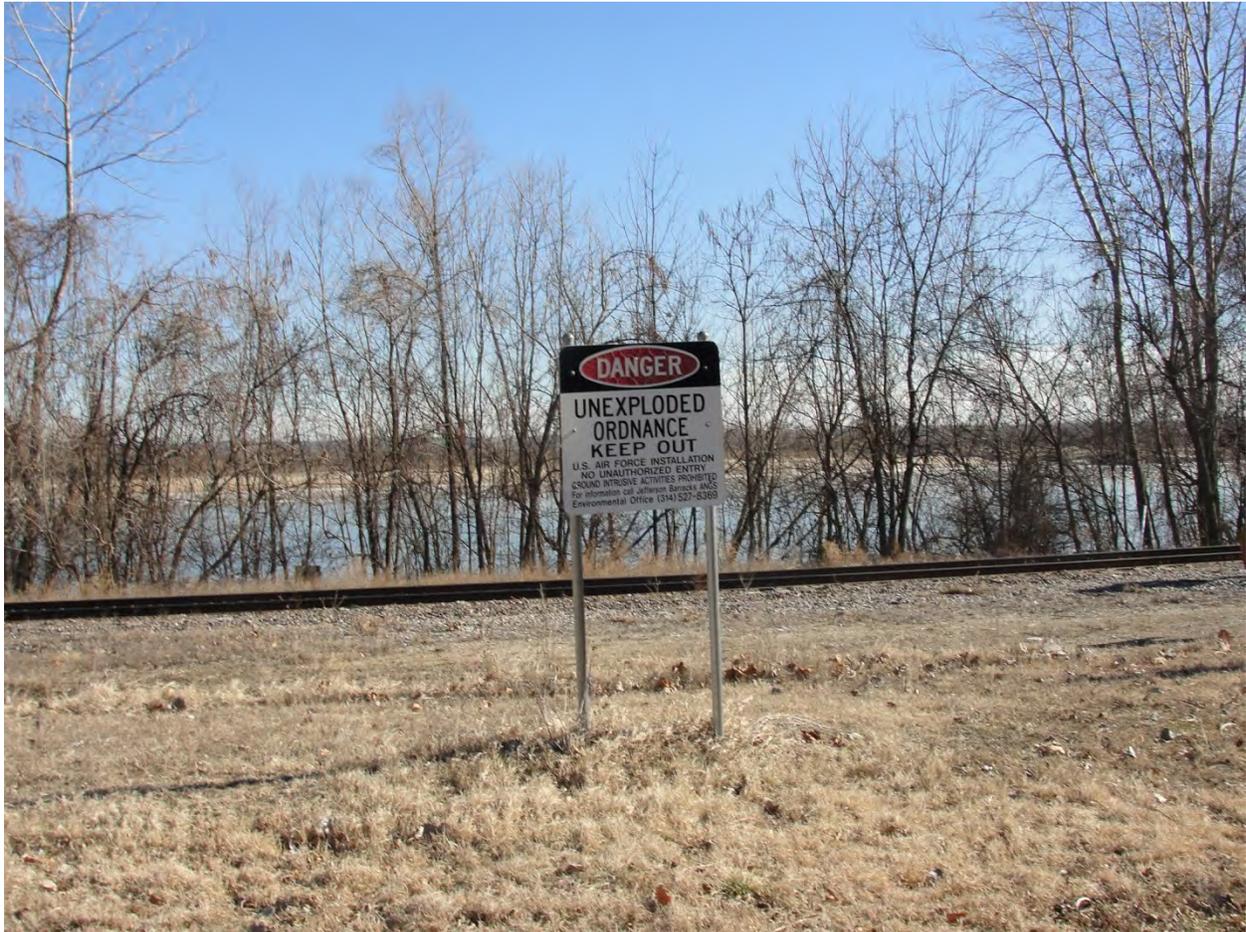
Description: Warning Sign No. 3, located at the end of the entry road depicted in Photo 1; note railroad tracks running parallel to river located directly behind sign; the top portion of Sign #9 is visible just above the RR tracks and to the left of Sign #3.

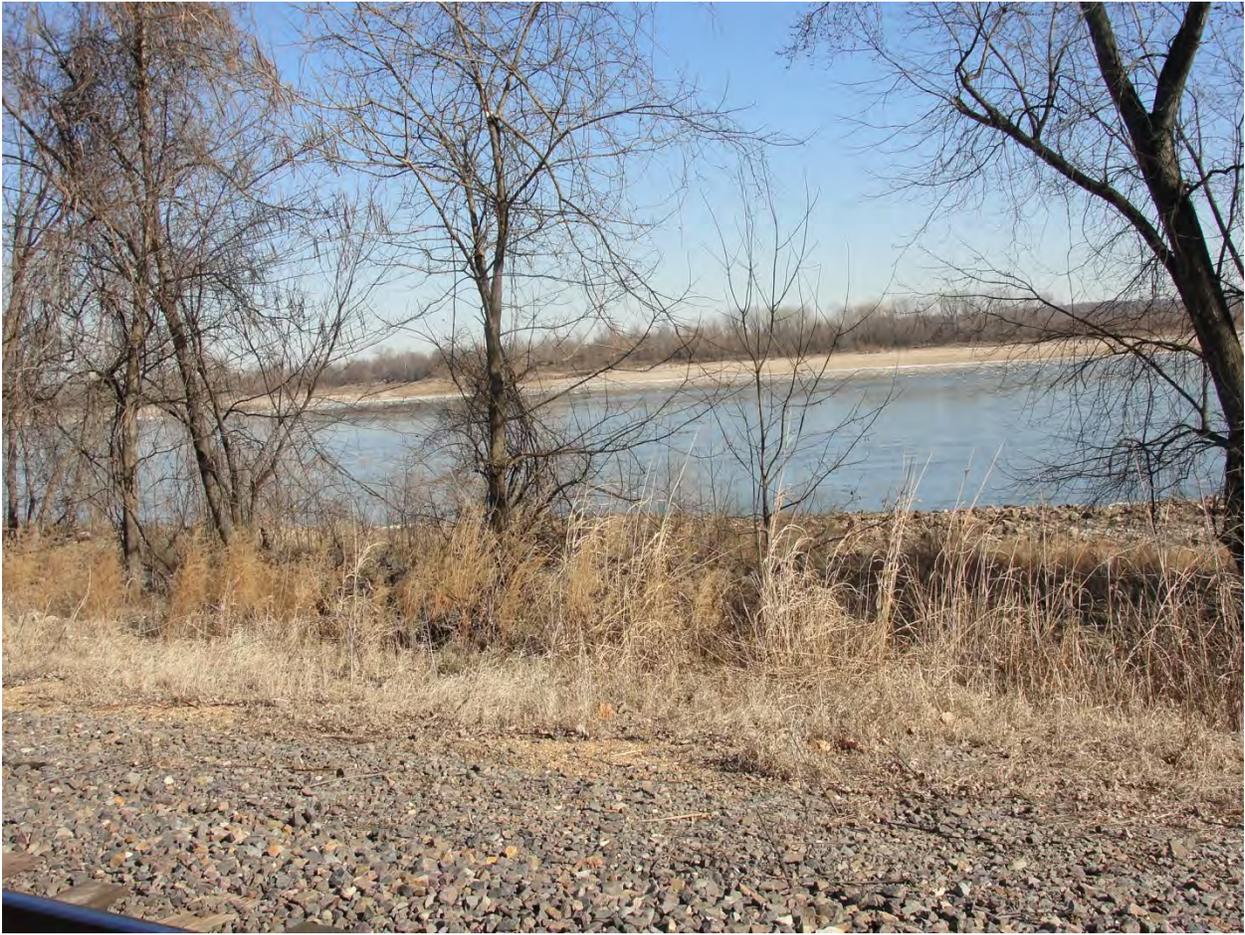
Photo 6. Jefferson Barracks Former Post Dumping Grounds

Description: View is to the east, from east-side of railroad tracks; Warning Sign No. 8 is visible; the original Warning Sign No. 8 is severely undercut and its replacement has already been erected; riprap is visible between the river and the tree line.

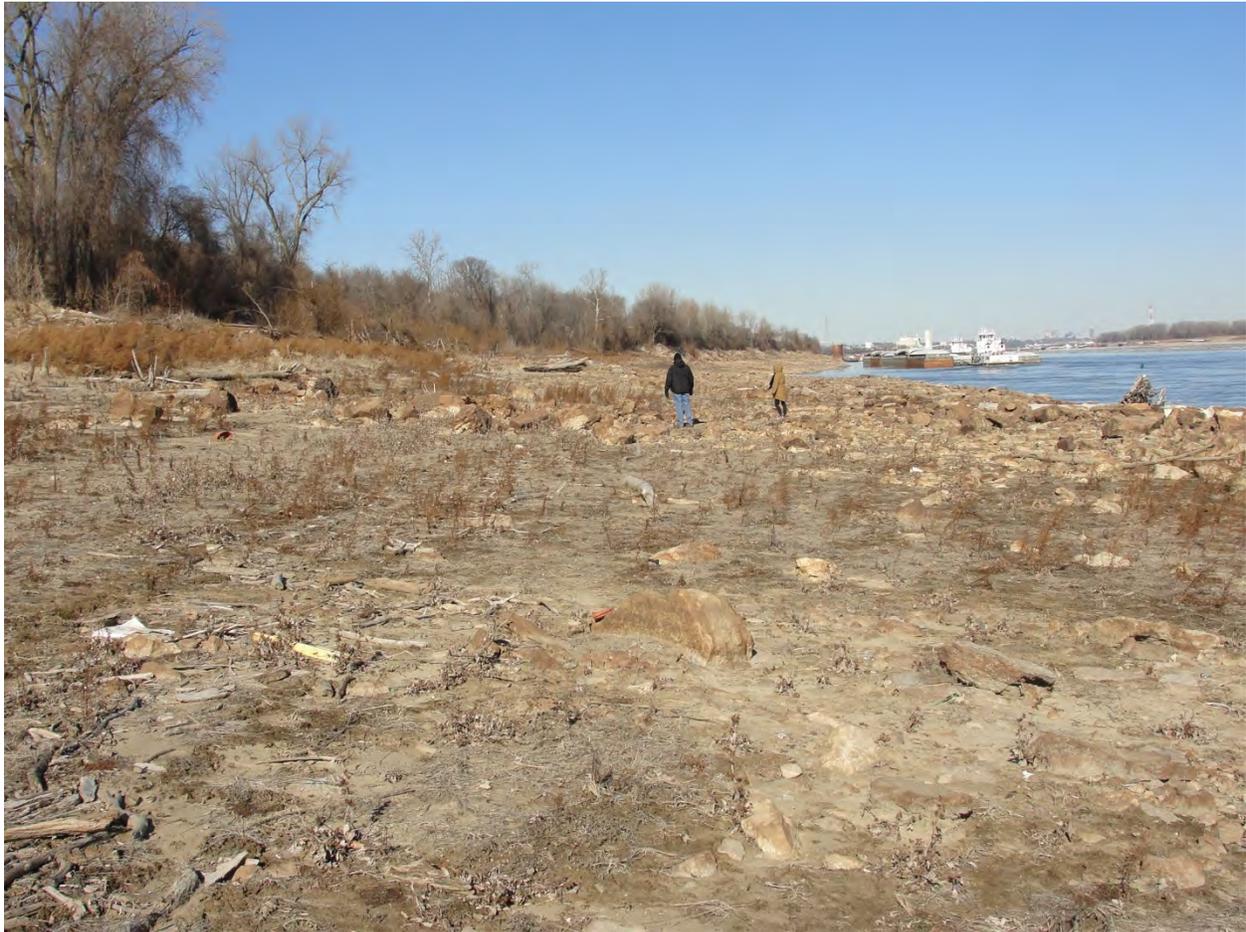
Photo 22. Jefferson Barracks Former Post Dumping Grounds

Description: View is towards the north, taken from an area apparently having more sediment than adjacent area as riprap is not as predominant on the surface. USACE PM states that this area had received placement of riprap. Location is north of the erosion channel, between warning signs #8 and #9. Panoramic photo 1 of 2.

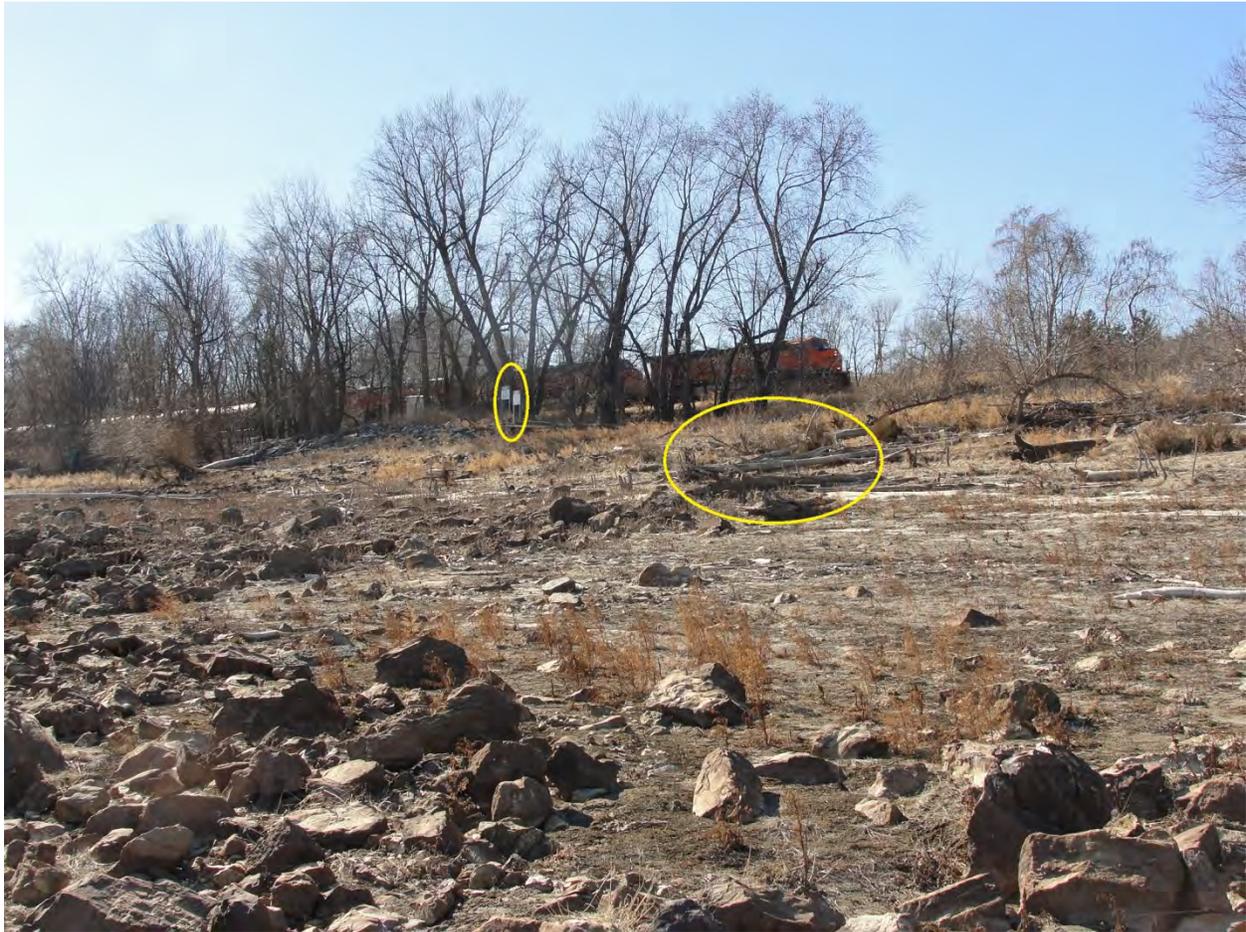
Photo 27. Jefferson Barracks Former Post Dumping Grounds

Description: Continuation of panoramic of photo #26, panning from looking south along the river towards looking westward toward the escarpment. Warning Sign No. 8 (paired with its replacement sign) is visible just left of center, and the erosion channel depicted in photos #18 through #20 is believed to be located at center-right.

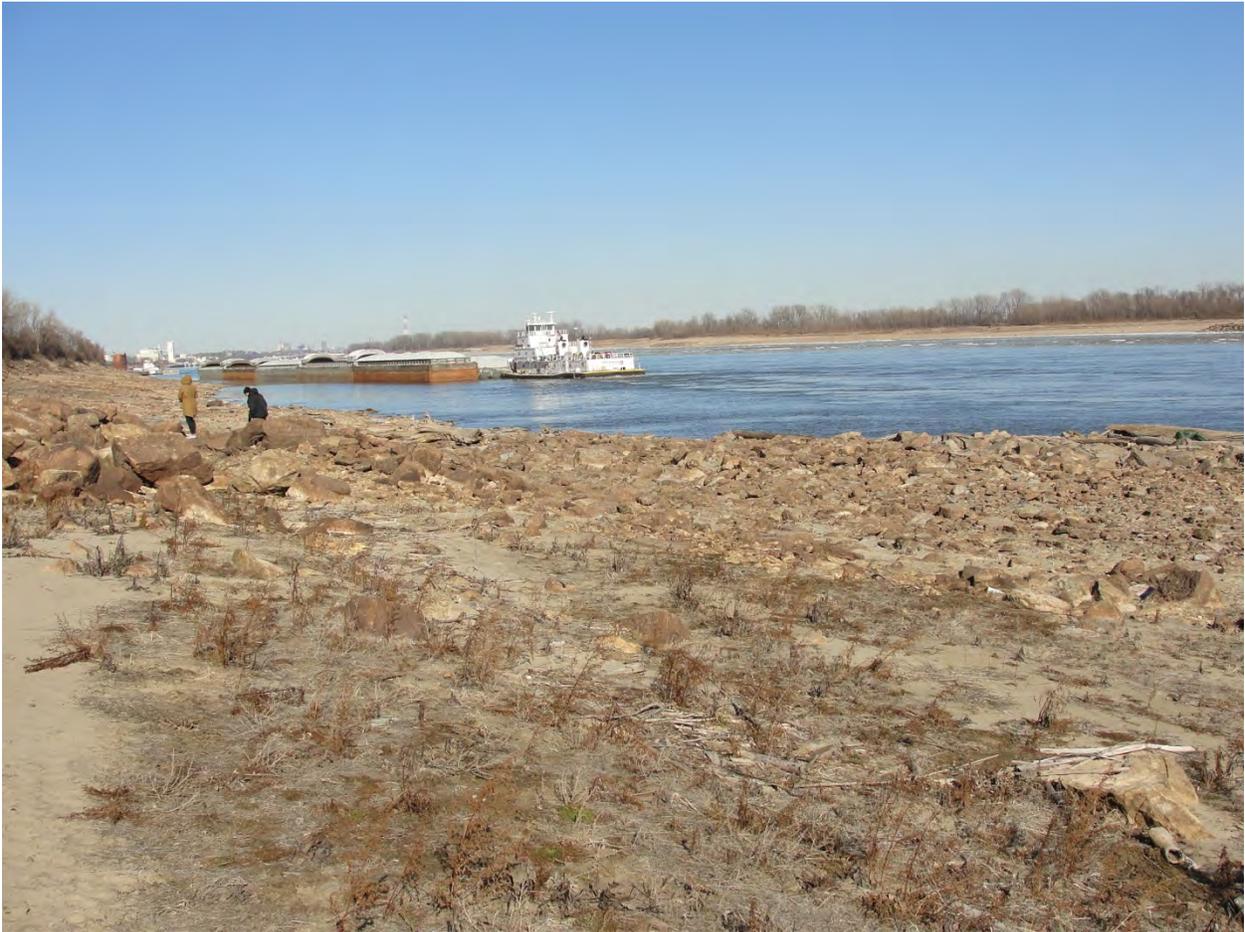
Photo 39. Jefferson Barracks Former Post Dumping Grounds

Description: Second photo taken from location of Photo 38, the camera has been panned towards the river (eastward); surface riprap is more abundant between camera location and the river.

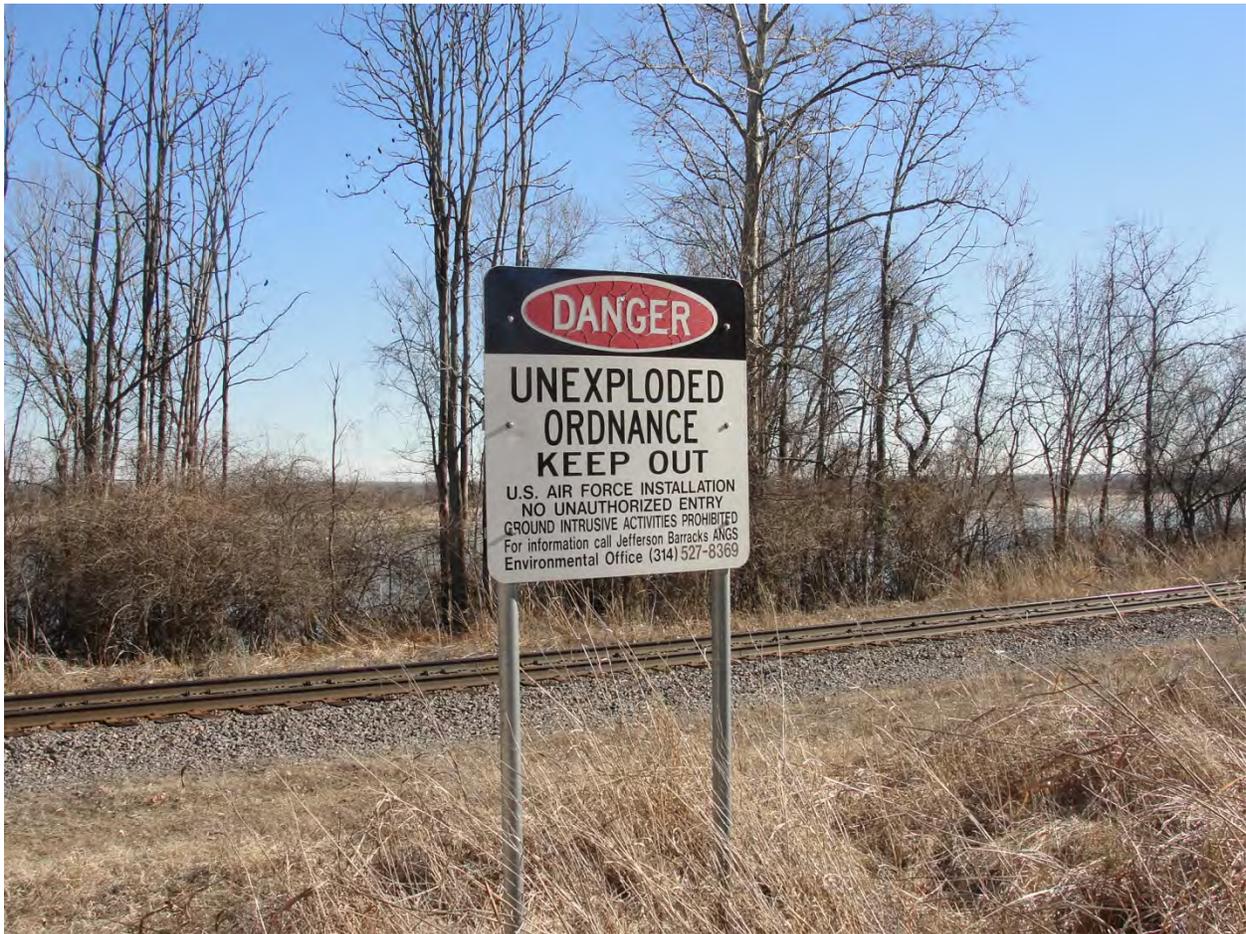
Photo 47. Jefferson Barracks Former Post Dumping Grounds

Description: Warning Sign No. 5, located on east side of railroad tracks.

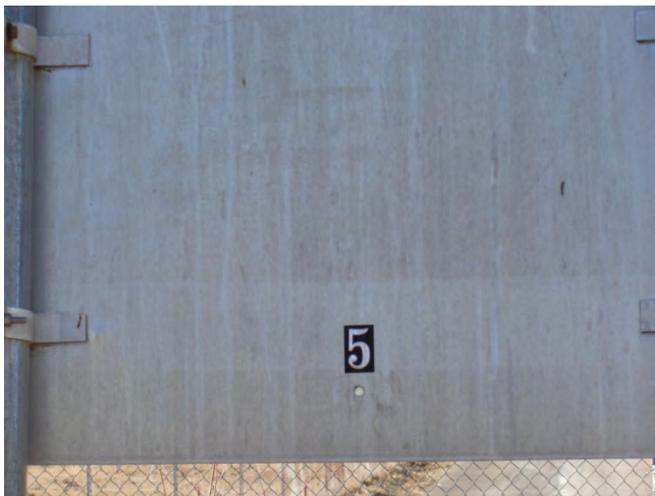
Photo 48.

Description: Backside of Warning Sign No. 5.

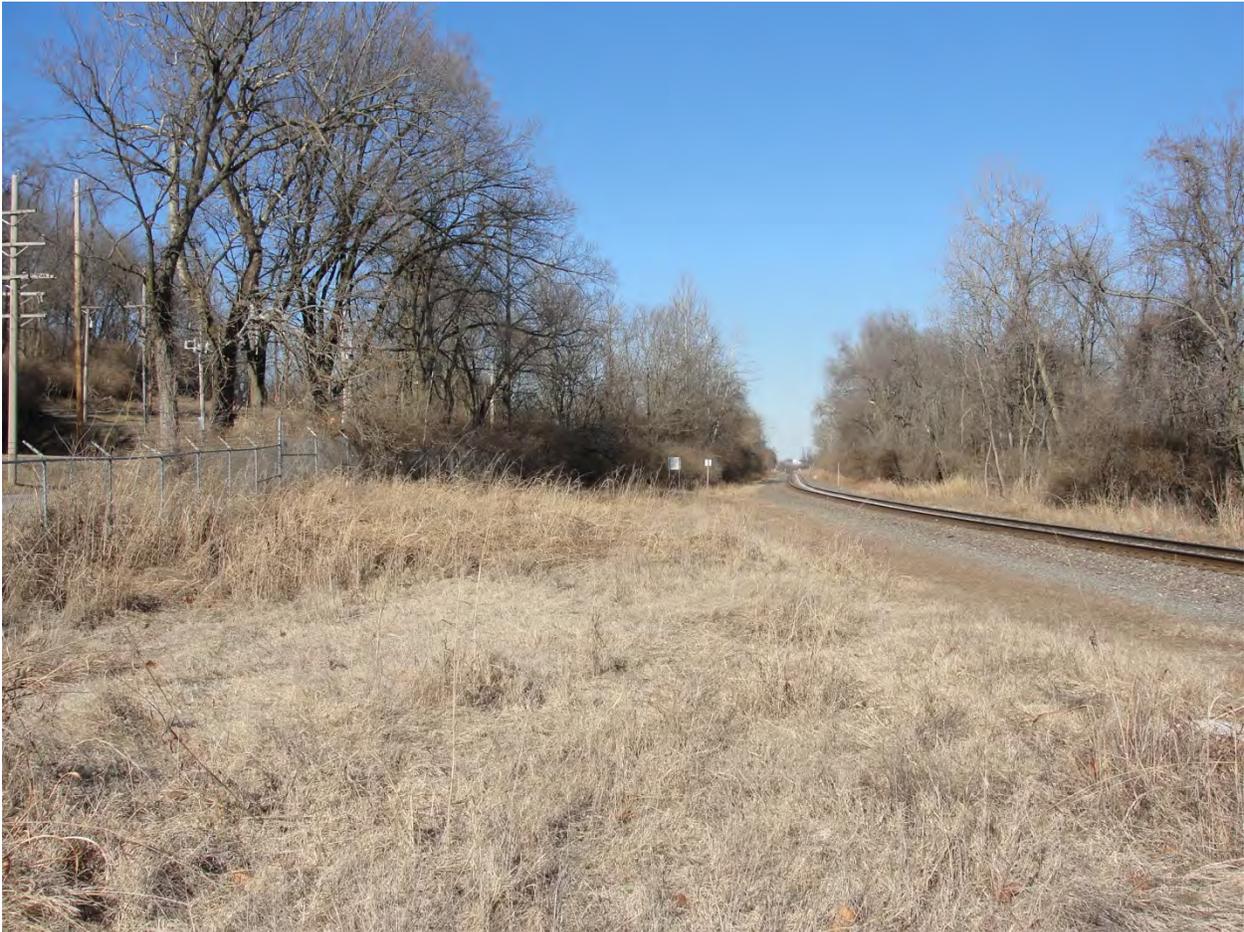
Photo 49. Jefferson Barracks Former Post Dumping Grounds

Description: View is towards the north, as taken from the vantage point of Warning Sign No. 5; the backside of Warning Sign No. 6 is visible at center of photo. Note chain link security fence topped with barbed wire situated west of the railroad tracks.
