RECURRING REVIEW REPORT
Former Jefferson Barracks Post Dumping Grounds
St. Louis County, Missouri

Defense Environmental Restoration Program
Formerly Used Defense Site
Site ID: B07MO0143

September 2014

U.S. Army Corps of Engineers
Kansas City District
Kansas City, Missouri

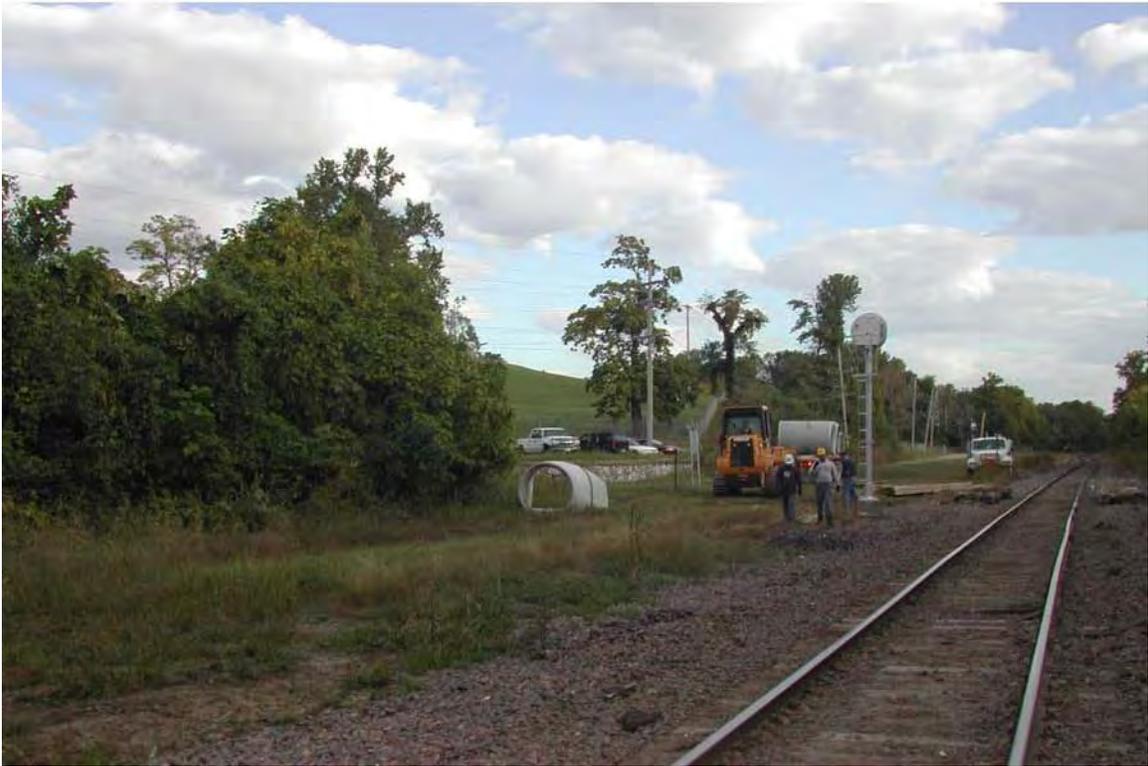
Figure 6

grubbing operations. The front end loader remained at the staging area (Figure 6) on the western side of the RR tracks to off-load sewer pipes and transport and stockpile crushed aggregate and rip-rap. The representative from MSD rejected the first loads of rip-rap (Figure 7) due to the fact that it failed the specifications for Class C stone. This issue was later resolved and the stone used. Work was periodically interrupted by passing trains (Figure 8). There were no other noteworthy incidents during site mobilization.

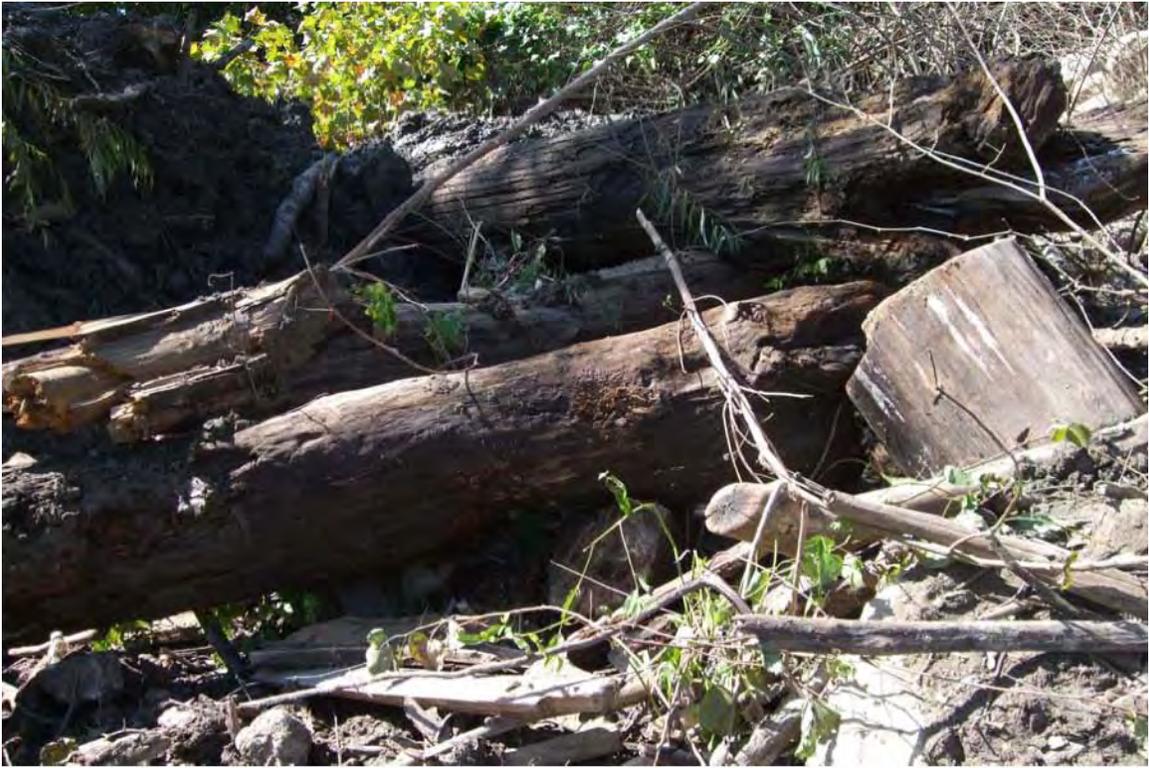
Figure 11

Prior to commencing with excavation/construction activities it was necessary to remove a band of vegetation from the eastern edge of the RR tracks to the bank of the Mississippi River (Figures 9-10); in addition to debris that had been deposited by flood water (Figure 11). The clearing operation was wider than originally anticipated. This was necessary to accommodate both the spoil piles and the volumes of materials that needed to be staged east of the RR tracks. Approximately eight trees having a trunk diameter of one foot or greater were taken down. The trunks of these trees were repeatedly used as temporary pads to support the weight of the trackhoe throughout the trenching and filling operations. The trunks were finally dug out and neatly placed side-by-side at the eastern base of the RR levy. This was done to enhance the wildlife habitat within the area.

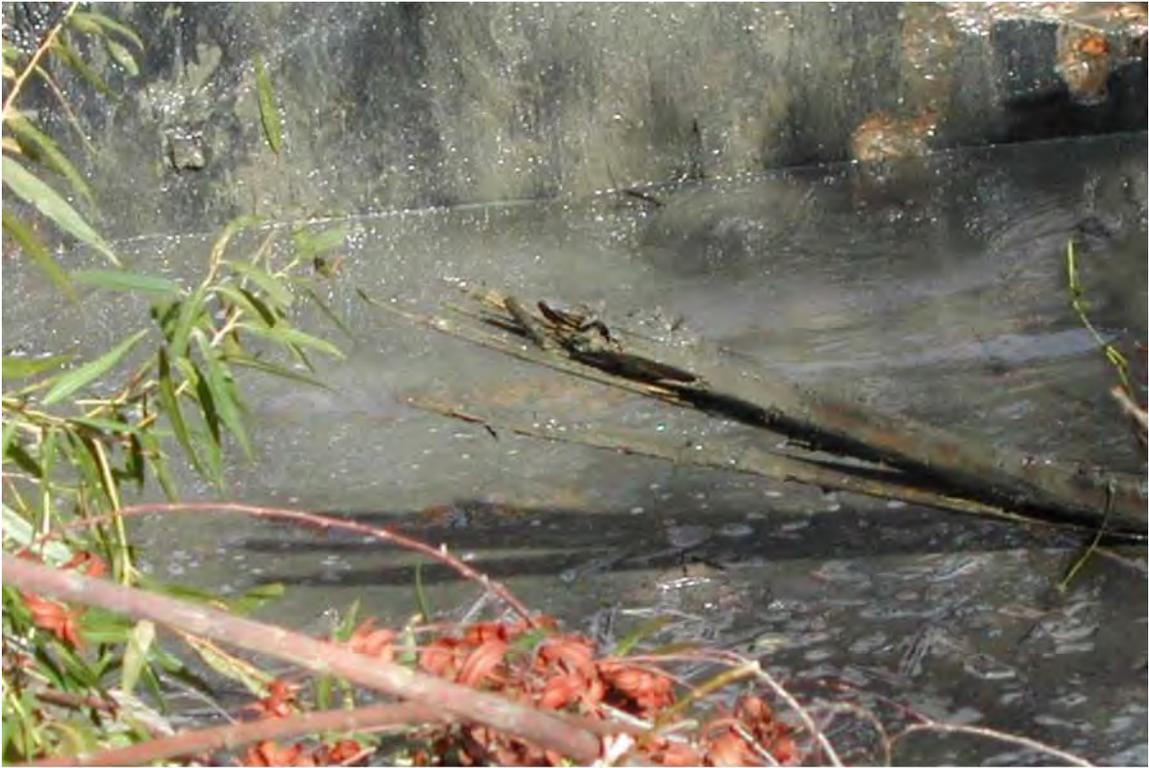
Figure 15

Excavation activities started at the location of the buried outfall of the historic sewer line. Excavated material was stockpiled parallel to the excavation (Figures 12-14). The trackhoe encountered the outfall and footwall (Figure 15) approximately 12 feet below ground surface. Both structures were constructed of CCC era concrete and proved extremely difficult to remove. The outfall was a concrete box channel with a semi-circular top (Figure 16– note raw sewage). Berra set the sewer flare pipe (Figure 17) at the location of the previous outfall and installed the first section of the sewer pipe (Figure 18). The elevation of the bottom of the flare was approximately one foot below the river's elevation. The trench remained open overnight and the fluid level in the trench equalized with the elevation of that of the river. The fluid in the trench was pumped out and measurements for the filter fabric lined, rip-rap channel were taken off of the end of the flare.

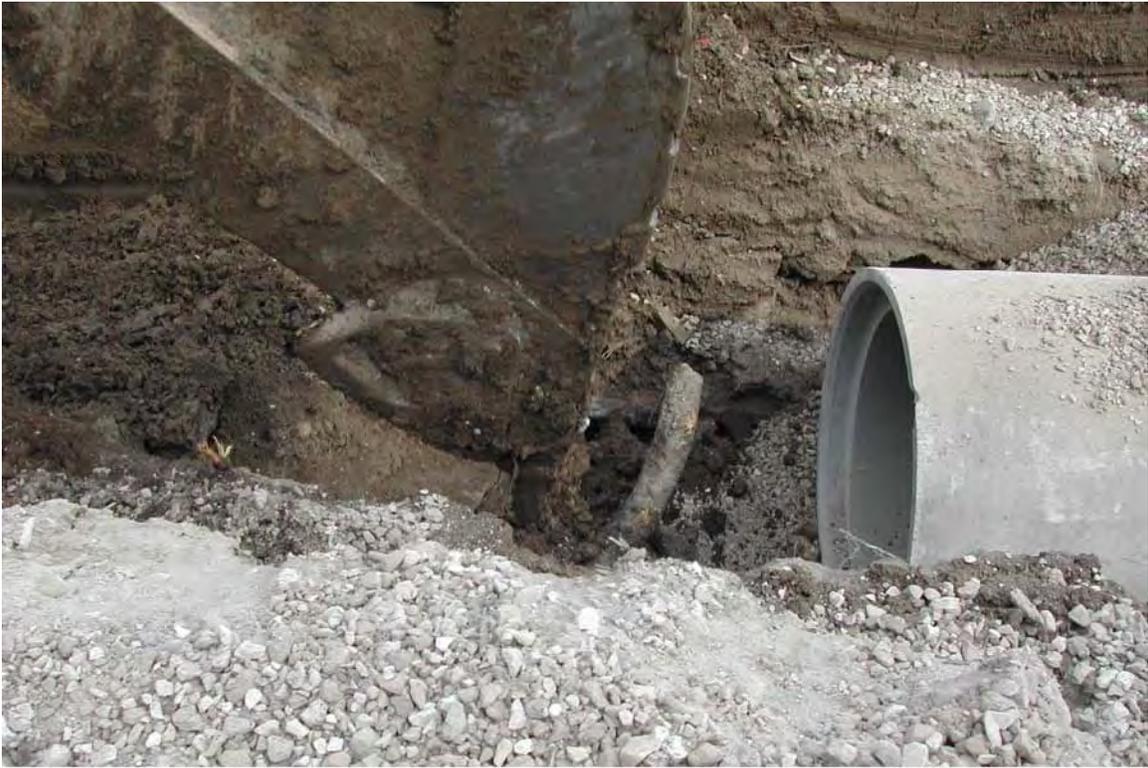
Figure 36

The sewer line replacement standard operating procedure was to excavate a sufficient length of the trench to allow for the installation of two sections of sewer pipe (Figure 33). The trench was excavated (Figures 34-37) to required depth, surveyed, backfilled with crushed aggregate (Figure 38), and pipes were set and joints glued. This process was repeated continuously until

The excavation removed the southern side of the 1930s era sewer (Figures 39-40). Due to unexpected site conditions the excavation was both wider and deeper than originally expected (Figures 36-37). The manhole was then removed (Figures 41-42). Shoring was installed (Figure 43) and the headwall was being installed. Although the excavation was still open at the time, MDNR suspended field oversight, the rip-rap remaining to be installed was staged at the end of the trench and the remaining spoil/backfill had been examined repeatedly for munitions debris and solid waste.

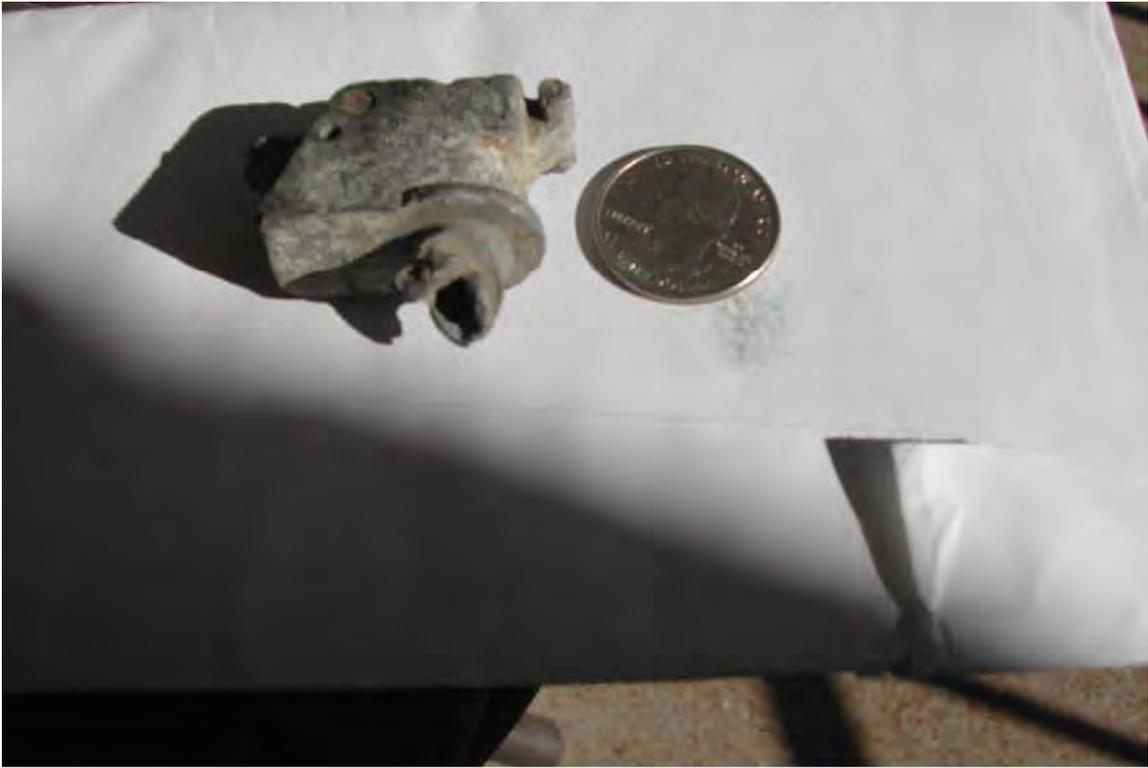
Figure 44

Mr. Mitchell Scherzinger and Mr. Patrick Anderson provided MDNR field oversight for this project. Their primary responsibility was to ensure that no solid waste or hazardous waste attributable to the Jefferson Barracks Dumping Grounds, were excavated. Their secondary responsibility was to assist the USACE in watching for excavated munitions debris and UXO. MDNR personnel scrutinized the material as it was being excavated (paying particular attention to sidewalls and the bottom of the trench), the spoil as it was being dumped, and the spoil piles. Spoil piles and disturbed areas were routinely reexamining for debris. Only two items potentially attributable to the Jefferson Barracks Dumping Grounds were encountered. These were found in the spoil piles. The first item resembles the remnants of a hand grenade fuse (Figures 44-45) and a slag (slightly magnetic) covered rock (Figure 46).
